Architectural Services Department

Appraisal and Architectural Impact Assessment Report of  
Clondalkin Library, Monastery Road, Clondalkin, Dublin 22.

30<sup>th</sup> August 2024

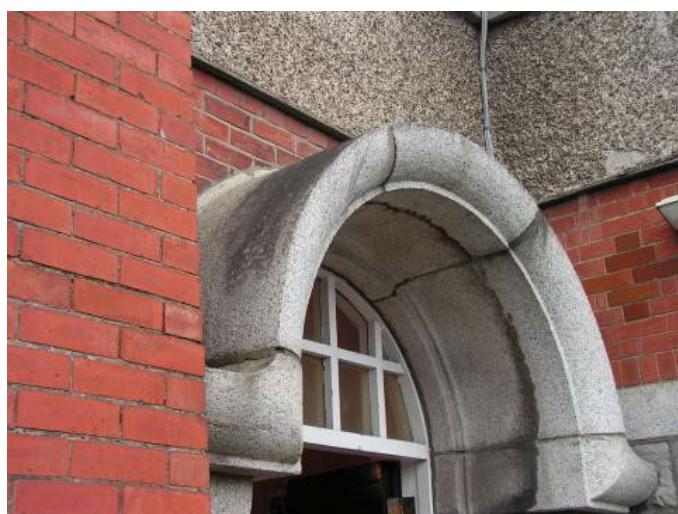
The granite hood over the entrance. Note the different texture, colour and finishing profile of the OPC binder mortar in the joints between the bricks in this area and the lime bonder mortar elsewhere. the fire exit.

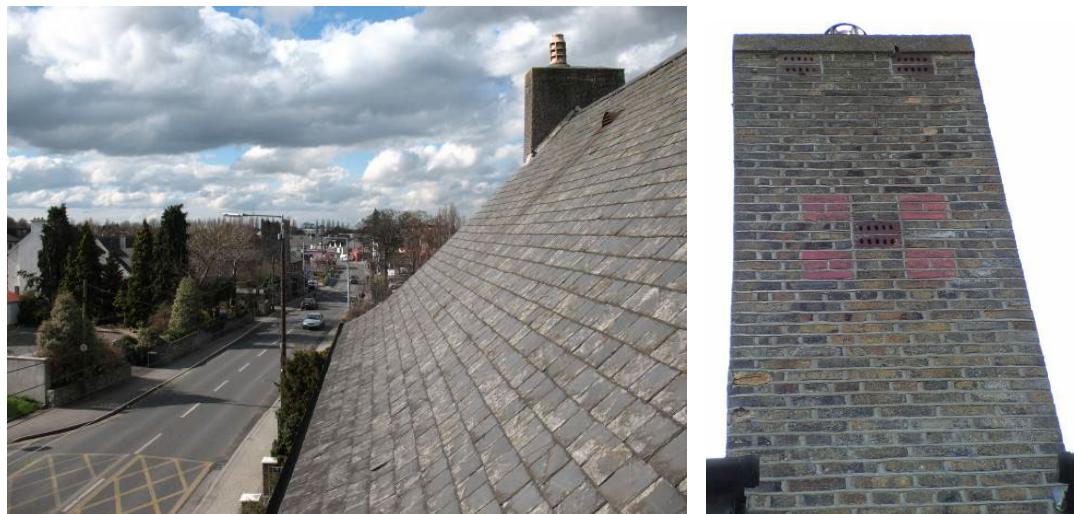
There are three chimneys, one above the centre of each gable and one above the middle of the northern wall. The northern chimney is built of a coarse yellow brick and has been re-pointed recently with a hard mortar. There is one cowl or chimney pot on the western chimney and a space where one is missing. Brickwork has recently spalled from the northern chimney.

The principal defect in the external walls of the library is localised dampness at one distinct location: the chimney in the centre of the northern wall and the immediate surrounding area. This is evident on the external facade by the extensive staining of the render on both sides of the chimney, particularly in the upper half of the façade. It is evident on the inner surface of the chimney where the internal paint has blistered and peeled from the wall. It is likely that this defect is caused by three, maybe four concurrent

1. Two rainwater gutters and soil vent pipes congregate at this point. The pipes and hoppers are generally in poor condition and the fall toward the down pipe is questionable.
2. The brickwork has been re-pointed with a hard, dense and impermeable OPC mortar which has altered the normal drying cycle of the brickwork, trapped moisture and led to spalling of the upper bricks during the recent cold winter.
3. There are insufficient vents in the flue. Formerly this would have been extensively ventilated by the open fireplaces.
4. The leadwork at the junction of the roof and the chimney may be defective. Further investigation is recommended here.
5. The condition of the top of the chimney is unknown. Further investigation is recommended here.

A view of the roof & northern chimney. Note the decorative pattern and the bright coloured patches of recently spalled brickwork.

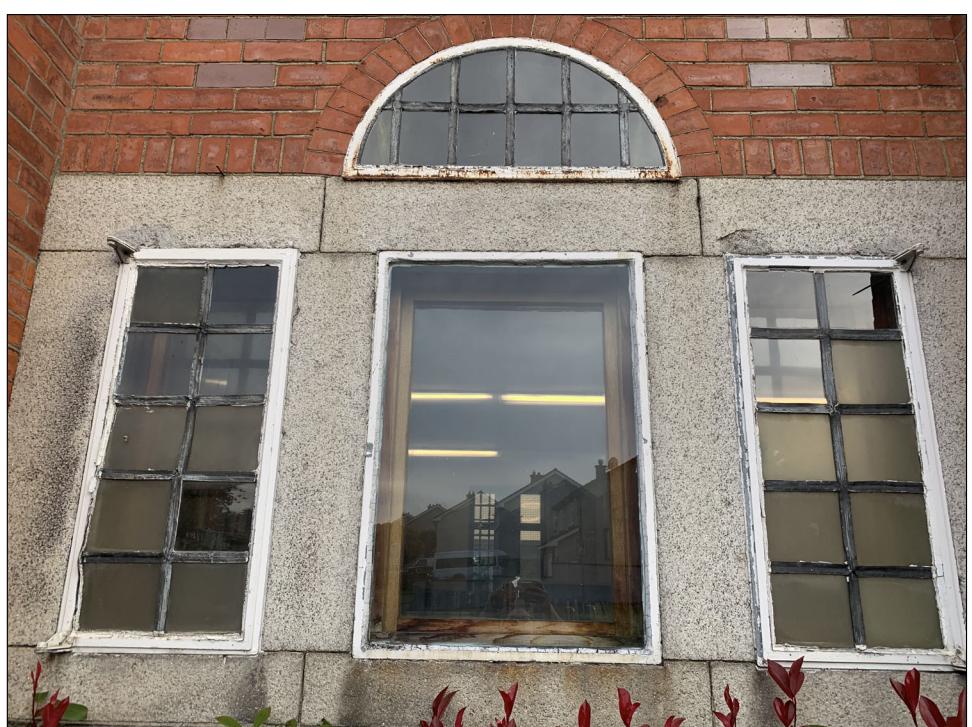
## EXISTING GROUND FLOOR WINDOWS (with perspex outerframe)

The windows are generally in good condition. Some of the casements have been painted shut in the past, are stiff with age and dust and can no longer be operated. One window in the north-eastern corner of the ground floor has been distorted as a result of mechanical damage, probably after being forcibly pried open in the past. Most of the windows still have their original ironmongery including their decorative scrolled handles. The steel framed window in the staff room is in poor condition; the plaster around its edge having fallen away and the window poorly re-fixed to the wall opening with plastic lugs in the recent past.
