ARBORICULTURAL REPORT

Tallaght - Knocklyon, Co. Dublin

South Dublin County Council - Tallaght Active Travel Scheme

13th September 2023

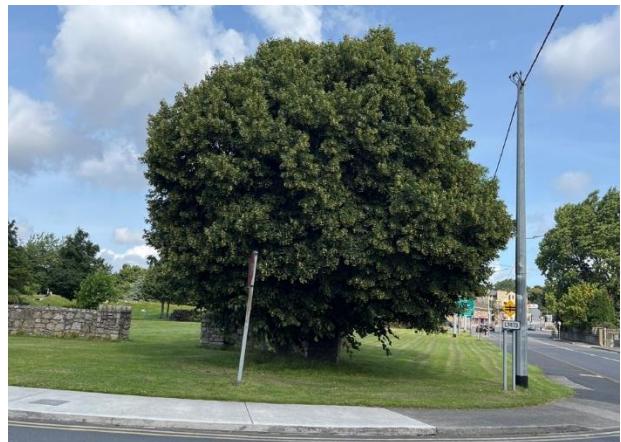
Image 22: Tag No. 7551

Tree No.	Species	Ht (m)	Stem Diam (mm)	Crown Spread (m)				C. Ht (m)	RPA (m) r	Age Class	Phys Cond	Struc Cond	Comments	Management Recommendations	LE (years)	Cat.
				N	S	E	W									
7551	common lime <i>Tilia x europaea</i>	8	410	5	3	5	3	2	5	Early Mature	Good	Good	It is growing in the open grass area at the entrance to Water Gate. Bark included junction developing from 1.5 m likely due to the crossing stems at this junction.	Prune lower branches for clearance when they are of a small size (fine presently). It would benefit from woodchip mulch being applied to the extent of its crown spread. Review bark included junction annually for signs of splitting.	40+	A2
7552	horse chestnut <i>Aesculus hippocastanum</i>	8	370	3	4	4	4	2	4	Early Mature	Fair	Good	It is growing in the open grass area near the entrance to Water Gate. Horse chestnut leaf miner is present	It would benefit from woodchip mulch being applied to the extent of its crown spread.	40+	B1

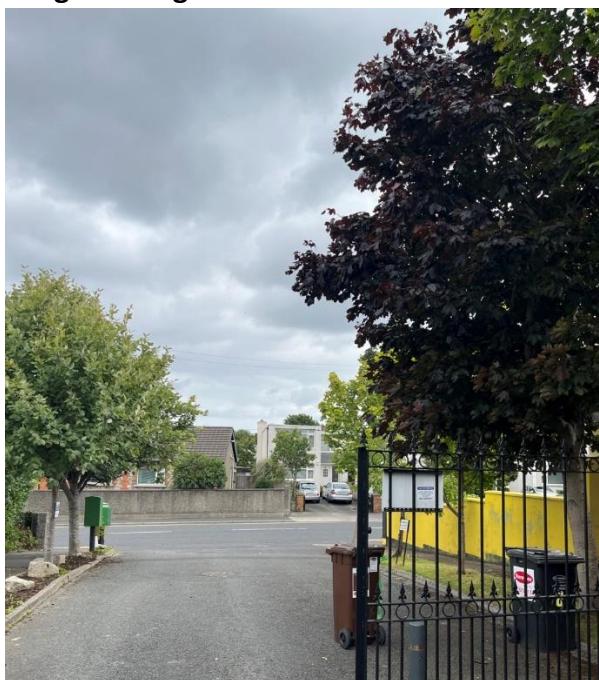
Image 25: Tag No. 7568

Tree No.	Species	Ht (m)	Stem Diam (mm)	Crown Spread (m)				C. Ht (m)	RPA (%)	Age Class	Phys Cond	Struc Cond	Comments	Management Recommendations	LE (years)	Cat.
				N	S	E	W									
7568	Norway maple 'Crimson King' <i>Acer platanoides 'Crimson King'</i>	7	240	3	2	3	2	2	3	Semi-Mature	Good	Good	It is growing in the grass verge between the public footpath and the entrance road to Old Bawn Court. Its crown overhangs the road	Prune branches over the road when they are over a small size, so to inflict minimal damage	20+	C1
7569	Norway maple "Drumondii" <i>Acer platanoides "Drumondii"</i>	4	70	1	1	1	1	2	2	Semi-Mature	Good	Good	It is growing in the grass verge between the public footpath and the entrance road to Old Bawn Court. Its crown overhangs the road	Prune branches over the road when they are over a small size, so to inflict minimal damage	20+	C1
7570	Norway maple "Drumondii" <i>Acer platanoides "Drumondii"</i>	4	70	1	1	1	1	2	2	Semi-Mature	Good	Fair	It is growing in the grass verge between the public footpath and the entrance road to Old Bawn Court. Its crown overhangs the road. Bark wound at base on northern side	Prune branches over the road when they are over a small size, so to inflict minimal damage. Review bark wound biennially for decay development	20+	C1

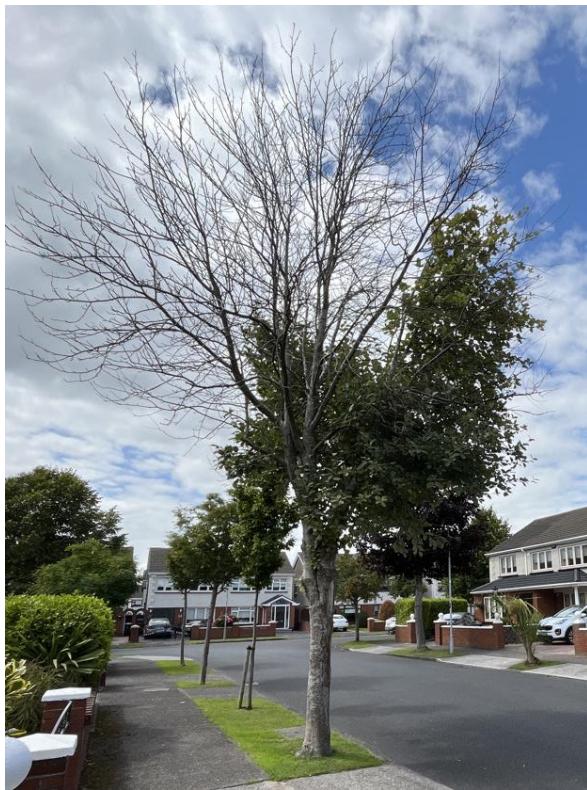
Image 28: Tag No. 7620

7620	whitebeam <i>Sorbus aria</i>	7	290	3	3	3	3	2	3	Semi-Mature	Poor	Poor	It is located at the entrance to Parkwood Road in the grass verge between the public road and path. It is in advanced decline, there is a bark included junction from 2 m and half of its crown is dead.	Remove and replace	<10	U
7622	flowering cherry <i>Prunus</i> sp.	3	170	1	1	1	1	2	2	Semi-Mature	Good	Good	It is located at the entrance to Parkwood Road in the grass verge between the public road and path. Its crown has been reduced in the past	Prune branches over road for clearance when they are of a small size so to inflict minimal damage.	20+	C1
7623	sycamore <i>Acer pseudoplatanus</i>	13	600	5	5	5	4	2	7	Early Mature	Fair	Fair	It is growing out of the grass verge between the path and road. Its lower branches have been removed to provide	Prune branches over road for clearance when they are of a small size	20+	B2

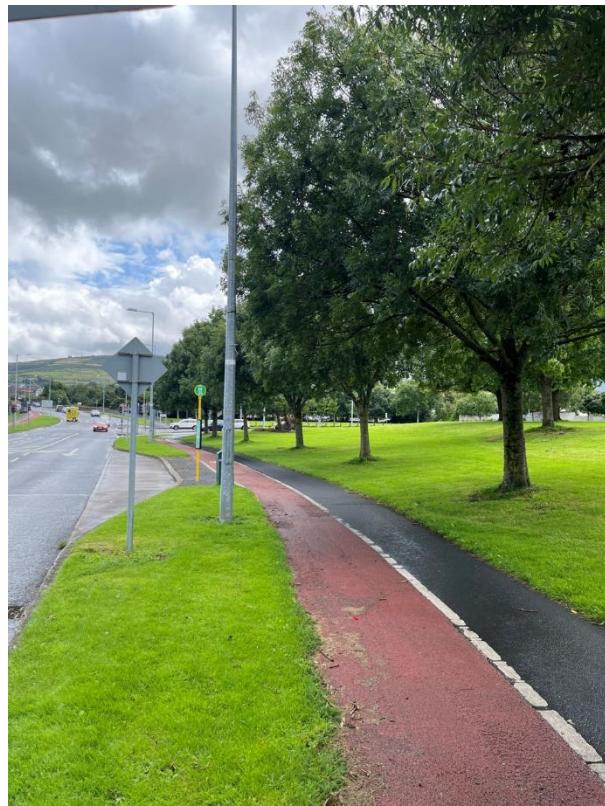
Image 30: Tag No. 7626 - 7633

7627	ash <i>Fraxinus excelsior</i>	6	240	4	4	4	4	2	3	Semi-Mature	Poor	Fair	It is growing in the open grass area and forms part of a tree line. Symptoms of ash die back, with small dead wood developing.	It will succumb to ash dieback in the future and need to be removed and replaced	<10	U
7625	ash <i>Fraxinus excelsior</i>	6	240	4	4	4	4	2	3	Semi-Mature	Fair	Fair	It is growing in the open grass area and forms part of a tree line. No symptoms of ash die back yet.	It will most likely succumb to ash dieback in the future and need to be removed and replaced	<10	U
7628	ash <i>Fraxinus excelsior</i>	6	240	4	4	4	4	2	3	Semi-Mature	Poor	Fair	It is growing in the open grass area and forms part of a tree line. Symptoms of ash die back,	It will succumb to ash dieback in the future and	<10	U

Tree No.	Species	Ht (m)	Stem Diam (mm)	Crown Spread (m)				C. Ht (m)	RPA (m) r	Age Class	Phys Cond	Struc Cond	Comments	Management Recommendations	LE (years)	Cat.
				N	S	E	W									
														with small dead wood developing.	need to be removed and replaced	
7629	ash <i>Fraxinus excelsior</i>	10	470	4	4	4	4	2	6	Early Mature	Fair	Fair	It is growing in the open grass area, set back from the line. Minor symptoms of ash die back.	It will most likely succumb to ash dieback in the future and need to be removed and replaced	<10	U
7630	ash <i>Fraxinus excelsior</i>	6	240	4	4	4	4	2	3	Semi-Mature	Poor	Fair	It is growing in the open grass area and forms part of a tree line. Symptoms of ash die back, with small dead wood developing.	It will succumb to ash dieback in the future and need to be removed and replaced	<10	U
7631	ash <i>Fraxinus excelsior</i>	6	240	4	4	4	4	2	3	Semi-Mature	Poor	Fair	It is growing in the open grass area and forms part of a tree line. Symptoms of ash die back, with small dead wood developing.	It will succumb to ash dieback in the future and need to be removed and replaced	<10	U

7632	ash <i>Fraxinus excelsior</i>	6	240	4	4	4	4	2	3	Semi-Mature	Poor	Fair	It is growing in the open grass area and forms part of a tree line. Symptoms of ash die back, with small dead wood developing.	It will succumb to ash dieback in the future and need to be removed and replaced	<10	U
7633	ash <i>Fraxinus excelsior</i>	6	240	4	4	4	4	2	3	Semi-Mature	Poor	Fair	It is growing in the open grass area and forms part of a tree line. Symptoms of ash die back, with small dead wood developing.	It will succumb to ash dieback in the future and need to be removed and replaced	<10	U
7634	ash <i>Fraxinus excelsior</i>	6	240	4	4	4	4	2	3	Semi-Mature	Fair	Fair	It is growing in the open grass area and forms part of a tree line. No symptoms of ash die back yet.	It will most likely succumb to ash dieback in the future and need to be removed and replaced	<10	U

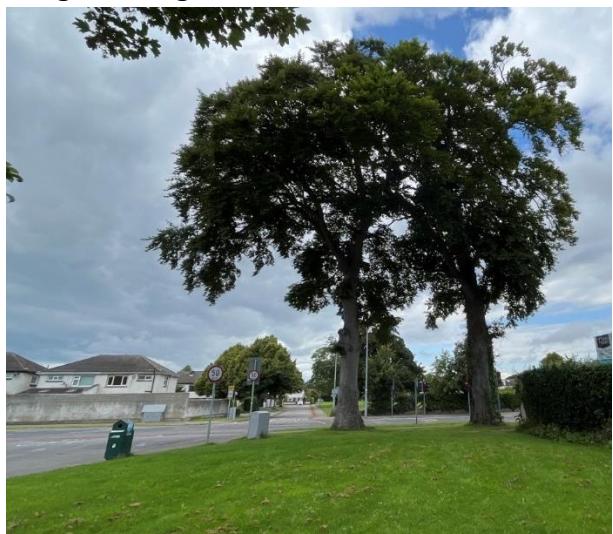
Image 40: Tag No. 1778 & 1779

4.4 The proposed footpath at the entrance to Castlefield Avenue would impact on the RPA of Tag No. 1778 & 1779. These trees are some of the only mature trees from this survey; therefore, the proposed footpath will either be realigned to outside of the RPAs or No-Dig methods will be implemented to mitigate soil and root damage, see section 5.7 & 5.17 of the AMS for more detail on No-Dig methods and working within RPAs.
