ARCHITECTURAL CONSERVATION REPORT

Rathcoole courthouse: Proposed Extension and Alterations to the former Court of Petty Sessions, Rathcoole, county Dublin

Part VIII Process, carried out under Part VIII of the Planning and Development Regulations 2001, Part 8.

Issued April 2021

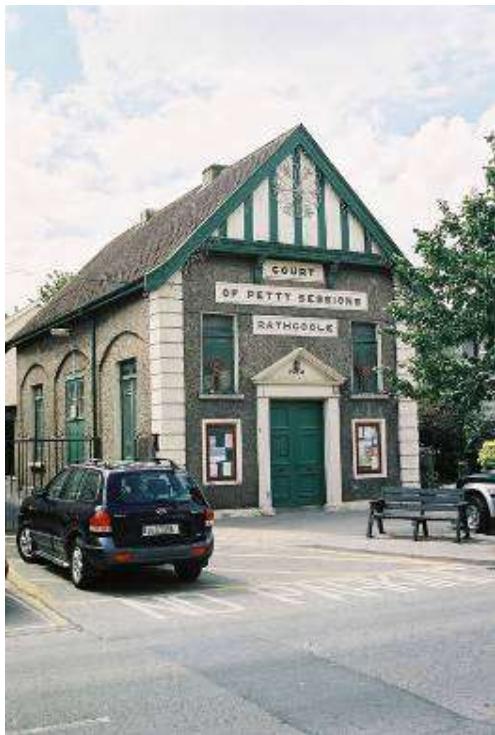
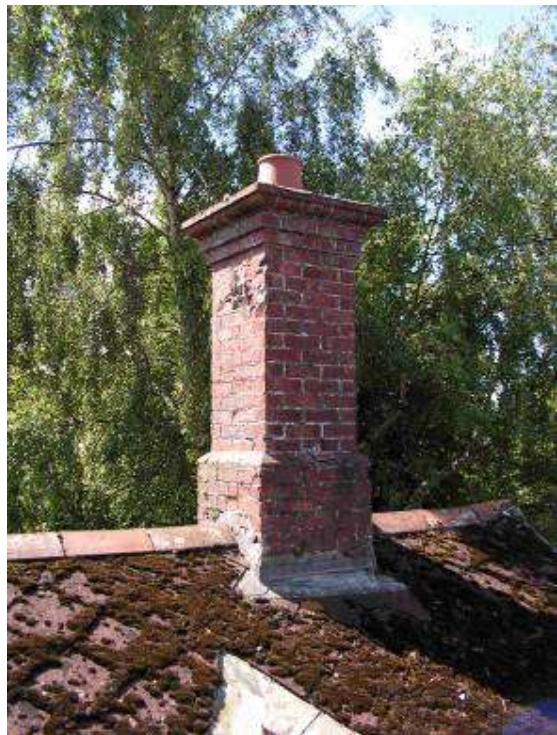
Left side: Photograph sourced from the Local Studies website of South Dublin County Council, filed as "4519-rathcoole courthouse, 2006-5533" and attributed to "T. Maher. Right side: A 2012 photo of the decorative brick chimney above the judge's robing room. Note the roof tiles and accumulated moss.

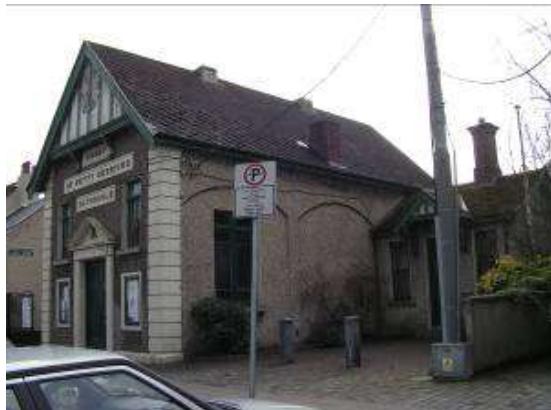
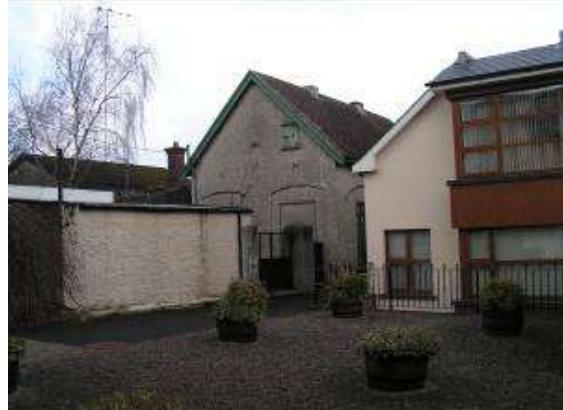
Left side: A view of the courthouse and forecourt from the south-east. Right side: A view of the rere gable of the courthouse. Note the sheds and gates to the yard. Note the small door to the attic space

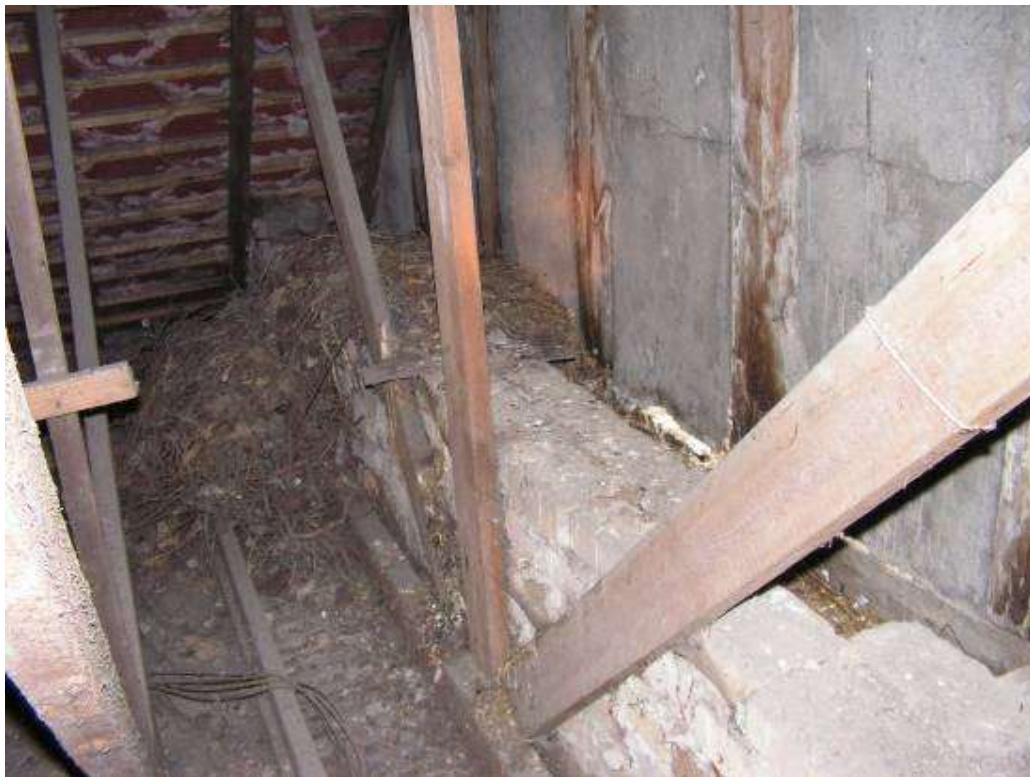
Some of the roof tiles have slipped or fallen in recent decades and been secured with lead and copper tingles or replaced with new tiles. This which has admitted rainwater to the attic which has caused localised decay of structural roof timbers and damage to internal finishes. The tiles are coated with a parging mortar on their undersides which was a common, traditional building technology to secure the tiles in place and to allow the gradual passage of any moisture out of the roof covering. Most of this layer of parging mortar has fallen away which indicates movement in the roof covering. This and the ongoing slippages of roof tiles means that this roof covering is approaching the end of its useful life.

A view of the north end of the attic above the court room. Note the King Post roof truss and the inner surface of the gable to Main Street, the remains of the lime parging mortar on the undersides of the tiles, the original plaster-on-lathe of the cornice (behind the parapet wall) and the modern plasterboard of the main ceiling to the left of it. The debris in the far corner is the remains of a bird's nest

In conclusion, we propose to remove the existing roof tiles and to replace them with new, similar fibre-cement tiles in a similar colour, profile, shape, size and pattern, laid on a breathable roofing felt.

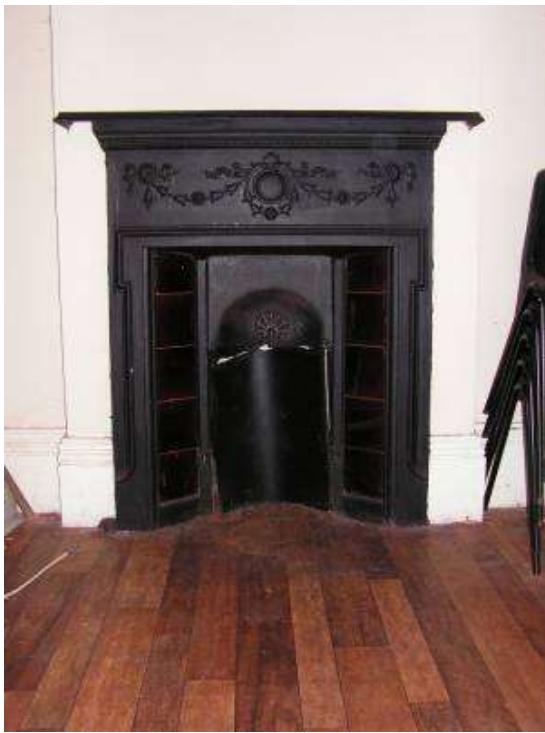
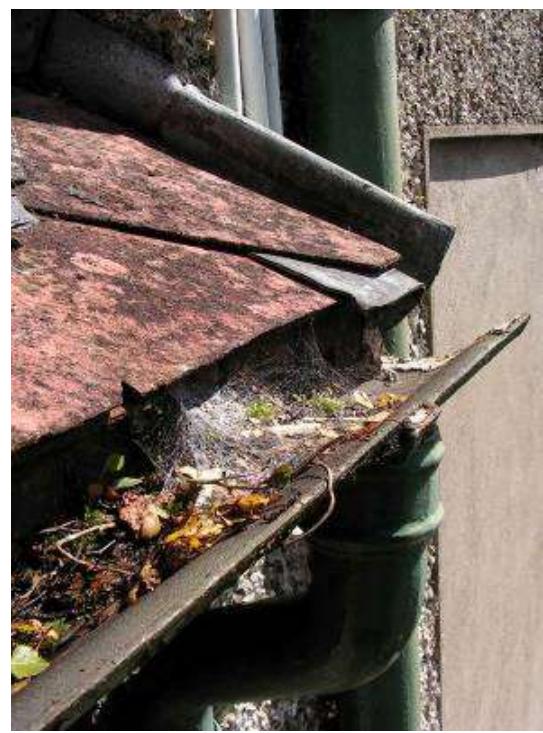
Left side: The cast iron fireplace in the former judge's robing room. Right side: A close up view of one of the asbestos cement tiles and debris-filled cast iron gutters.

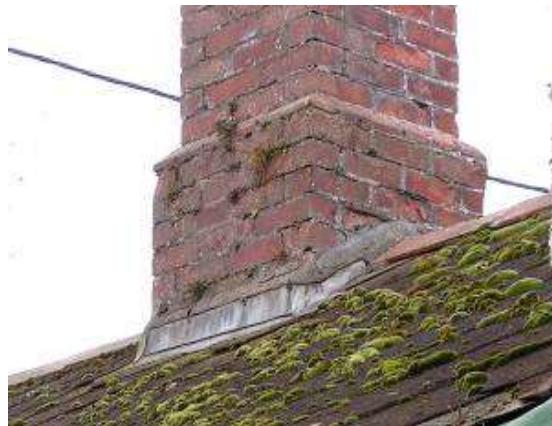
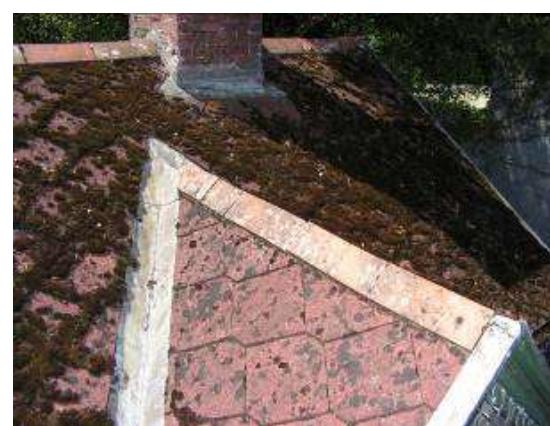
The tiles themselves are in places covered with a spongy organic growth of moss where shaded by trees – a common feature of these asbestos cement roof tiles. This growth has added to the weight of these tiles and to the mossy debris accumulating in the gutters below. This organic growth retains water and causes breakdown of the surface of the tiles during hard frosts and freezing weather. The removal of this growth is desirable, but its removal is a specialist skill because of the risk of releasing asbestos fibres during any mechanical cleaning.

Left side: The chimney above the robing room and part of the southern roof pitch of the smaller roof. Note the eroded mortar joints in the bricks and under the ridge tiles. Right side: The northern pitch of

the same roof. Note the spongy accumulation of moss and organic colonisation on the sheltered side.

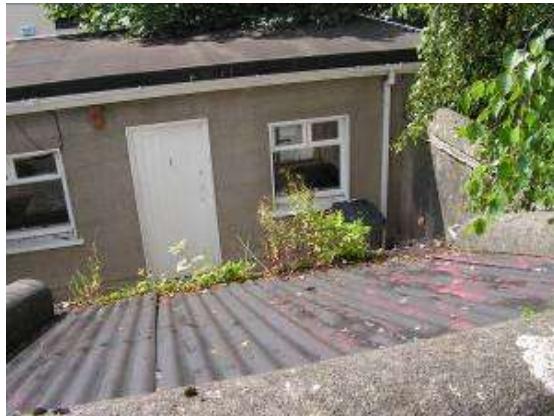
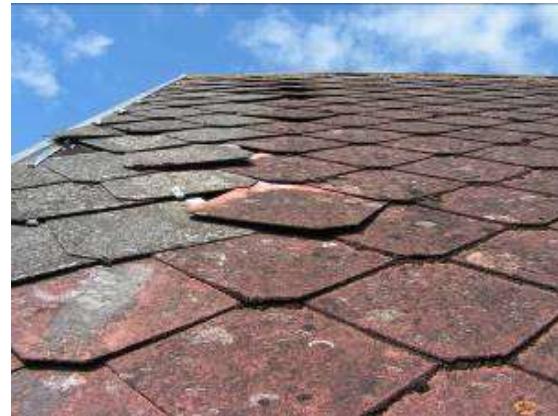
Left side: A corrugated metal roof above the boiler house and built-up felt roof over the offices. Right side: The southern end of the east pitch of the main roof. Note the grey-coloured tiles from a previous repair, two lead tingles, one gap where a cut tile has fallen away and slipped tiles. The most seriously

decayed timber in the roof space is below this area. The grey tiles also contain asbestos fibres.

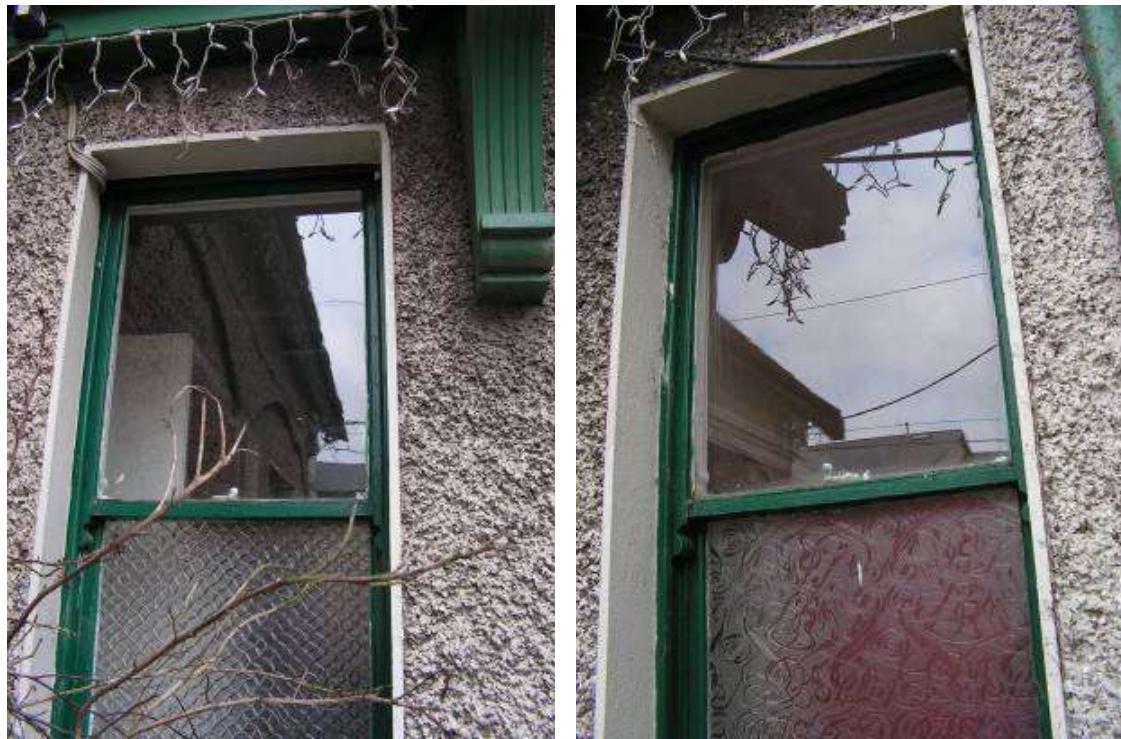
Left side: Historic rolled glass in the upper sash of the window to the former judge's robes room, probably original. Modern replacement patterned glass below. Right side: Modern float glass in the upper sash of the adjacent window to the toilet. A different patterned glass is used in the lower sash.

The large scrolled horns at the junction of the sash meeting rails and stiles are typical of the Edwardian period

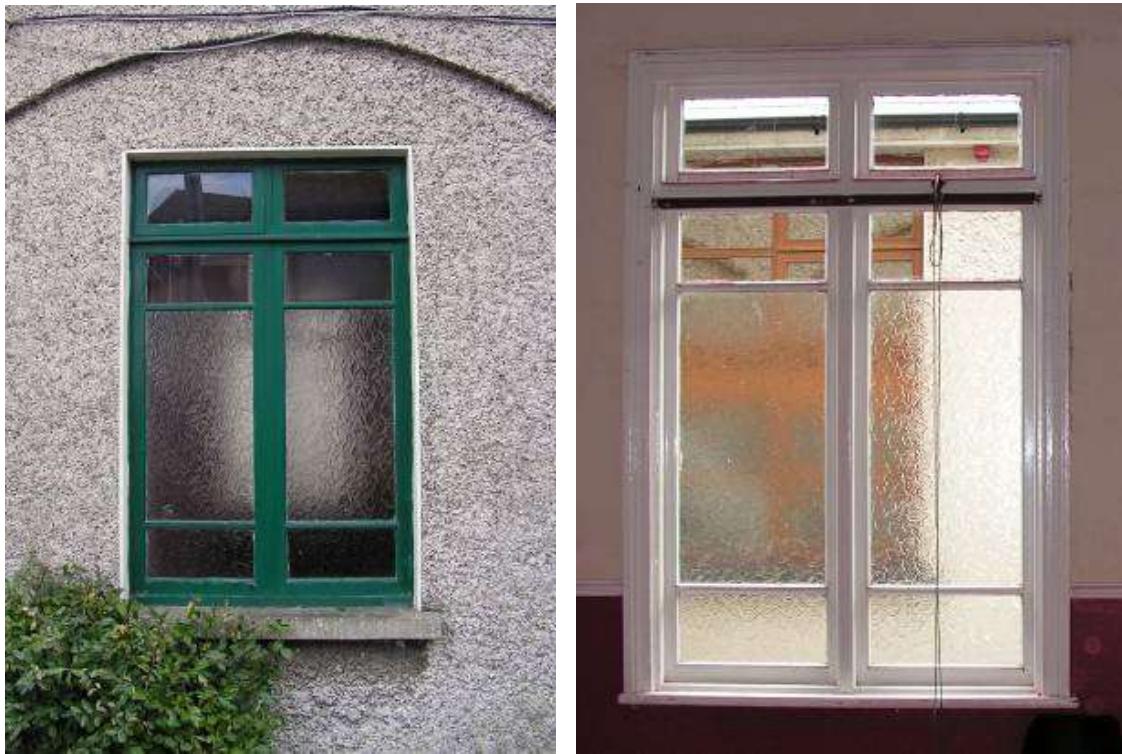
Left side: The casement window in the north-west part of the courtroom. Right side: The inside of the window in the south-east part of the courtroom. Note the cord which operated the upper vent lights

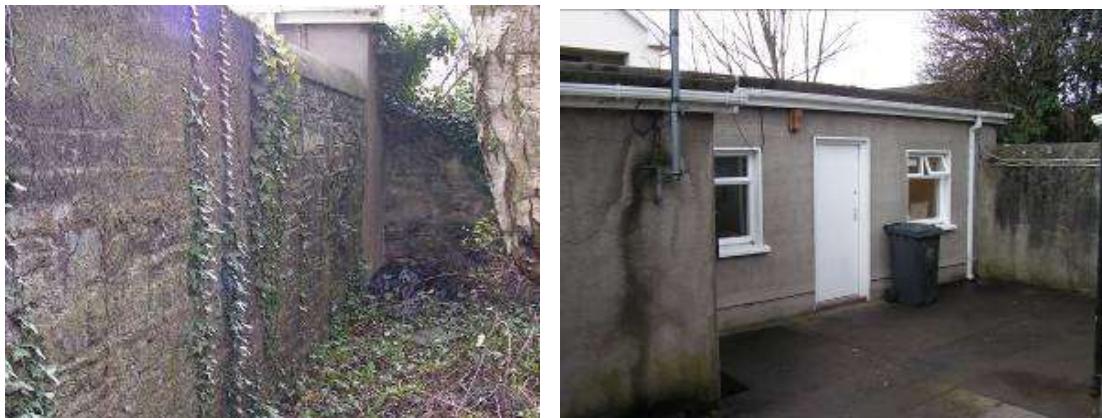
Left side: A part of the old western calp limestone boundary which is being colonised by ivy. Right side: The same wall viewed from the yard side where it has been rendered with sand and cement.

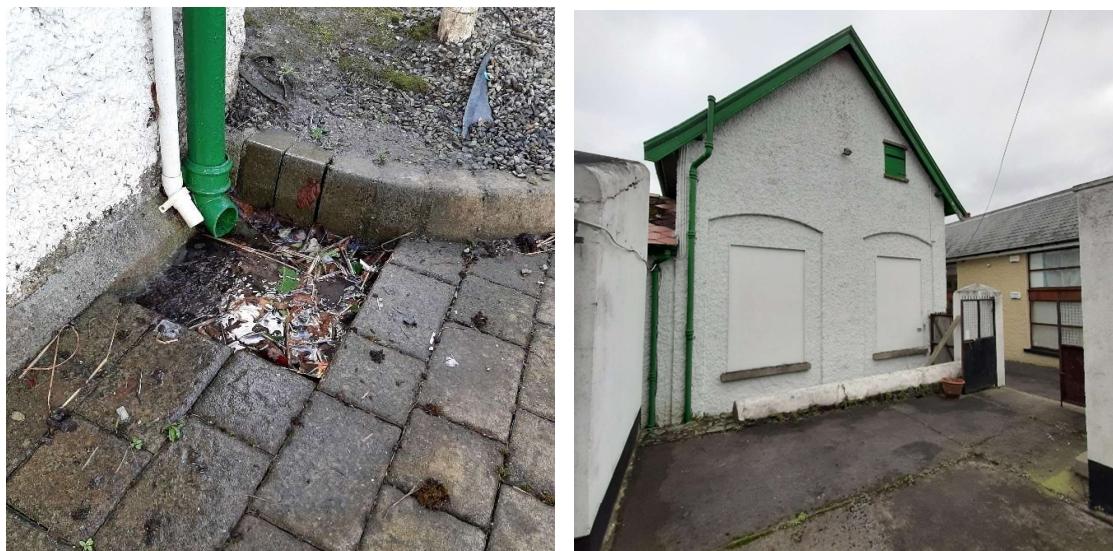
Blocked and distorted rainwater goods: Most of the cast iron rainwater gutters and down pipes are probably original to the building, some were replaced by conservation work in 2013 – 2014. The gullies to which the rainwater down pipes discharge are mostly blocked with debris, leaves and mud, causing the water to flow at high concentrations to the surrounding subsoil and into the walls and foundations. This is causing localised rising dampness in the walls and damage to the internal finishes near some of the gullies. This defect is the result of inadequate maintenance.

Two former window openings in the back wall of the courtroom were filled in with mass concrete or concrete blocks at some time in the past. No photographs which show the previous appearance of the wall and windows was discovered during research of the historical documentation.

Left side: A blocked and overflowing rainwater gully. Right side: The two former window openings in the rere façade which were blocked up.

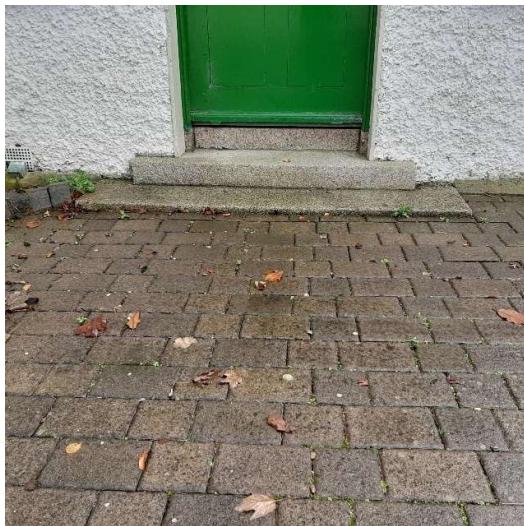
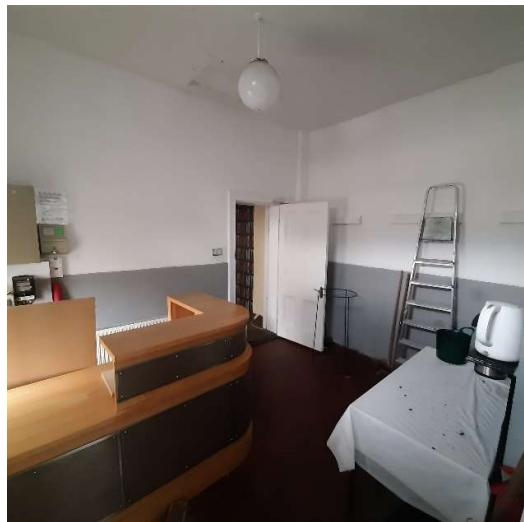
Left side: The lower granite step at the entrance to the former judge's robing room has been partly buried beneath the modern pavement. Right side: A view of the former judge's robing room.

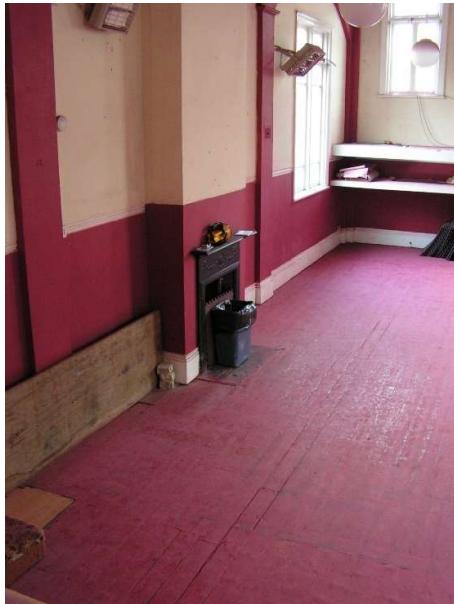
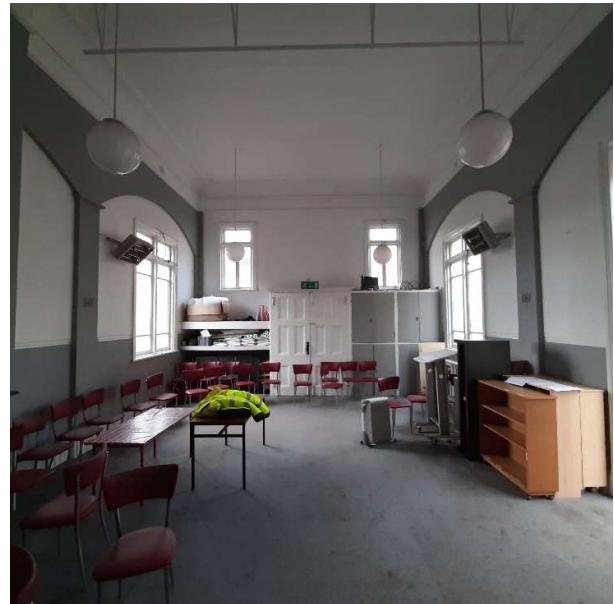
Two views of the interior of the former courtroom from a similar vantage point, in 2012 before the carpet tile and ply was laid on the floorboards and the interior was repainted, and 2021
