ARBORICULTURAL ASSESSMENT & IMPACT REPORT

CLONBURRIS SHD

DUBLIN 22

Project No.	Project name	Date	Revision
TCLO002	Clonburris SHD	25/04/22	B

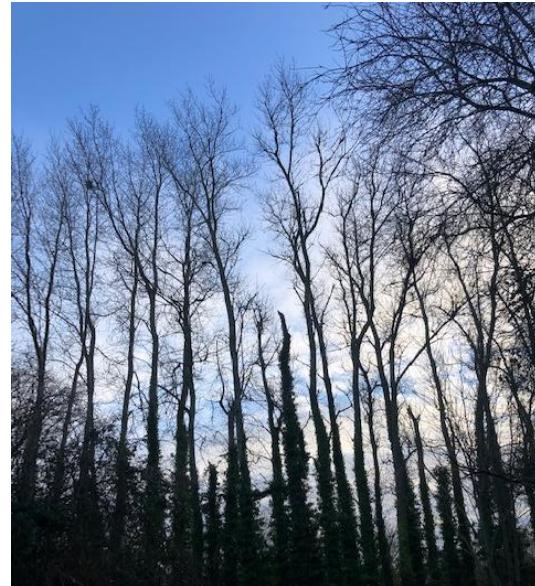
The screen / shelter-belt plantings are composed of hybrid black poplar (*Populus nigra* var) with original spacings of 1m (image 1). There has been no discernible management of the trees to date with the result that competition between trees has resulted in poorly developed specimens predominating throughout the planting. The corresponding loss of vigour could be a contributory factor in the development of bacterial canker throughout the plantings resulting in many of the trees becoming structurally weak. This species has also a limited lifespan particularly within urban areas where issues such as deadwood and structural weaknesses can be considered hazardous.

Image 1. Typical view of poplar screen plantings. Note the drawn-up nature and poor quality of the trees.

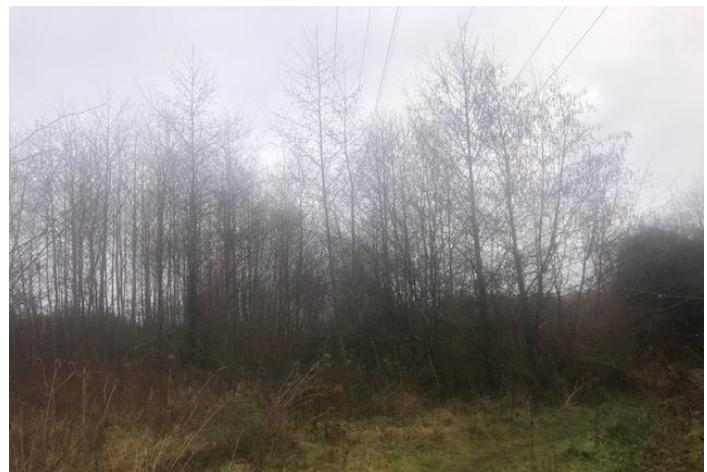
The internal linear plantings (image 2) were originally designed to be nursery stock for planting by SDCC with species such as Norway maple (*Acer platanoides*) and fastigate hornbeam (*Carpinus betulus 'fastigiata'*) predominating. The abandonment of tree production by SDCC has resulted in these linear planting developing without the normal thinning and pruning operations to select trees for installation into parks and streetscapes. The trees are now generally poorly developed and of poor quality. The relocation of any of these trees for use within the open space provision of the proposed development would be unlikely to be successful as normal practices to prepare trees for lifting such as root pruning and crown management have not been undertaken.

Image 2. Typical image of internal nursery plantings

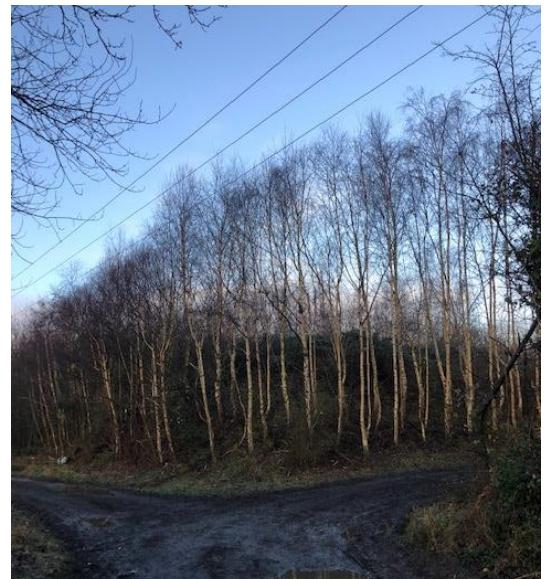
An internal screen planting of birch (image 3) has developed relatively well though the close proximity of trees has led to the development of a sub-dominant element within the planting. The SDCC depot accessed from Kishogue Lane contains a number of mature trees located within a small green space beside a stream within the yard (image 4). These trees which are primarily sycamore (*Acer pseudoplatanus*) appear to have been incorporated into the depot and probably originate from a former hedgerow. The condition of these trees is generally good though they contain varying degrees of management and age-related decay. A small number of trees most likely originating from this group are located by the roadside and are included within this report. Leyland cypress (*xCuprocyparis leylandii*) have been planted in this area but are of poor quality overall. A ditch with a hedgerow on both sides is located along the track leading from the depot into the main area of the site (image 5). This is primarily populated by alder (*Alnus glutinosa*) which have developed relatively well. In addition to the linear plantings described above the internal areas contain occasional self-seeded trees (image 6) such as sycamore, birch, goat (*Salix caprea*) and white willow (*Salix alba*). The condition of these trees is varied with the sycamore and willow generally multi-stemmed having been browsed or cut back in the past. Open areas are dominated by bramble (*Rubus fruticosus* agg) and buddleia (*Buddleia davidii*) forming impenetrable thickets.

Image 3. Birch screen planting

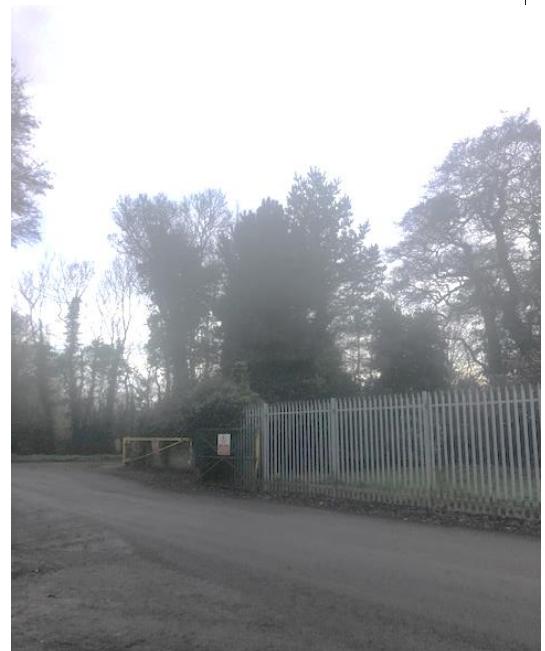
Image 4. Trees within depot lands

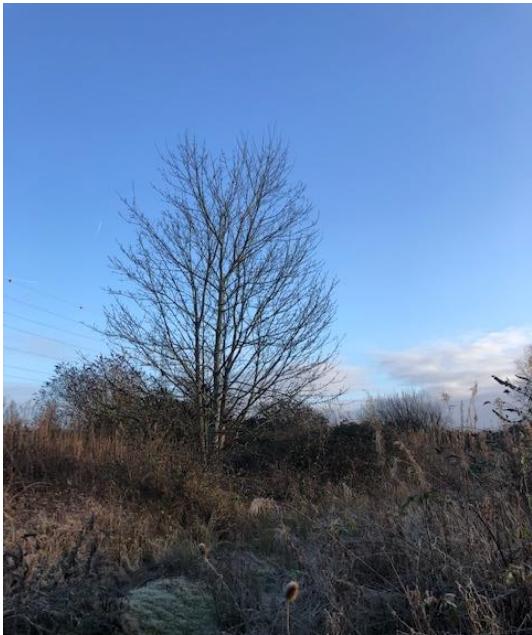
Image 6. Typical view of self-seeded sycamore within bramble scrub

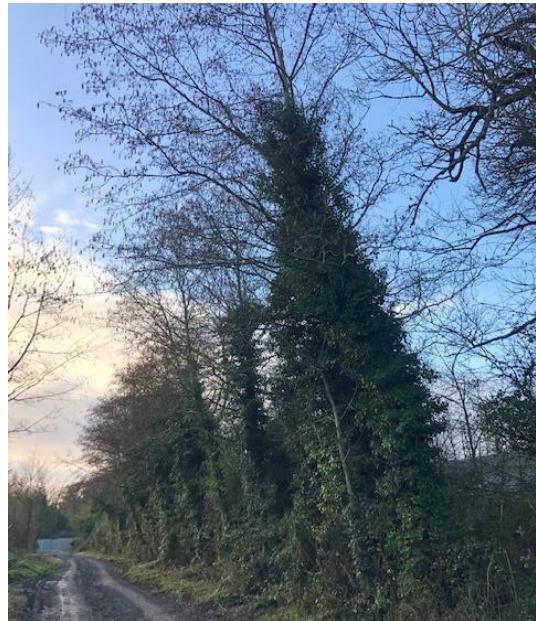
Image 5. Alder along track leading from Kishogue Lane

The alder along the stream provide a natural edge to the stream and ecological value as native species.
