**TREE SURVEY**

**Lucan Demense,  
Lucan,  
Co Dublin.**

**May 2024**

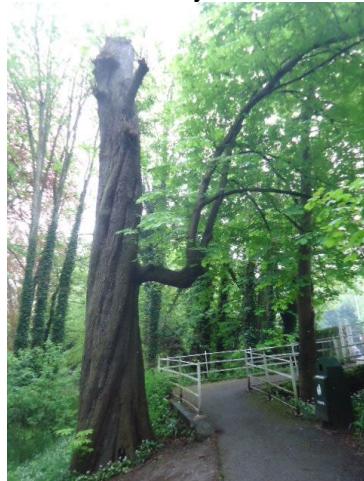
T1994 does however have a large branch overhanging the proposed boardwalk and given the trees declining condition it is recommended that this branch be removed if construction were to proceed.

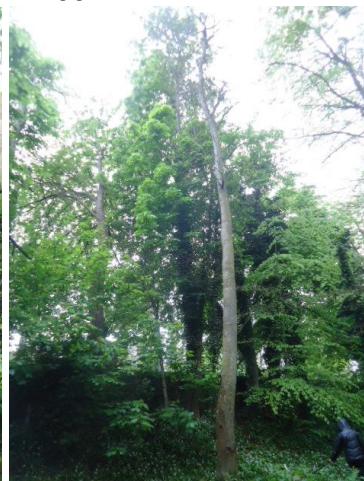
T950/T951

Tag	Species	Height (m)	Crown Spread (m) N/S/E/W	Diameter (mm)@ 1.5m	RPA circle radius (m)	Height lowest branch (m) & direction of growth	Life Stage	Estimated remaining contribution (years)	Category of retention + sub-category			Notes
									Physiological Condition	Structural Condition	Preliminary management recommendations	
1993	<i>Acer platanoides</i>	14	2/6/4/4	390	4.68	7m s	MA	20+	Good	Fair	Remove Ivy	B2
1994	<i>Aesculus hippocastanum</i>	11	0/4/0/0	1300	15.60	4m s	V	10<	Fair	Fair	Remove overhanging branch	B2
947	<i>Fagus sylvatica</i>	17	0/7/4/4	430	5.16	8m s	MA	40+	Good	Fair	Remove Ivy	B1
948	<i>Acer pseudoplatanus</i>	15	0/7/6/3	490	5.88	9m all	MA	40+	Good	Fair		B1
949	<i>Fagus sylvatica</i>	9	1/3/1/1	100	1.20	2m all	Y	40+	Good	Fair		C1
950	<i>Aesculus hippocastanum</i>	21	3/6/4/4	500	6.00	1m n	MA	40+	Good	Fair	Remove Ivy	B1
951	<i>Fagus sylvatica</i>	21	3/3/3/3	400	4.80	8m n	MA	40+	Good	Fair		B1

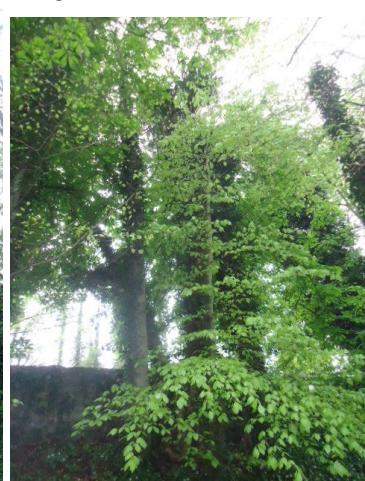
T952-954

952	<i>Fraxinus excelsior</i>	17	3/5/2/4	330	3.96	15m all	MA	40+	Good	Fair	Remove Ivy	B2
953	<i>Fagus sylvatica</i>	18	1/3/2/2	320/230	4.73	0m e/w	MA	40+	Good	Fair	Remove Ivy	B2
954	<i>Aesculus hippocastanum</i>	20	3/3/3/3	340	4.08	8m w	MA	40+	Good	Fair	Remove Ivy	B2
955	<i>Fagus sylvatica</i>	22	5/5/5/5	560	6.72	10m w	MA	40+	Good	Fair	Remove Ivy	A2 1986
956	<i>Fagus sylvatica</i>	22	4/5/2/4	540	6.48	12m all	MA	40+	Good	Fair	Remove Ivy	A2 1985
957	<i>Fagus sylvatica</i>	15	1/3/1/1	210	2.52	4m all	Y	40+	Good	Good	Remove Ivy	B2
958	<i>Fagus sylvatica</i>	22	5/3/4/4	600	7.20	4m e/w	MA	40+	Good	Fair		A2
959	<i>Fagus sylvatica</i>	18	8/0/3/3	280/120	3.66	0m s	MA	40+	Good	Fair		B2
960	<i>Fagus sylvatica</i>	19	0/3/1/1	250	3.00	6m all	Y	40+	Good	Fair		B2
961	<i>Fagus sylvatica</i>	22	5/5/5/5	610	7.32	7m n	MA	40+	Good	Fair	Remove Ivy	A2 self bracing
962	<i>Fagus sylvatica</i>	19	8/0/2/2	530	6.36	5m n	MA	40+	Good	Fair	Remove Ivy	A2
