# Stables and Courtyards at Rathfarnham Castle

Conservation Management Plan

30th April 2025

RATHFARNHAM CASTLE, CO. DUBLIN. 11551. W.L.

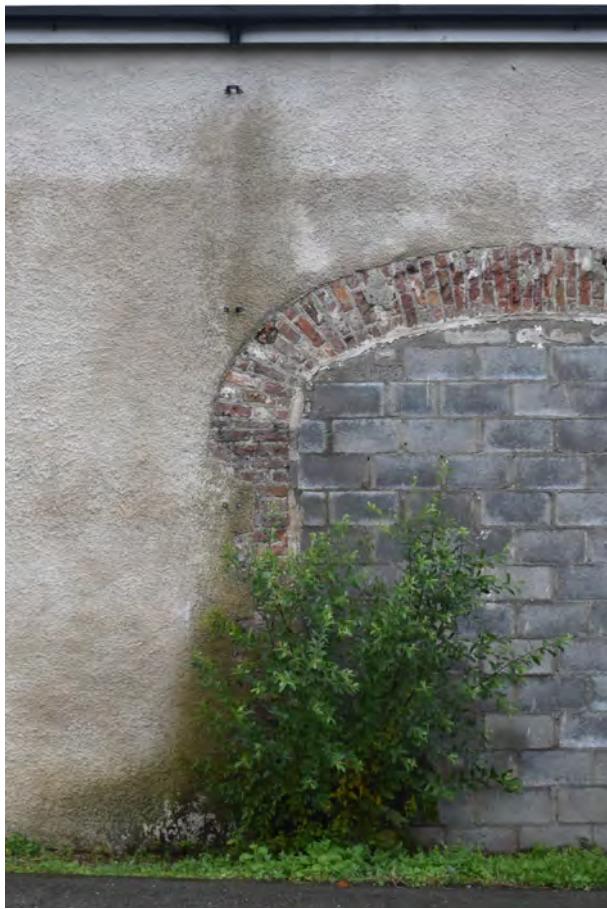
Missing downpipe resulting in staining to wall, vegetation and algae growth. Horizontal line of saturation visible on plasterwork above archway. This was visible running the length of the eastern facade.

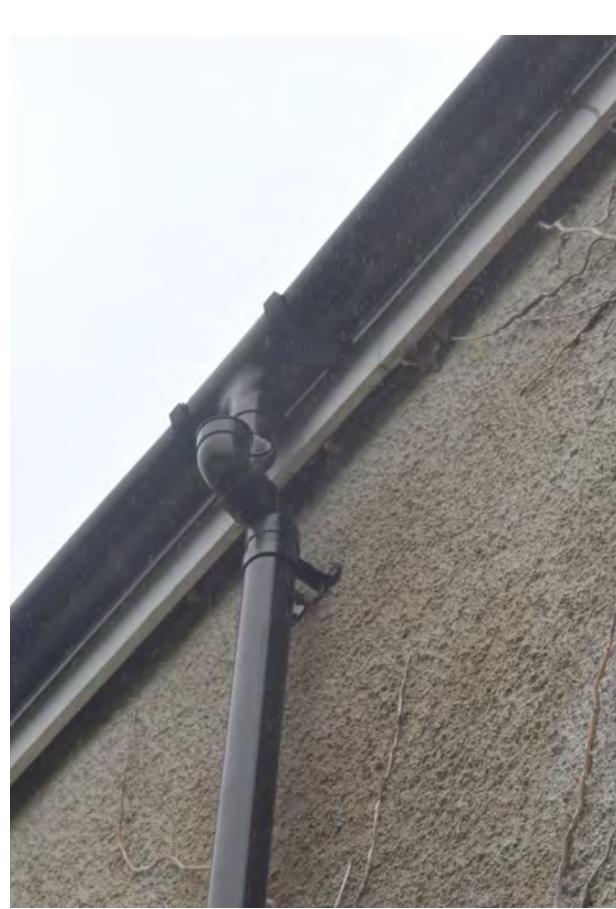
Downpipe out of alignment with gutter outlet.

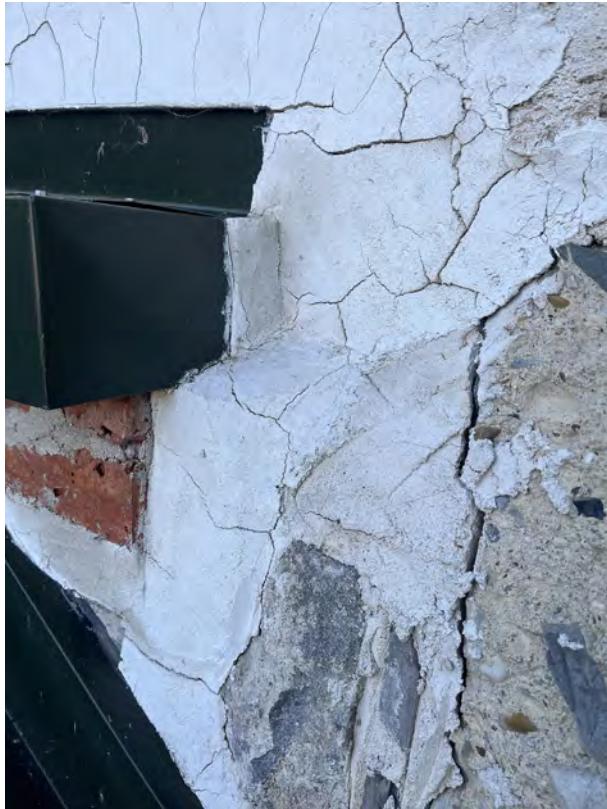
Cracks visible in plasterwork to North-West corner where edge of gully meets corner of wall.

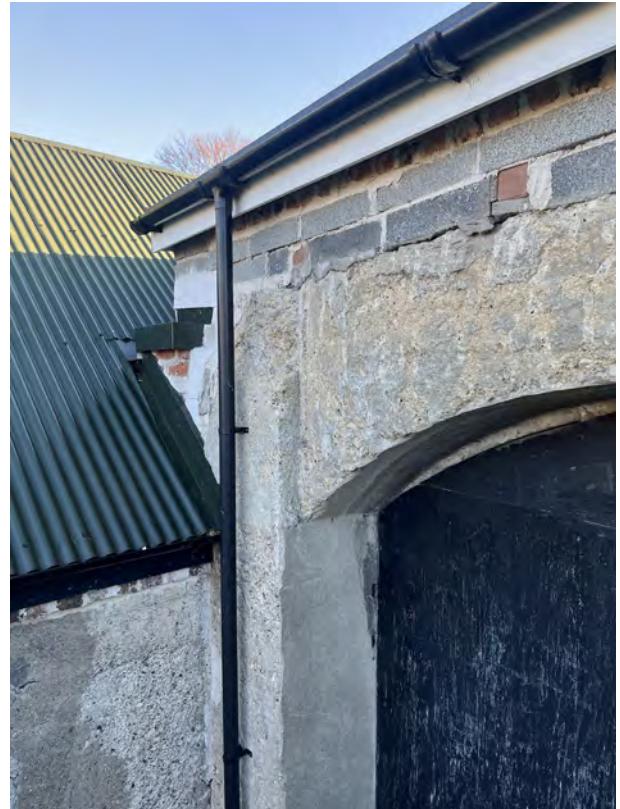
Unrendered blockwork built above existing brick & stone walls at North-West entrance.

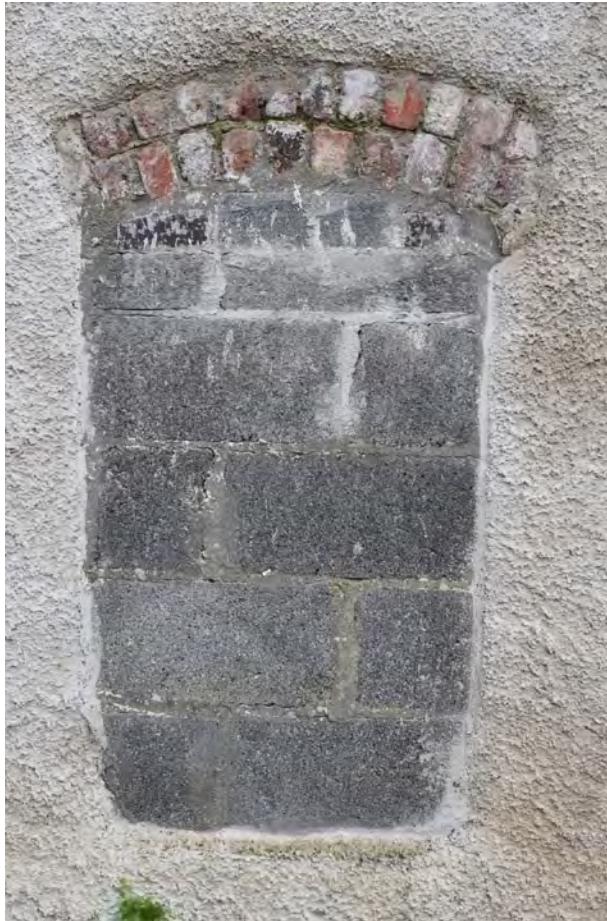
Ope 12, blockwork infill unrendered. Brick arch visible. Missing cill.

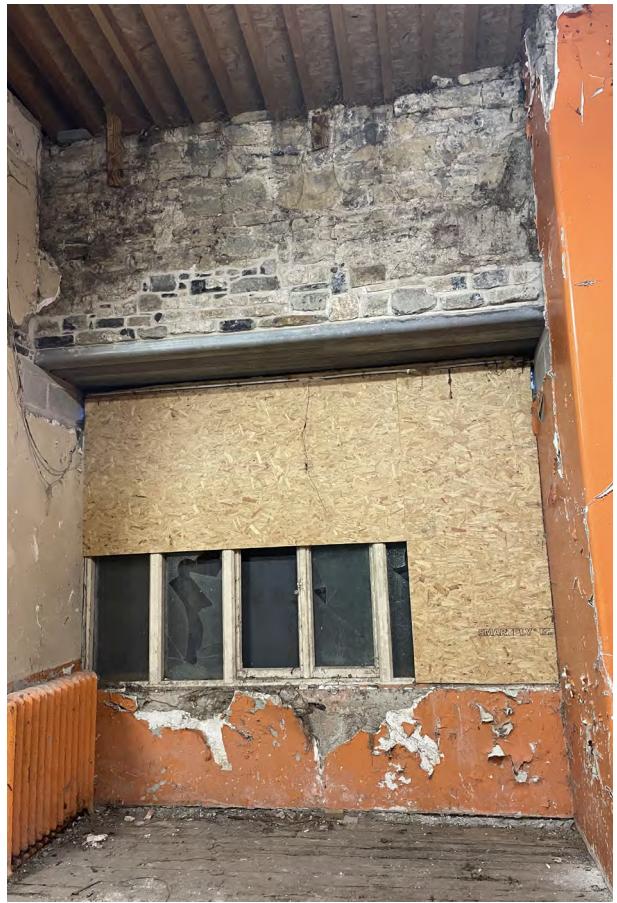
Ope 10: Timber framed window partially concealed with plywood. Damage to glazing. A concrete lintol has been recently installed.

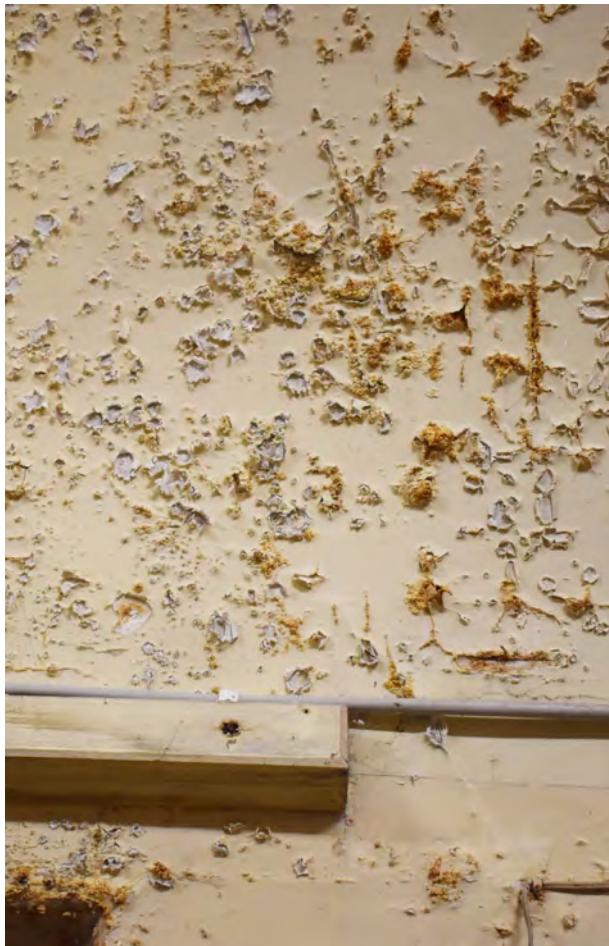
There is extensive peeling and damage to the paintwork of the vaulted ceiling & walls in room 1.1, indicating a high level of moisture and lack of ventilation internally.

Extensive damage to paintwork throughout, including peeling and growth to walls indicating dampness internally.

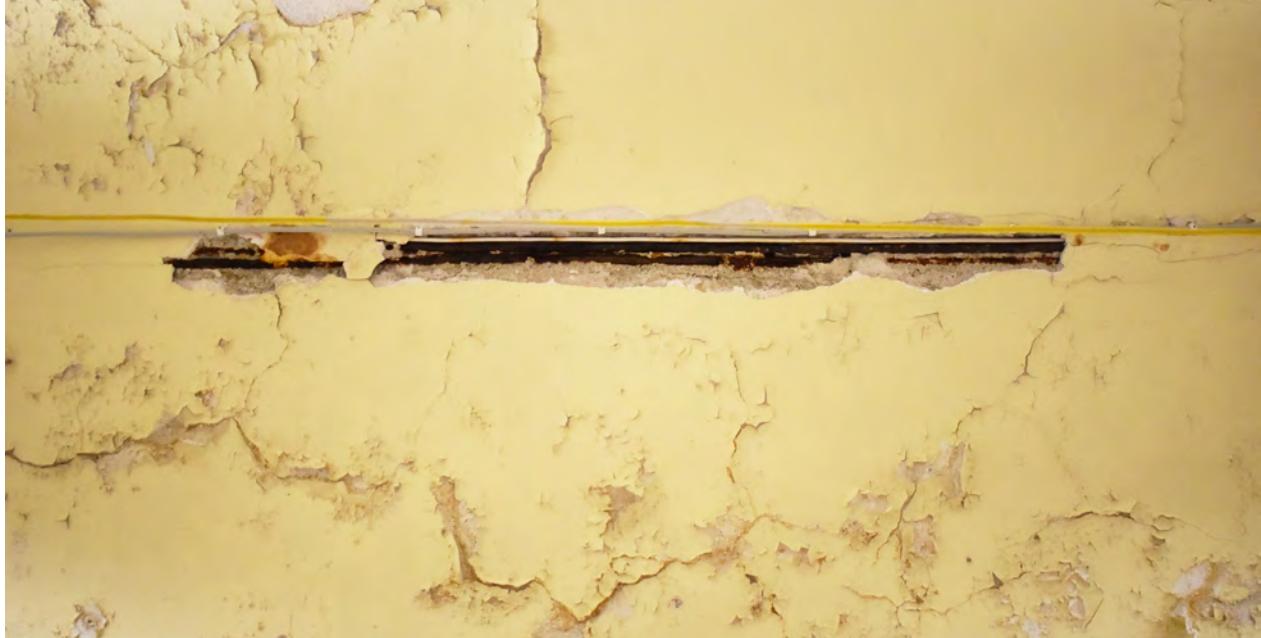
Metal bars, rusted, exposed at top of vaulted ceiling arch.

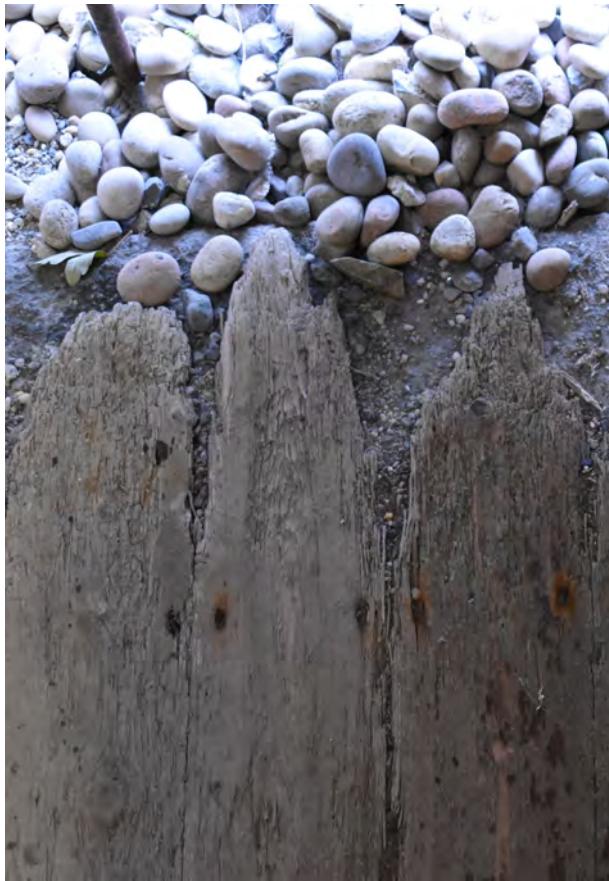
*Damage to ends of floor boards at southern entrance. External ground is level with internal floor and there is no threshold.*

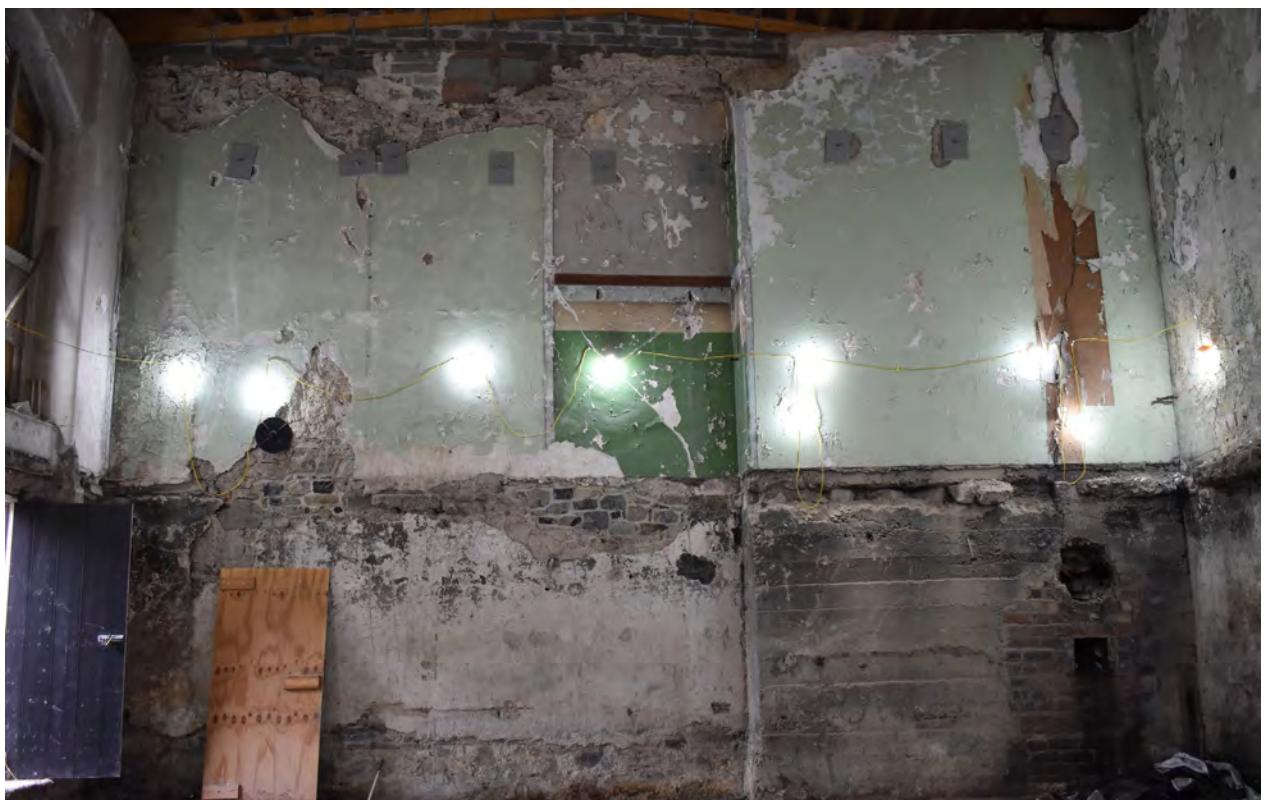
The walls of room 1.2 are in poor condition with extensive cracking and damage to the wall surfaces and in some areas portions of masonry have been damaged where embedded services installations have previously been removed.

Northern wall, Room 2. Walls are in poor condition. There is damage to masonry where the first floor and services installations have been removed.

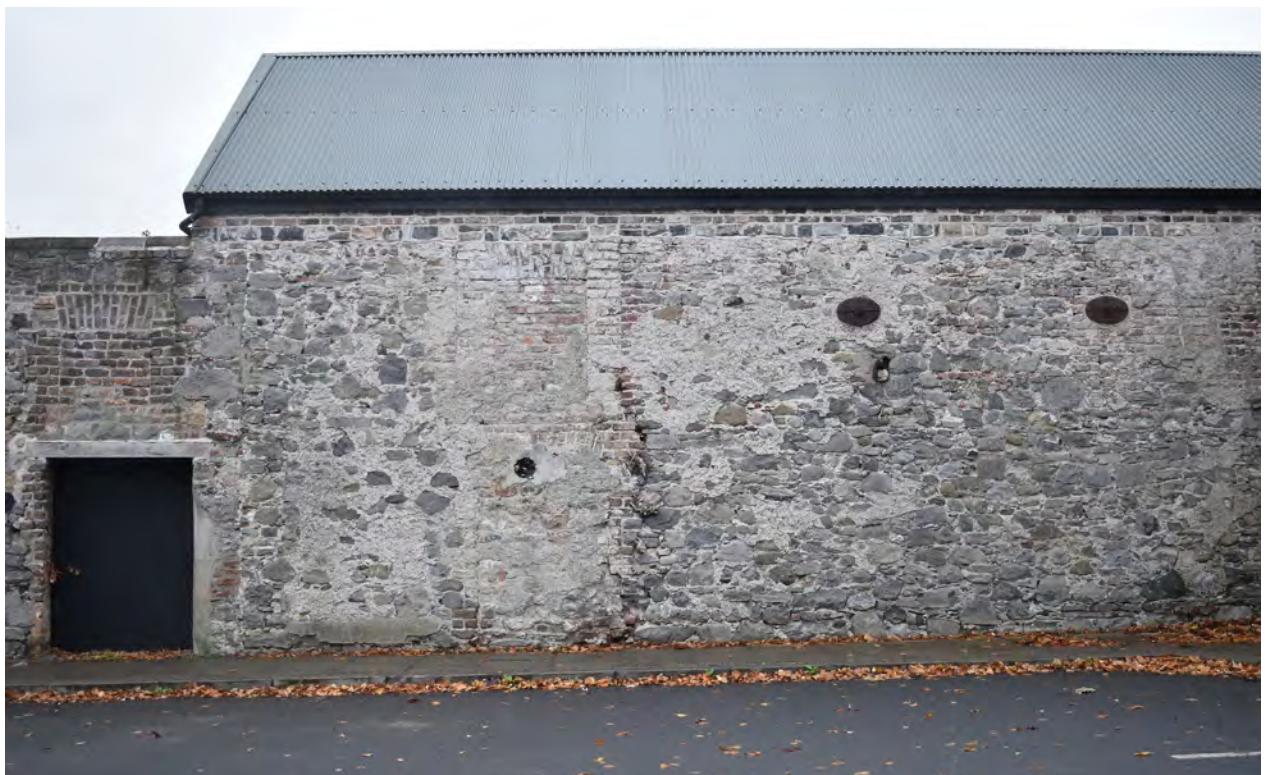
*East Range, West Elevation, View from Rathfarnham Road Car Park. Remnants of lime plaster visible. Former window openings infilled with brickwork are visible where plaster has decayed.*

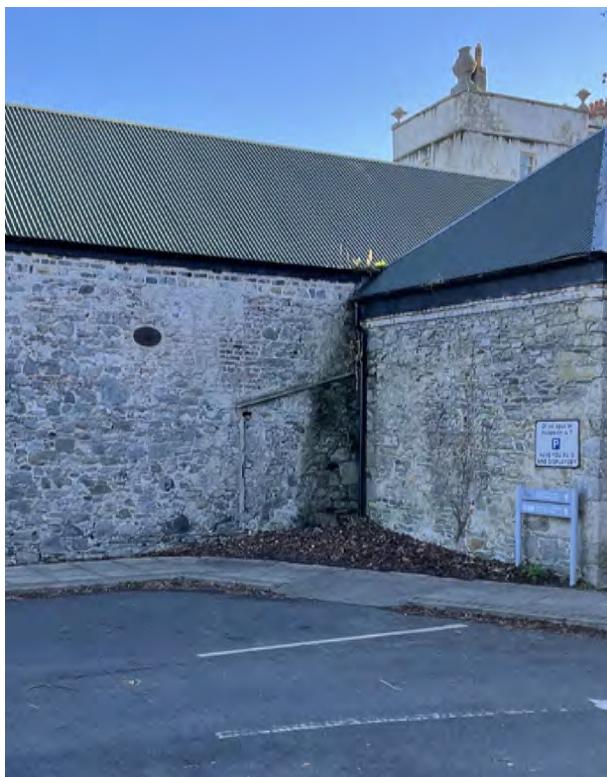
*Downpipe to north-west corner discharging from valley gutter. Vegetation growth within gutter and staining to adjacent wall indicating saturation due to overflowing discharge. Leaf build up at base of downpipe.*

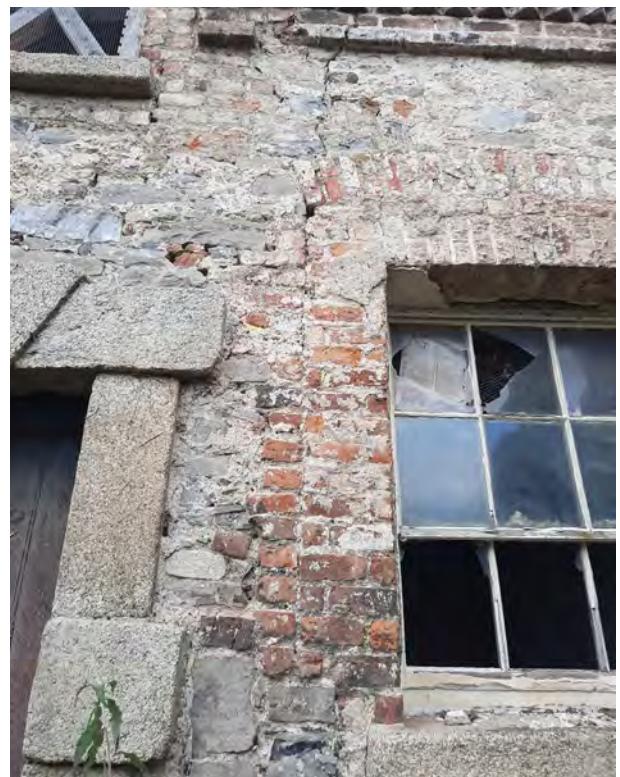
*Crack in east facade between door and window at the north end of the facade. Damage to brick cornice.*

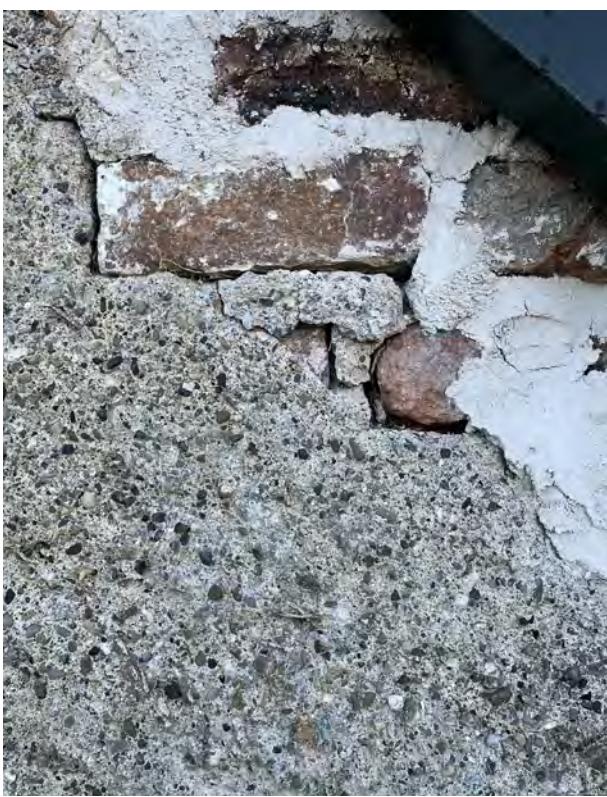
*Loose bonding of brickwork to top of gable wall (north).*

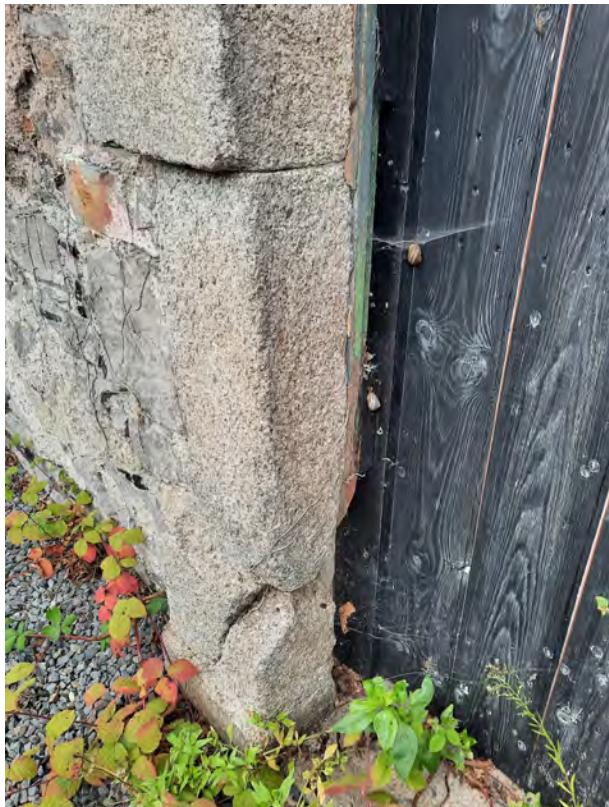
*Damage to stone doorway surround at entrance to 2.6*

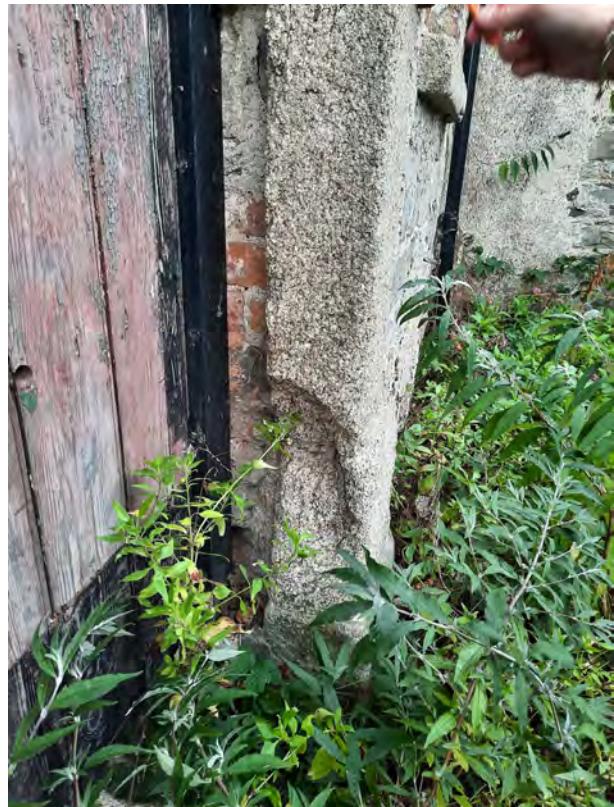
*Damage to stone doorway surround at entrance to 2.7*

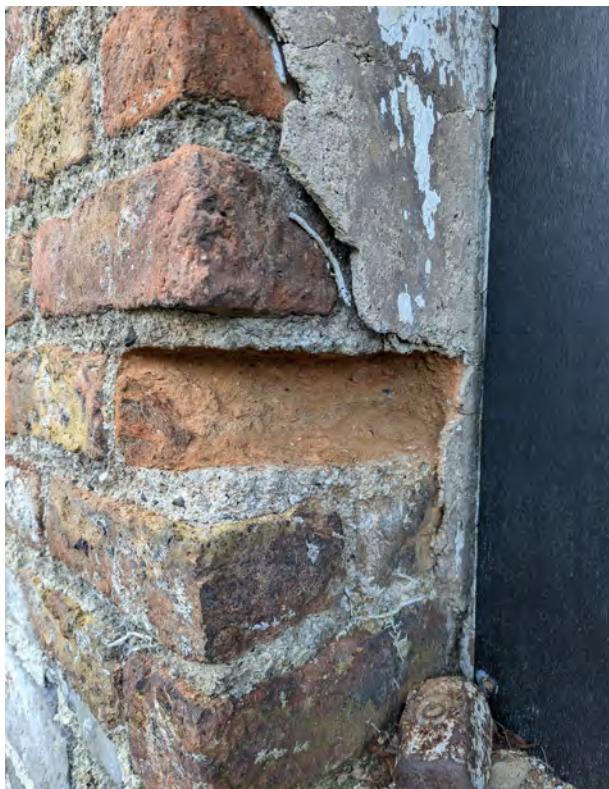
*Damage to brickwork and loose plaster to window reveal.*

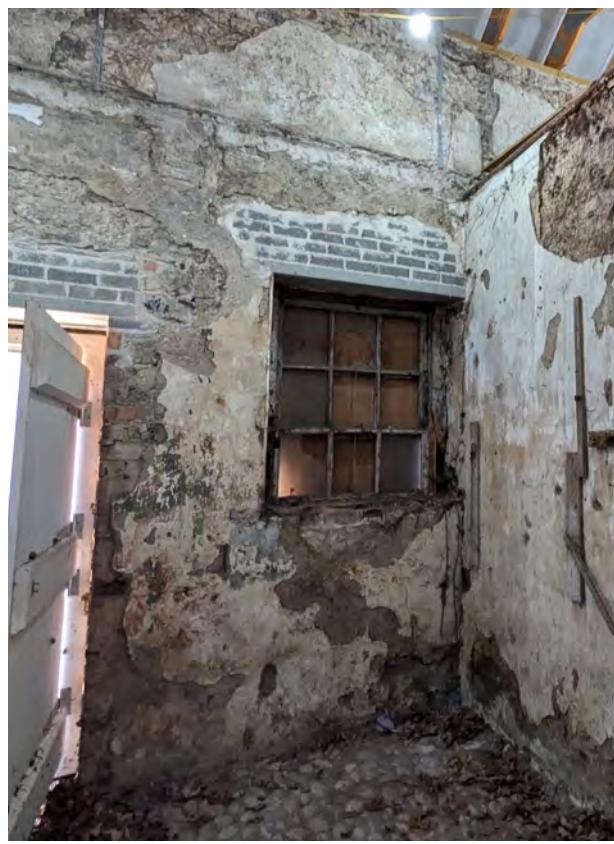
6 over 3 timber sliding sash window in room 2.6. Concrete lintol and blockwork over. Glass panes broken or missing.

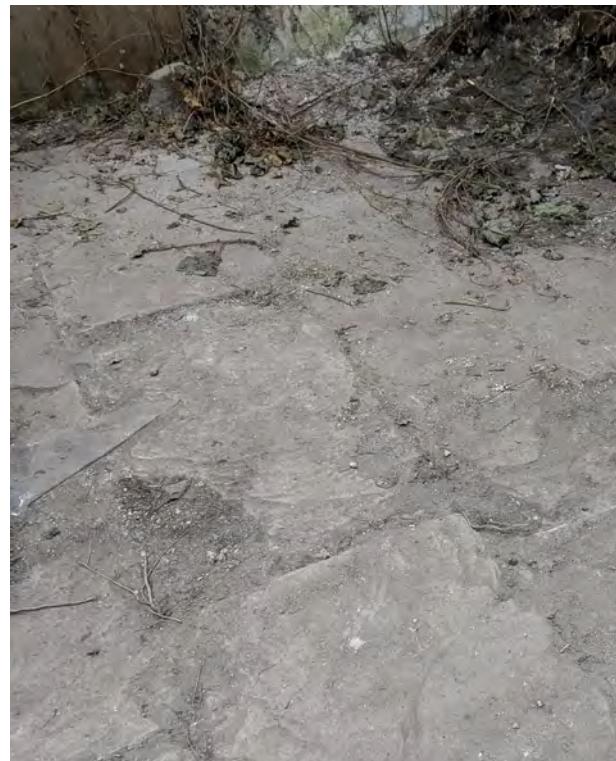
Limestone flag floor to room 2.4. Flags are uneven and damaged in places.

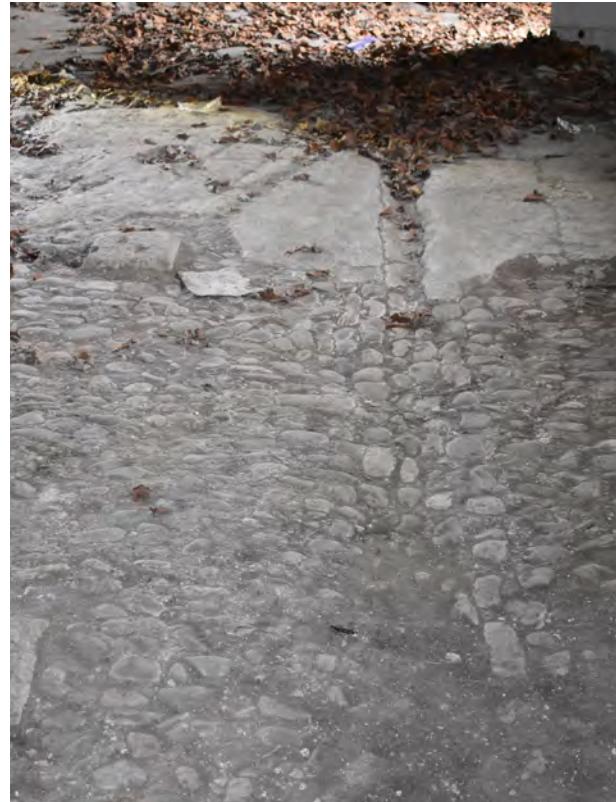
*Cobbled floor and drainage channel within room 3.1, partially covered with a concrete covering, mostly damaged.*

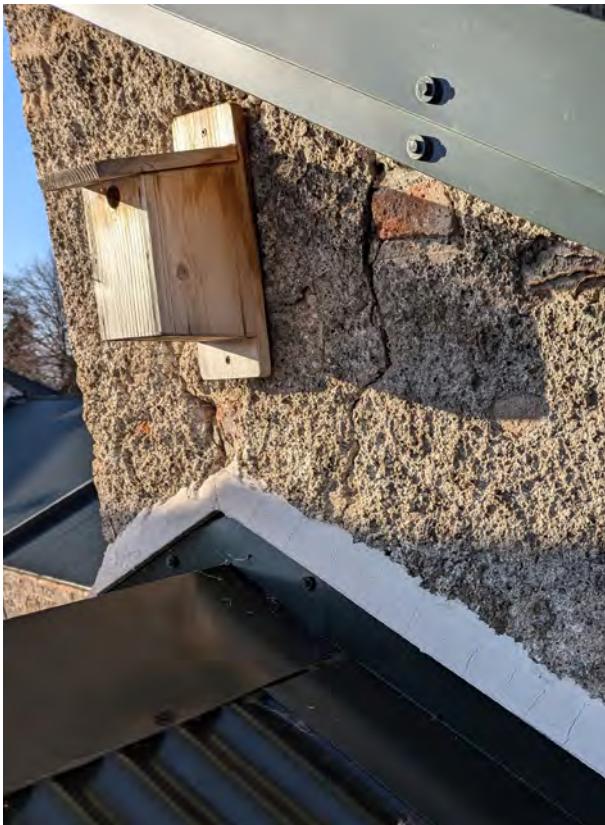
*Nesting box to south wall above roof of building 5 (A). Crack visible in plasterwork to wall.*

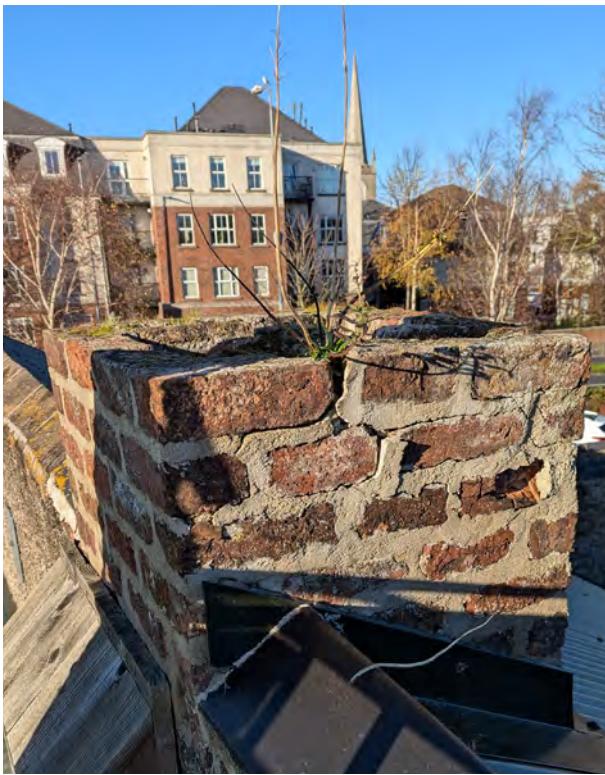
*Vegetation growth has caused separation of the mortar joints causing damage to the chimney stack.*

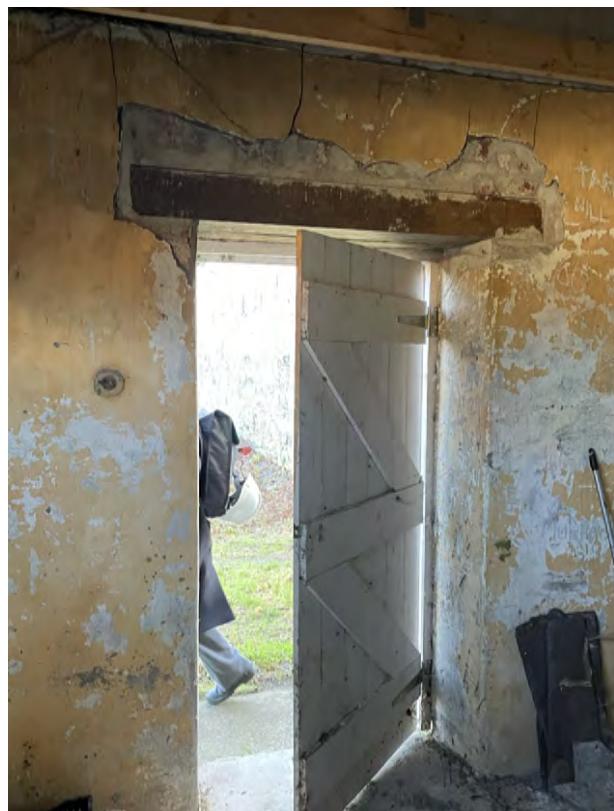
Interior view Building 5 (B), east wall, entrance door. Damage to plaster-work where lintel has previously been replaced.

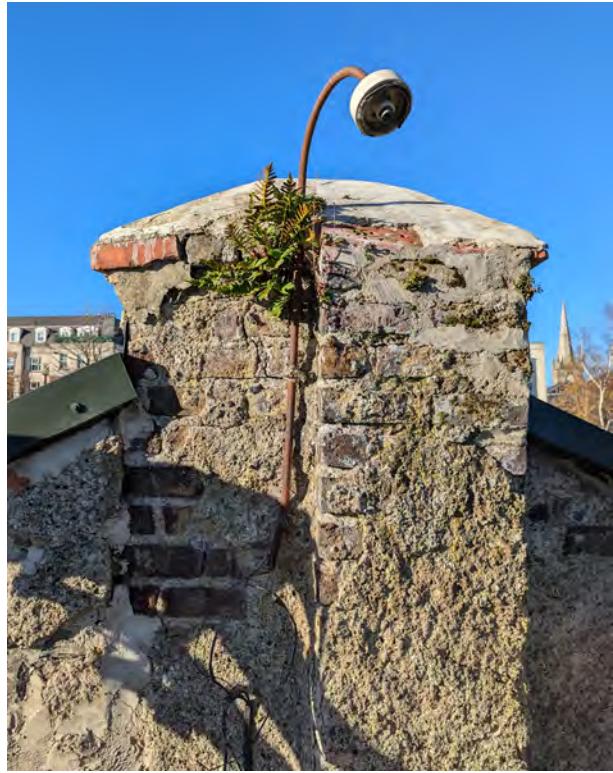
The shared wall with Building 6 forms a pier, matching that of Building 4. Vegetation growth is visible from the top of the pier, near a redundant lighting fixture. Render partially remains but is in poor condition.

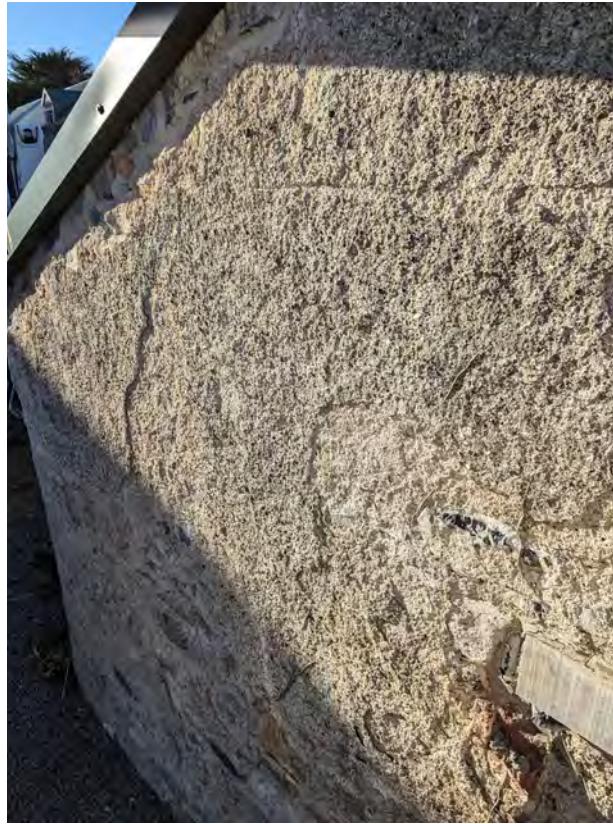
Lime render partially remains on the east facing gable, but shows signs of spalling and crumbles to touch.

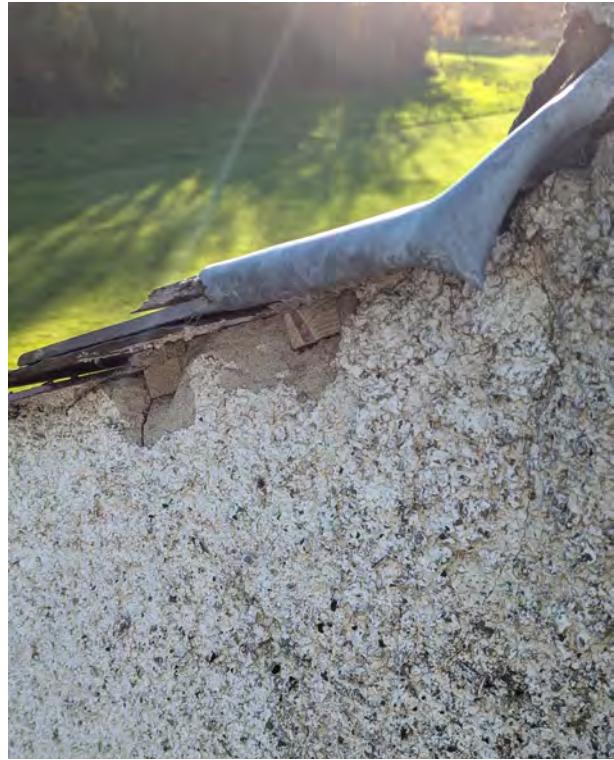
*Ends of the timber roof battens are exposed where render has broken away.*

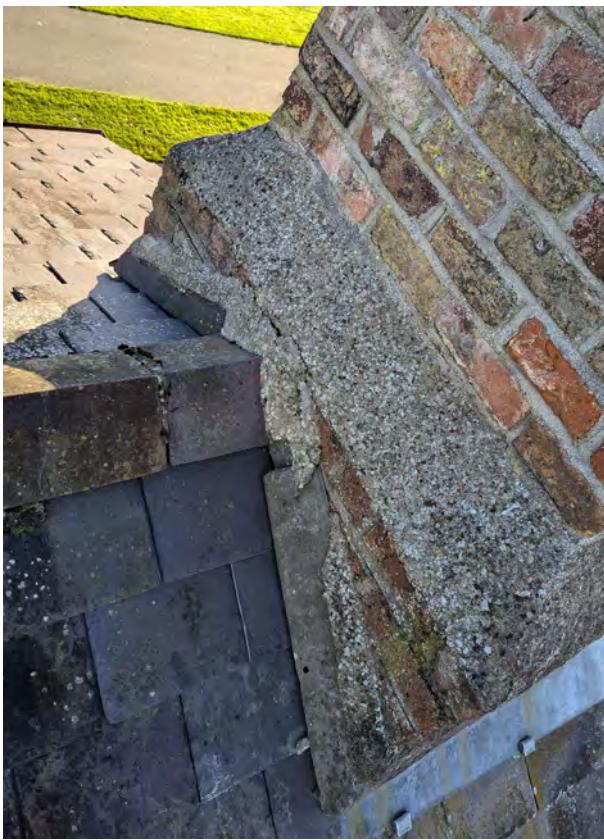
*The render to the base of the southern chimney appears loose*

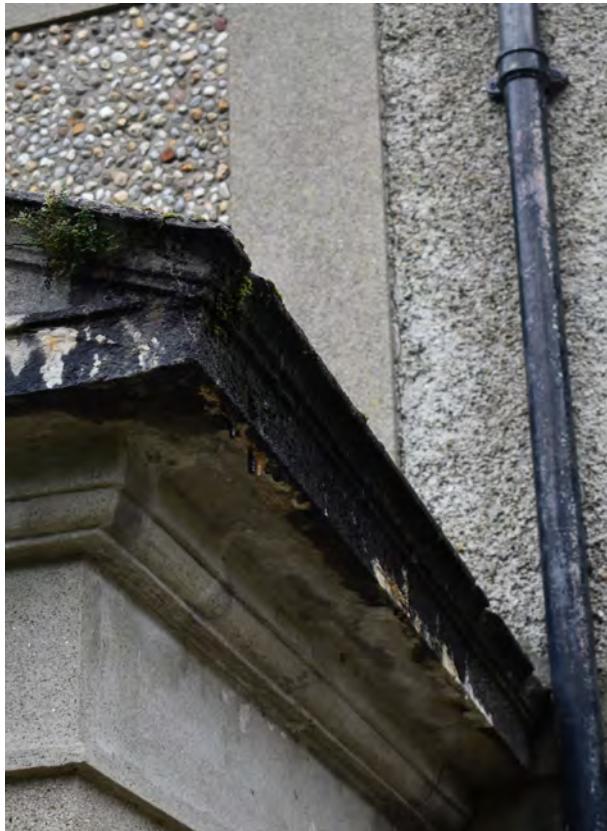
*Stone work to western entrance porch. The edges of the stonework are damaged, with vegetation growth and damp staining visible*

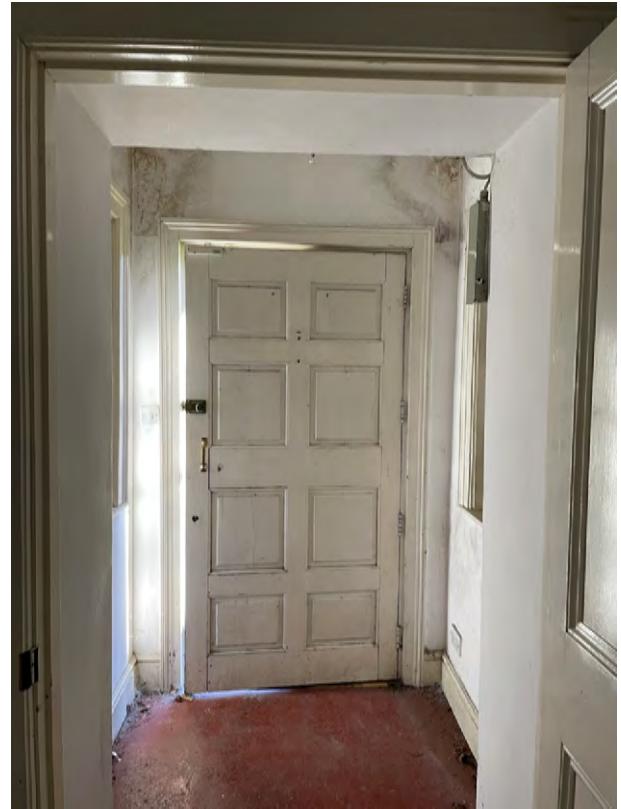
Porch leading to entrance hallway. Damp staining visible above doorway at north and south corners of the western wall.

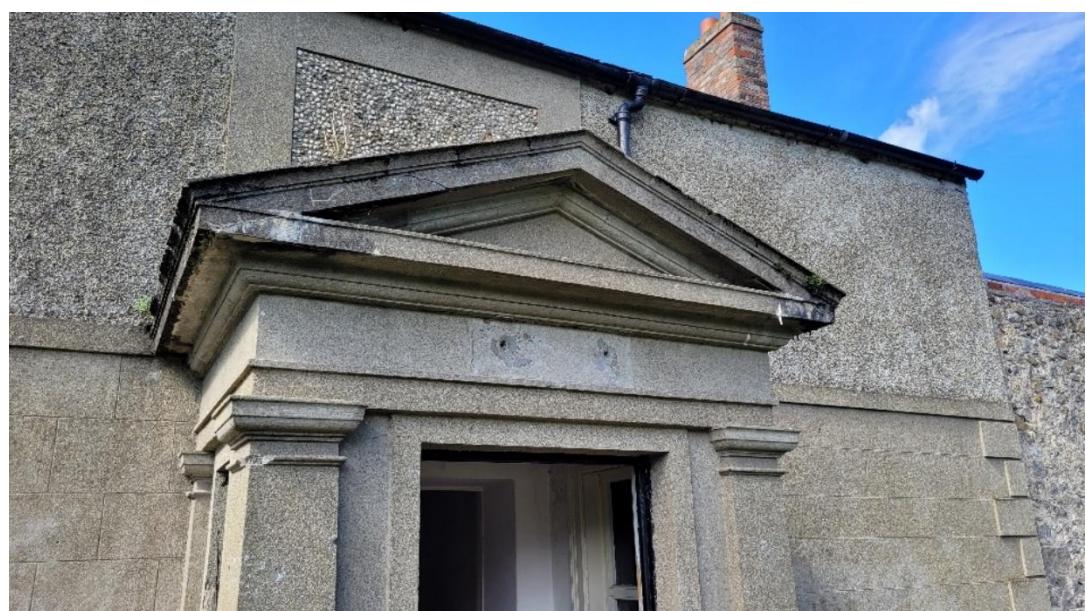
*Fig 4.7.3. East Elevation detail – note cracked lime leaching render*
