# CONSERVATION REPORT

## Proposed Saggart Community Centre.

Conservation, renovation and extension at  
St Marys National School (protected structure)  
Slade Castle Walk  
Boherboy  
Saggart

20<sup>th</sup> February 2020

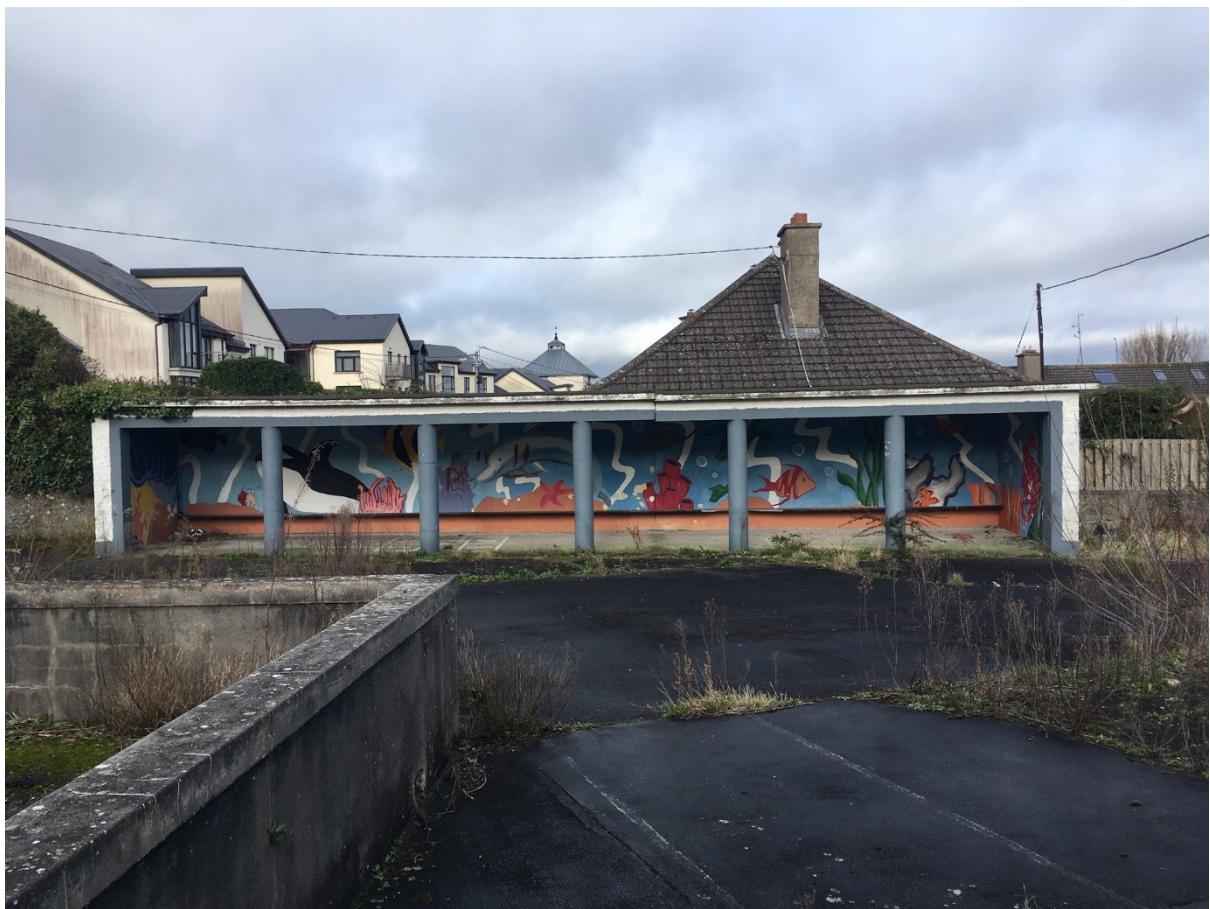
External areas are generally in poor condition and will be fully upgraded, and repurposed. The remaining play shelter to be repaired and retained

Figure 5 - Play shelter

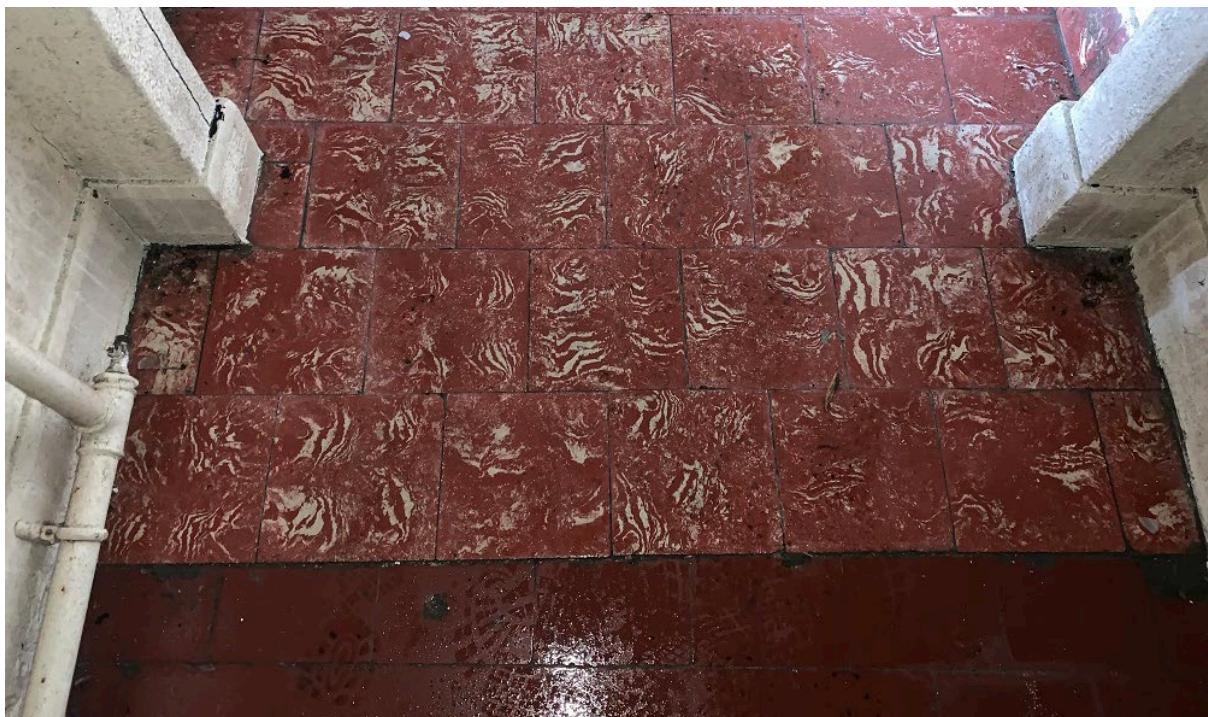
Floors: Floors are finished in ceramic tiles on solid bearing. Significant dampness indicates lack of adequate damp proofing and insulation. These floors require thermal upgrading and damproofing Ceramic tiles to be carefully salvaged and reused where possible

Figure 12 - Ancillary building, corridor view 2 (lighter coloured tiles used in 1950s extension)

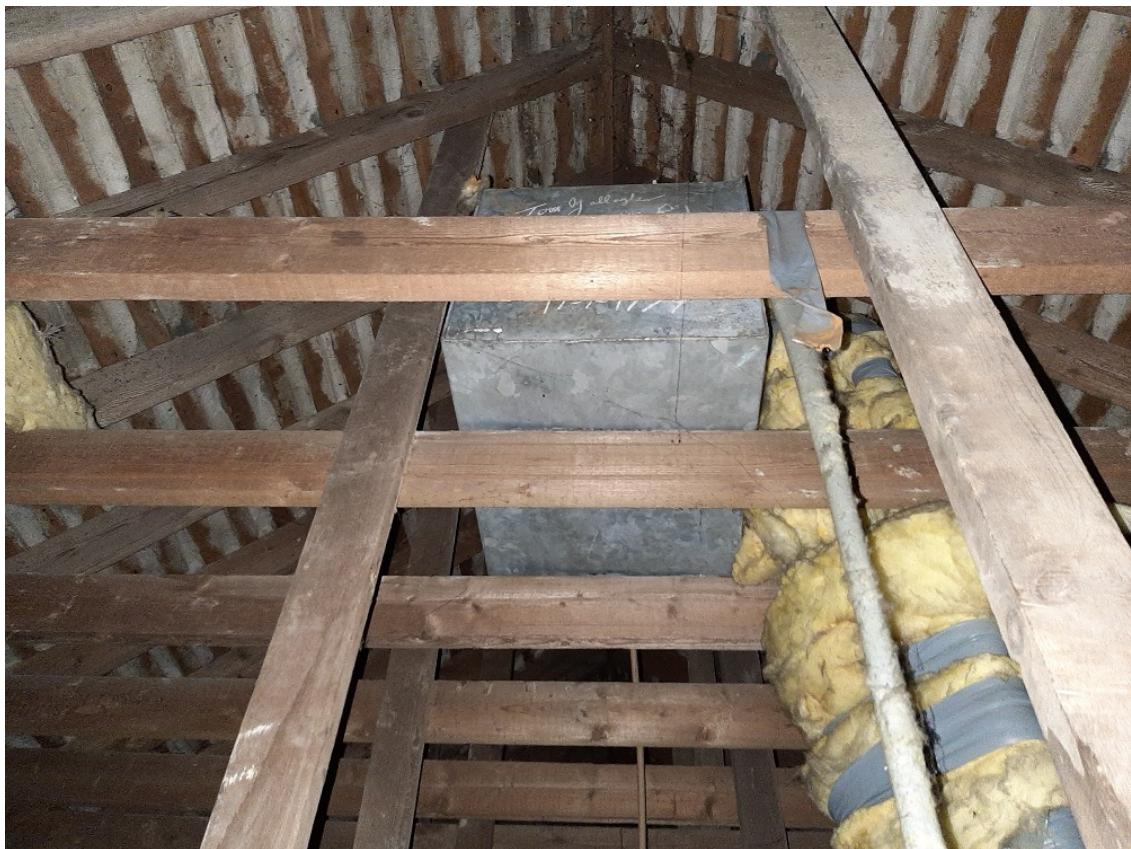
Figure 17 - Roof and galvanised steel water tank (for further details refer to Appendix 2)

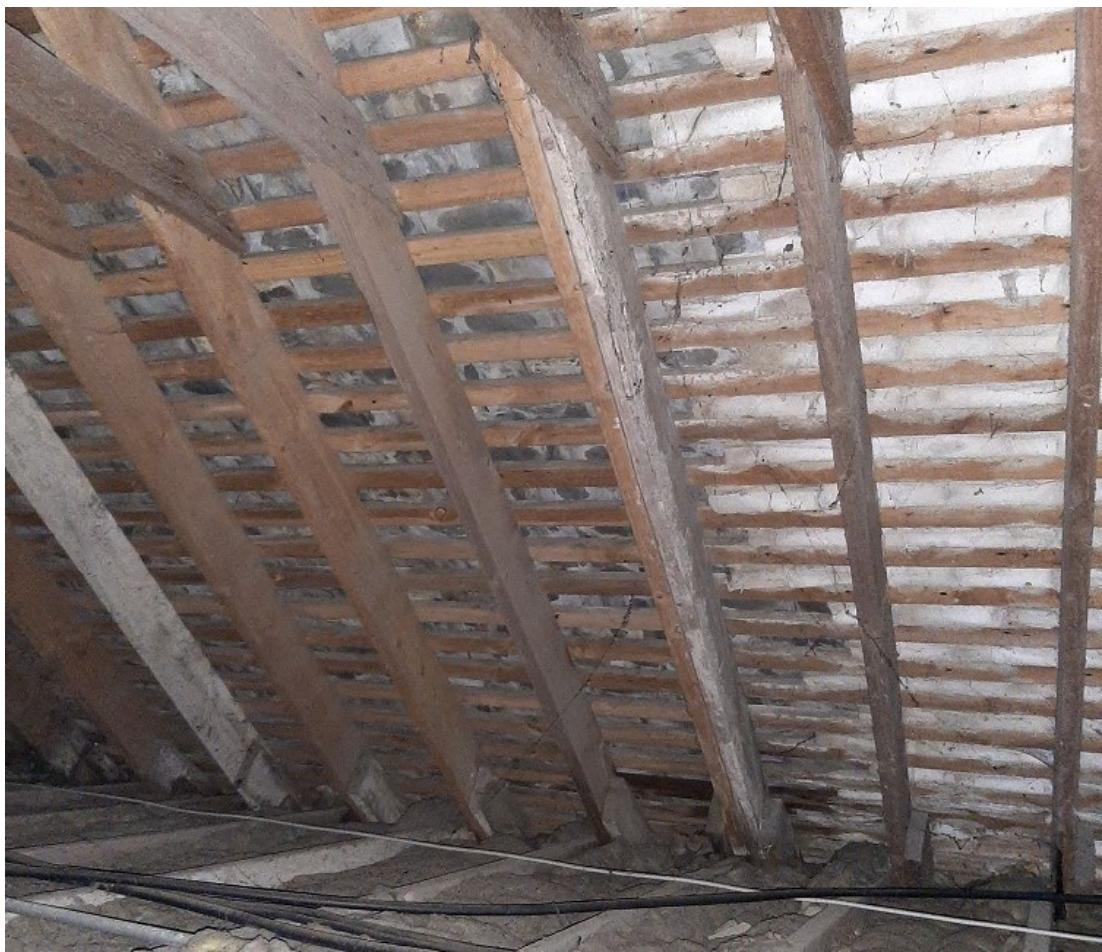
Figure 18 - Roof and galvanised steel water tank (for further details refer to Appendix 2)

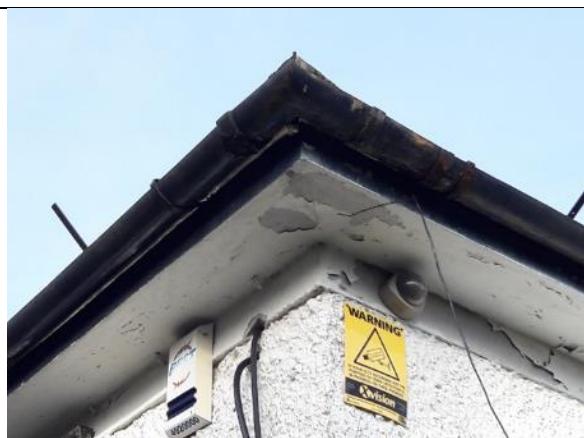
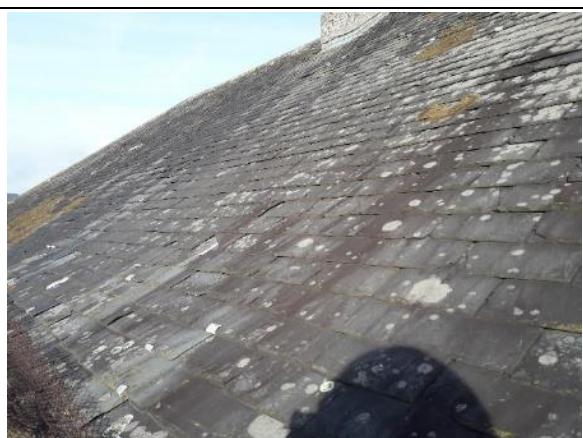
Concrete cornice projection at the south-west corner slope

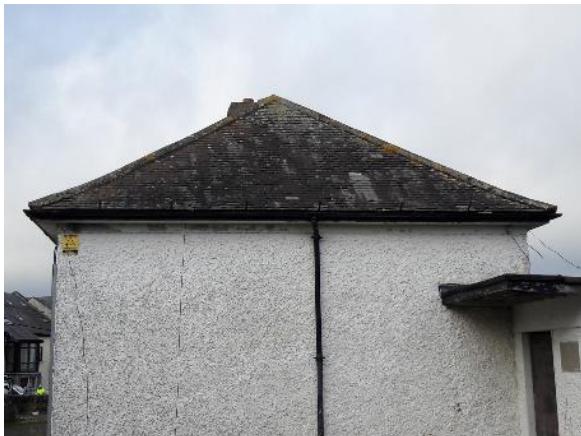
Roof and rainwater goods: A considerable number of slipped and fallen slates were observed the slate roof is generally in poor condition. The roof requires full repairing and thermal upgrade. Salvaged slates will be reused in this process. The cast iron rainwater goods are also generally in poor condition and require replacement

Slipped and missing slates on the western roof

The roof slates will be carefully taken down from the eastern and western roof pitches. The slate will be removed to ensure salvage and conservation of at least 30% of the existing slates for re-use. The parging mortar will be carefully removed from the back of each slate. Each slate will be tested for trueness, and evidence of wear and tear at the nail hole. Cracked and damaged slates will be discarded. The reusable slates will be carefully stacked according to size and condition, the best slates being retained for use on the most exposed, western roof pitch.

At least 70% of the existing slates should be salvaged from the roof for re-use. Most of the roof slates are in sound condition and can be salvaged and re-used. Some slate will inevitably be damaged during lifting, sorting, stacking. It should be noted that chipped or damaged larger slates may be suitable for re-use in the smaller slate courses in

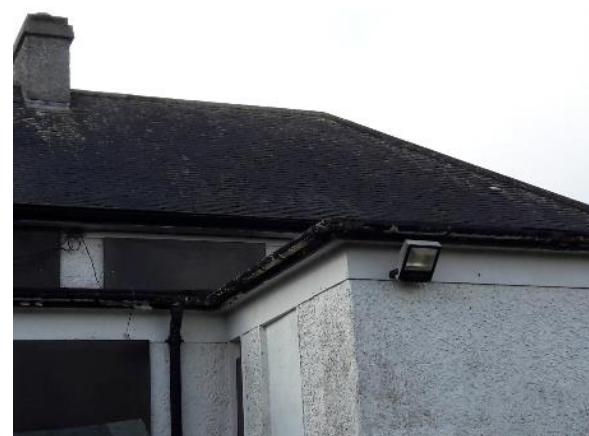
2 number, 4" diameter RWDPs to front façade, also one to each short side facade.	
<b>Size and shape</b>	100mm / 4" diameter half-round cast iron RW gutters  See note above for RWDPs	100mm / 4" diameter half-round cast iron RW gutters  See note above for RWDPs
<b>Original / non-original:</b>	Probably original	Probably original
<b>Condition:</b>	Generally, the rainwater goods are in poor condition – paint is peeling, raw iron exposed and corroding.	Generally poor. One RWDP at the back of the building has been broken. Another is badly damaged.

The hipped roof and RWDP at the south end main building

The cast iron rainwater goods will be carefully taken down and removed to a workshop where the old paint will be carefully sanded off to reveal the bare metal. The design team will decide on what ironworks still has enough section to warrant re-use and what will be discarded and replaced with new cast iron rainwater goods. The conserved and new cast iron rainwater goods will be painted with a three coat paint system.
