Arboricultural Report

Proposed Site: Sean Walsh Park

Client: South Dublin County Council

Project: Bowling Green

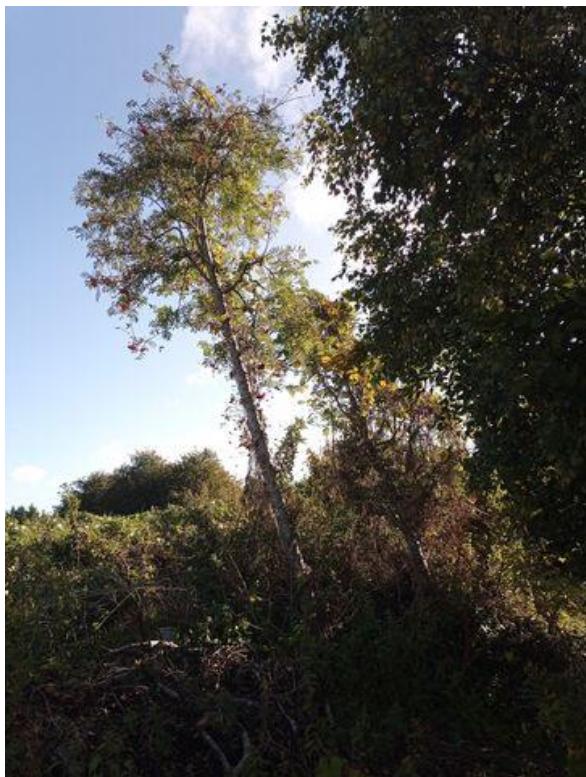
Figure 4: G001 Pair of rowan for removal.

Ref.	Species	Full Structure	Measurements	Survey Notes	Retention Category	RPA	Tree Features	Recommendations	Photo
G001	Rowan x2 (<i>Sorbus aucuparia</i>)	Group 2 trees	Height (m): 5 2 stems, avg.(mm): 80 Spread (m): 1N, 2E, 1S, 1W Crown Clearance (m): 2 Lowest Branch (m): 2(E) Life Stage: Semi Mature Rem. Contrib.: 10+ Years	Pair of trees growing on elevated ground. Significant stem lean to north and east. Bindweed obscuring stems. Good crown density.	C2	Area: 21 sq m.	Physiological Condition: Fair Structural Condition: Fair Public Amenity Value: Low Inspection Limitations: Vines Bat Habitat: None	Remove trees.

6.2. Works to the entirety of the site will result in the loss of groups G001-G003 (figs. 4-6), and the trees T2015-T2022 (fig. 7) and T2024 (fig. 8). While the loss is extensive, most of the trees are relatively young and small in stature. The ash T2021 (fig. 9) is not sustainable in the long term and should be removed for reasons of sound arboricultural practice.

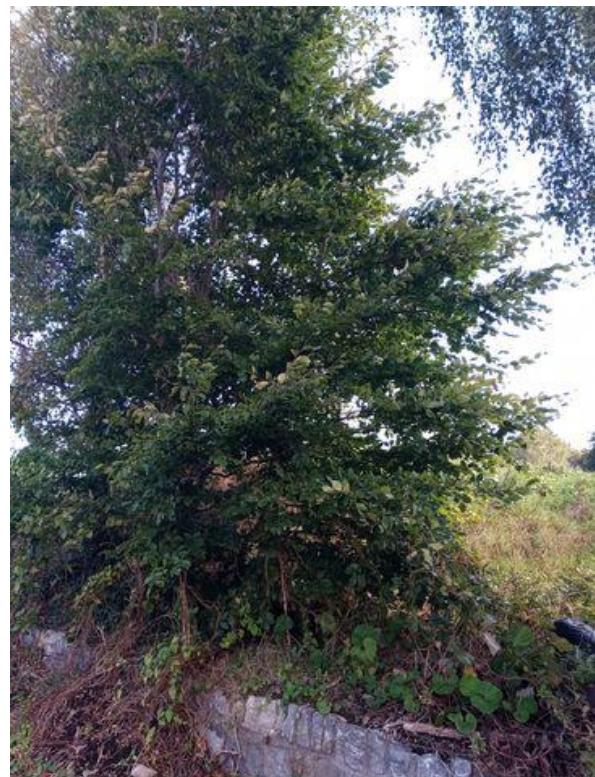
Figure 5: G002 Group of beech for removal.

G002	Common beech x6 (<i>Fagus sylvatica</i>)	Group 6 trees	Height (m): 7 6 stems, avg.(mm): 80 Spread (m): 2N, 2E, 2S, 2W Crown Clearance (m): 1 Lowest Branch (m): 1(S) Life Stage: Semi Mature Rem. Contrib.: 10+ Years	Group growing adjacent boundary wall. Sharing canopy with neighbouring tree. Good crown density.	C2	Area: 23 sq m.	Physiological Condition: Fair Structural Condition: Fair Public Amenity Value: Moderate Inspection Limitations: Vines Bat Habitat: None	Remove trees.

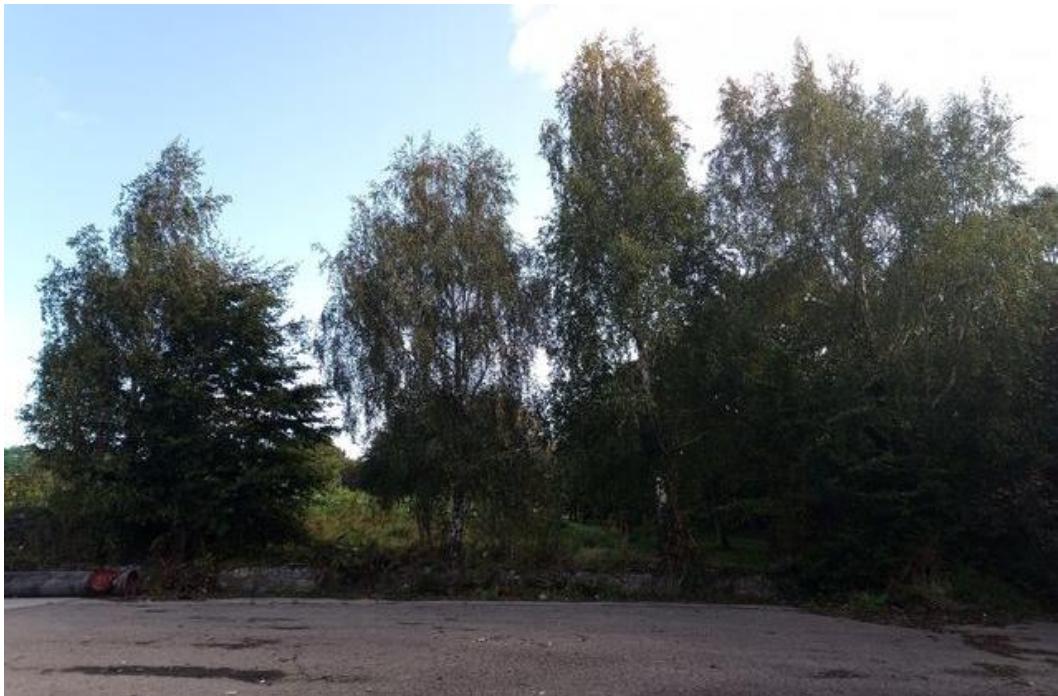
Figure 6: Overview of birch and beech for removal.

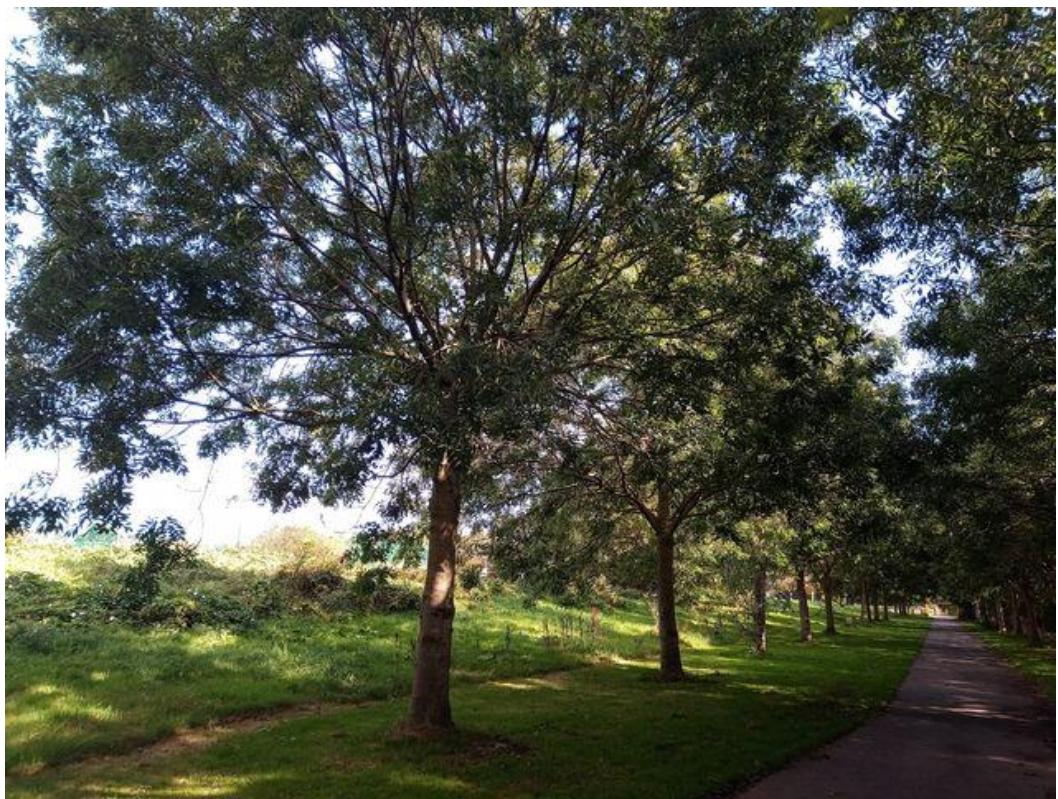
4.8 A row of ash trees, T2019 – T2022, line the southern boundary. These trees are in good condition, other than T2021, which has extensive dieback. Two shrubs are sited along the northern boundary, the grey willow T2024, and the buddleia T2025.

Figure 7: Row of ash T2019-22 for removal.

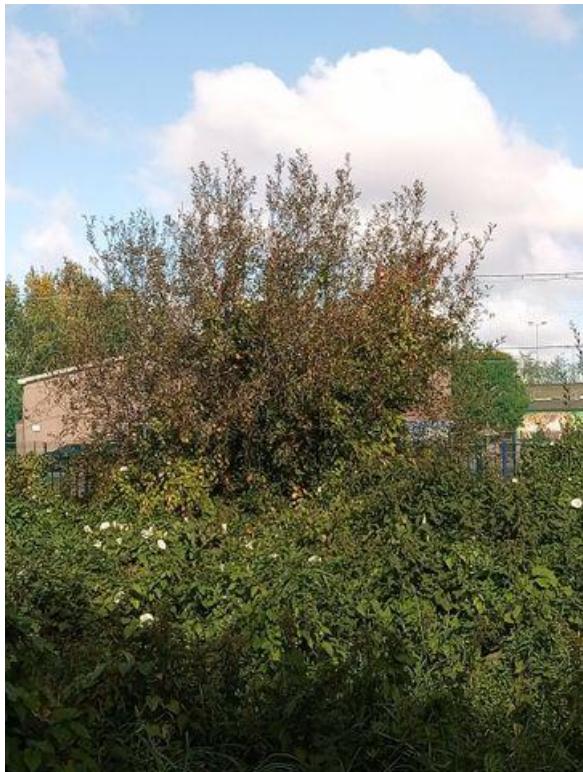
Figure 8: T2024 Grey willow for removal.

T2024	Grey willow (<i>Salix cinerea</i>)	Tree	Height (m): 5 Stem Diam(mm): 150# Spread (m): 2N, 2E, 2S, 2W Crown Clearance (m): 1 Lowest Branch (m): 1(E) Life Stage: Semi Mature Rem. Contrib.: 10+ Years	Bindweed obscuring lower canopy. Moderate crown density.	C2	Radius: 1.8m. Area: 10 sq m.	Physiological Condition: Fair Structural Condition: Fair Public Amenity Value: Low Inspection Limitations: Vines Bat Habitat: None	Remove tree.

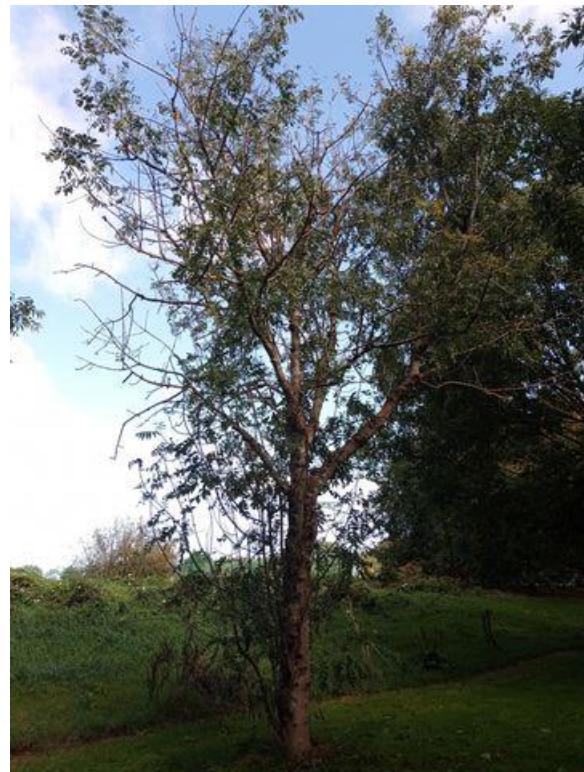
4.6 Tree species present include ash (one with ash dieback disease – *Hymenoscyphus fraxineus*), rowan, beech, silver birch and grey willow.

Figure 9: T2021 Ash displaying dieback disease.

Ref.	Species	Full Structure	Measurements	Survey Notes	Retention Category	RPA	Tree Features	Recommendations	Photo
T2021	Common ash (<i>Fraxinus excelsior</i>)	Tree	Height (m): 9 Stem Diam(mm): 310 Spread (m): 2N, 4E, 2S, 3W Crown Clearance (m): 1 Lowest Branch (m): 1(W) Life Stage: Early Mature Rem. Contrib.: 10+ Years	Epicormic growth on stem. Cankered stem and branches. Sparse canopy. Pests and Diseases: Ash Health Class 2 - 75%-50% remaining canopy	C2	Radius: 3.7m. Area: 43 sq m.	Physiological Condition: Poor Structural Condition: Poor Public Amenity Value: Moderate Inspection Limitations: None Bat Habitat: None	Remove tree.

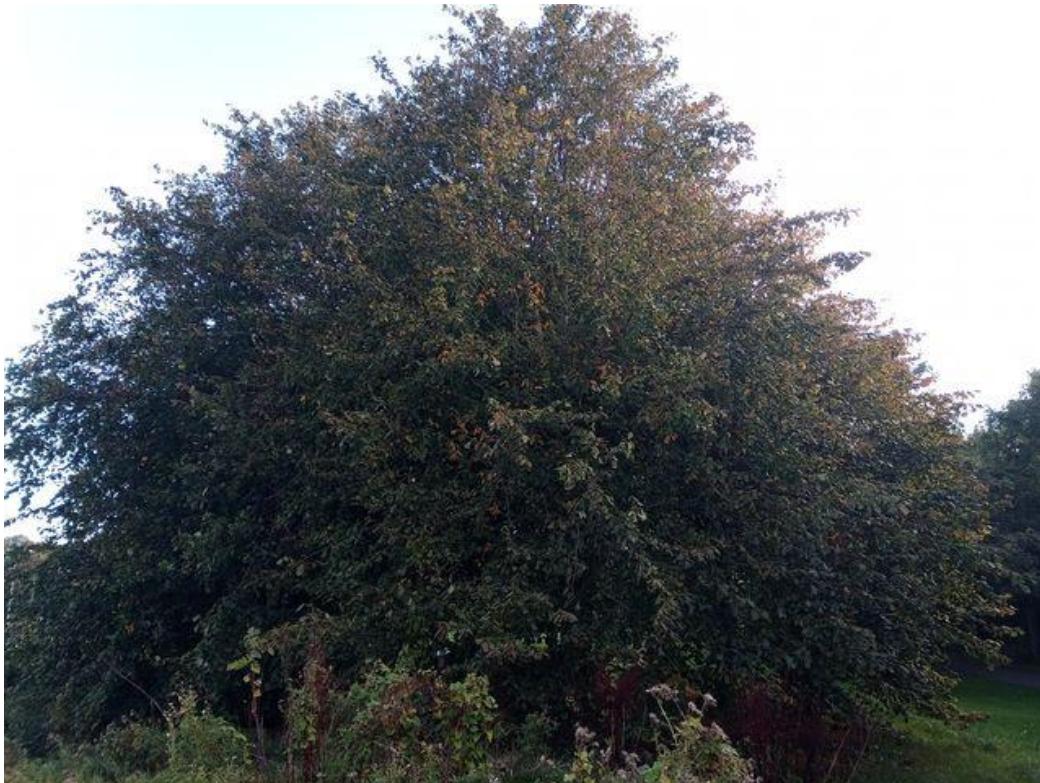
Figure 10: G004 Group of lime to be protected.

6.3 The group of broad-leaved lime G004 (fig. 10) to the east of the site is to be retained, as is the ash T2023. These trees must be protected during construction.

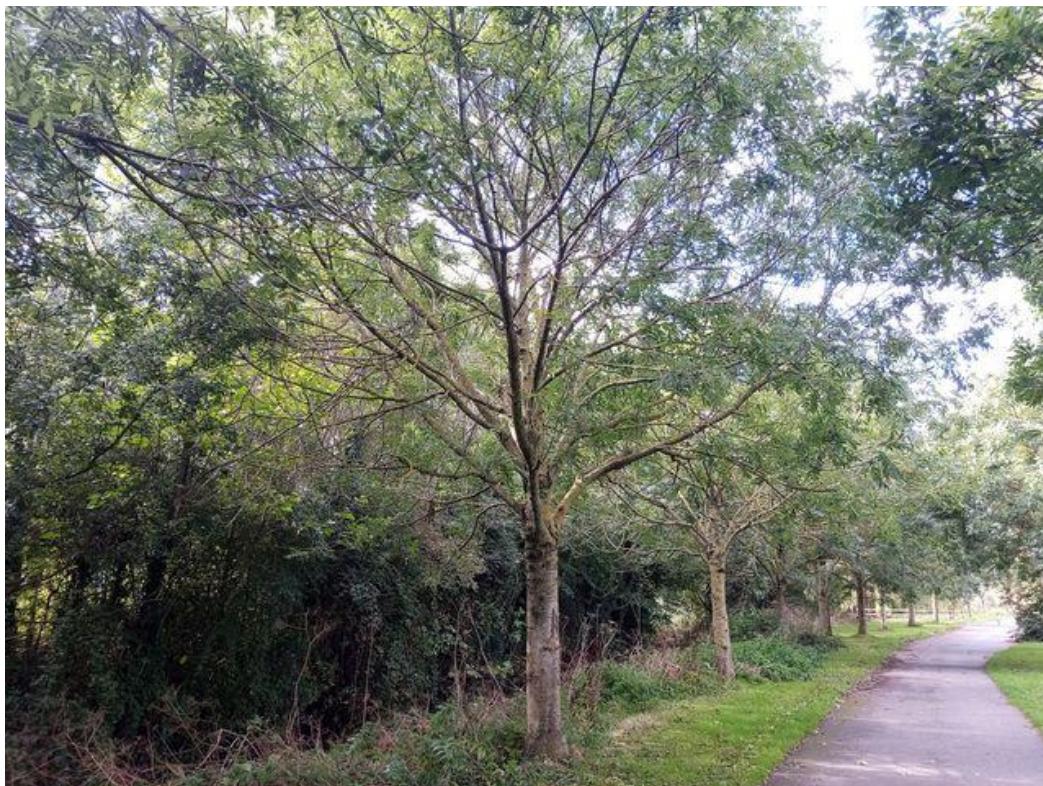
Figure 12: G005 Row of ash to be crown lifted and protected.

6.4 The row of ash G005 (fig. 12) adjacent the footpath will require crown lifting prior to construction and must be protected during the construction phase.
