Project title Knocklyon to Ballyboden Active Travel Scheme
Job number 284940-00
File reference
cc
Prepared by Jakub Radomski
Date 26 June 2025
Subject Stage 1 - Quality Audit

Knocklyon to Ballyboden Active Travel Scheme

Stage 1 Quality Audit

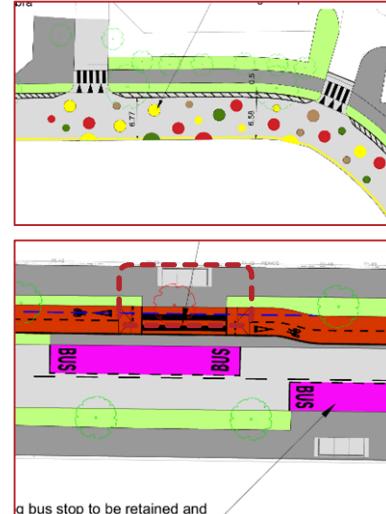
1. The eastbound bus stop on Firhouse Road to the east of the Firhouse Road/Knocklyon Road signalised junction.
2. The eastbound bus stop on Ballyboden Way to the east of the junction with Boden Park Green.
3. The eastbound bus stop on Scholarstown Road to the west of the roundabout junction between Scholarstown Road, Ballyboden Way and Templeroan Lawn.

The absence of tactile paving within the footpath at these Zebra crossings may lead to difficulties for visually impaired pedestrians in locating the crossing when boarding a bus resulting in them being unable to independently navigate the road.

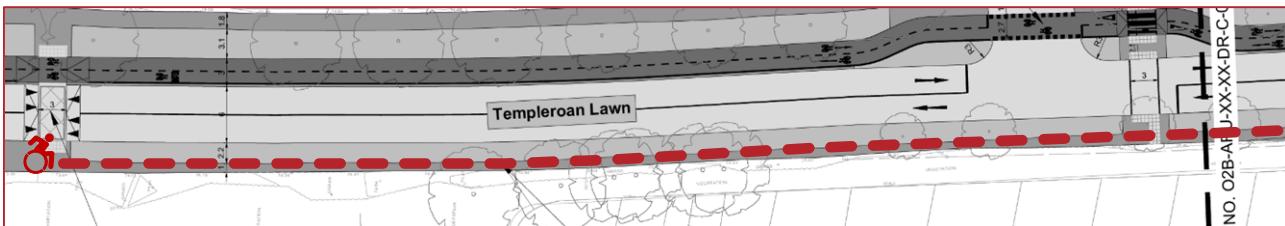
2.4 Narrow Footpath

A 1m wide footpath has been indicated on the western side of Templeroan Lawn between the existing uncontrolled pedestrian crossing and just upstream of the entrance to Dargle Wood. 1m is not a sufficient width for wheelchair users, or pedestrians pushing prams/strollers to travel within the footpath, in particular should they have to enter the adjacent verge to pass opposing pedestrians.

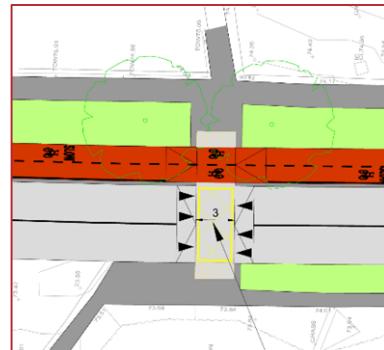
The existing uncontrolled pedestrian crossing on Templeroan Lawn, which links the footpaths on Templeroan Avenue and Knocklyon Road, is proposed to be realigned, raised, and widened to 3m. The crossing would be 9m wide in total and would require pedestrians to cross two traffic lanes and a two-way cycle track. The uncontrolled crossing would be inaccessible for, and, therefore, be unable to be used, by visually impaired pedestrians, without assistance, resulting in them being unable to independently navigate the road layout.

The uncontrolled crossing should be replaced with a controlled crossing.

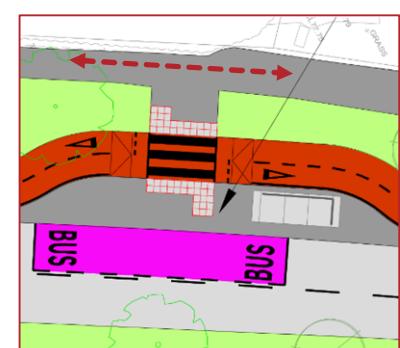
This may lead to visually impaired pedestrians continuing past the tactile paving and failing to detect the crossing, and thus the bus stop, resulting in them being unable to independently navigate the road layout.

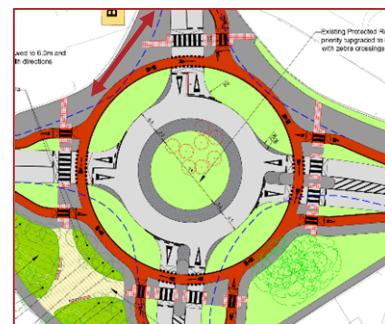
This may lead to visually impaired pedestrians, approaching from the south on Ballyboden Road, continuing past the tactile paving and failing to detect the crossing resulting in them being unable to independently navigate the road layout.

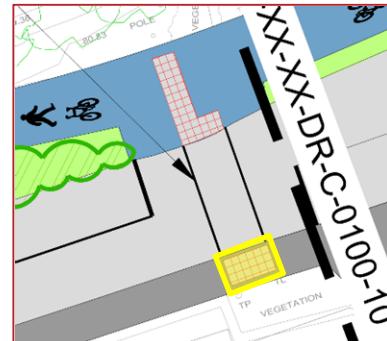
It is proposed to retain the existing signalised crossing on Knocklyon Road located to the east of the Knocklyon Shopping Centre. The tactile paving indicated on the southern side of this crossing, however, does not contain a stem and is, therefore, not the correct type of tactile paving for use at a controlled crossing. This may lead to confusion for visually impaired pedestrians or to them being unable to locate the push-button at the crossing.

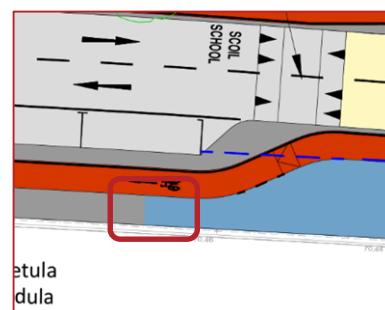
A failure to provide appropriate tactile paving at the transitions between different non-motorised road user facilities may lead to visually impaired pedestrians being insufficiently aware that they are moving between areas that may be shared with cyclists.

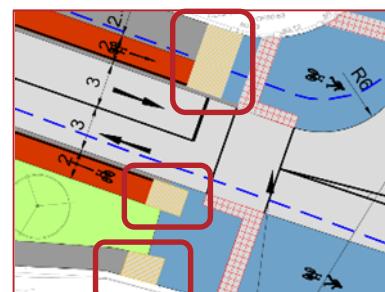
During the detail design stage, tactile paving, as necessary for the type of transition and adjacent surfaces, should be provided at all necessary locations within the scheme.

Care should be taken to also provide tactile paving at locations where existing footpaths, which are proposed to be upgraded to shared paths, transition back to the existing footpaths at the scheme's extents (e.g. on Boden Park Green (Sheet 25 of 30)).

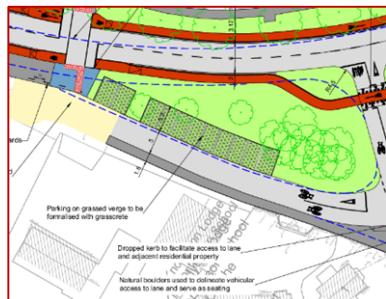
It is proposed to formalise the existing informal parking on the grass verge adjacent to the Knocklyon Lodge: Creche & Montessori through the provision of eleven standard-size car parking spaces. An accessible parking space has not been indicated at this location. A failure to provide an accessible parking space may cause difficulties for mobility impaired vehicle occupants when travelling between the creche and their vehicle.

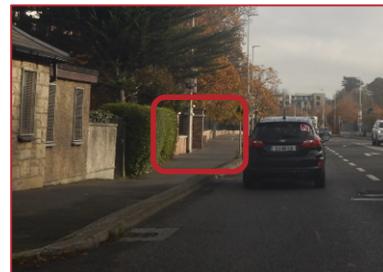
No tactile paving has been indicated on either side of the access to the recently constructed residential development on the northern side of Scholarstown Road opposite the Ballycullen Community Church and Olympian Gymnastics gym. The access does not appear to be currently in use by motorised vehicles due to bollards located within the development.

Dropped kerbs are currently provided at the access however no tactile paving has been provided. It is unclear if it is proposed to amend this layout as part of the proposed scheme however no pedestrian crossing has been indicated at this location.

If the access layout is amended, this may lead to pedestrians having to mount/dismount a full height kerb when crossing the side road resulting in difficulties, particularly for mobility impaired pedestrians.

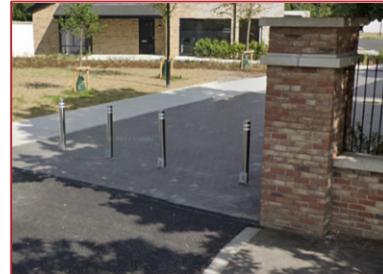
If the access is retained in its current layout, the lack of tactile paving may lead to visually impaired pedestrians being insufficiently aware that they are crossing an access, which may be used by cyclists.

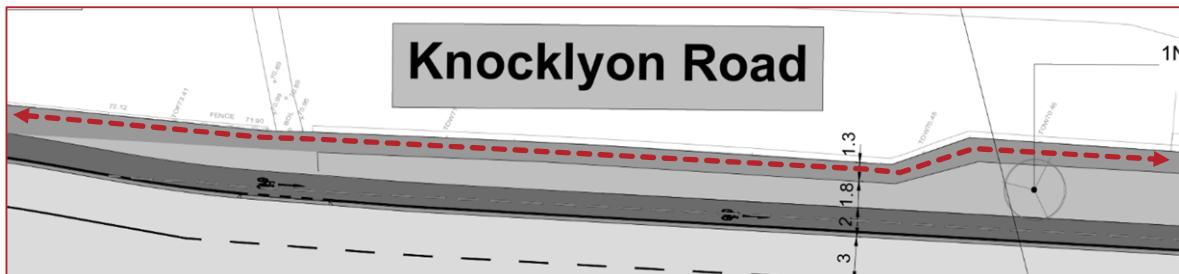
The footpath on the eastern side of Knocklyon Road opposite its junction with Delaney's Public House reduces in width at the commencement of the verge and continues with a relatively narrow cross-section for a short distance. This creates a pinch-point within the footpath which may lead to pedestrians having to enter the verge to pass opposing pedestrians.

In addition, the footpath travels through two horizontal curves in quick succession within this narrow section such that the adjacent boundary hedge may restrict a pedestrian's forward visibility to oncoming pedestrians.

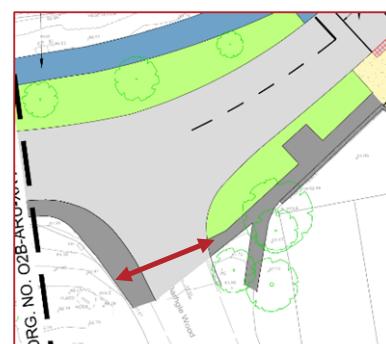
No pedestrian crossing, including associated infrastructure such as dropped kerbs and tactile paving, has been indicated across the Dargle Wood side road at its junction with Knocklyon Road. This may lead to pedestrians having to mount/dismount a full height kerb when crossing the side road resulting in difficulties, particularly for mobility impaired pedestrians.

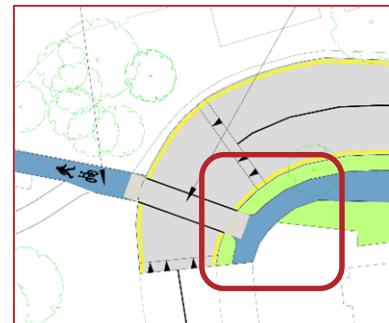
The proposed shared paths on the western side of Boden Heath and directly adjacent to the southern side of the uncontrolled pedestrian crossing on Boden Park Green, do not appear to be wide enough such that they would sufficiently accommodate both pedestrians and cyclists.

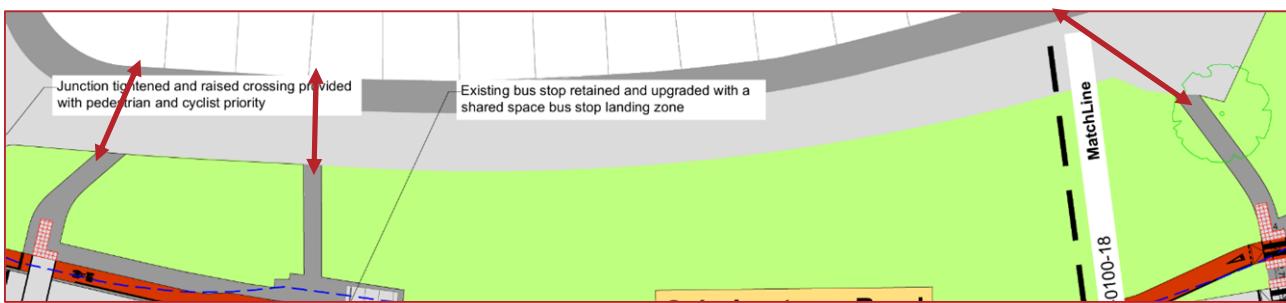
3.6 Lack of Crossings at Pedestrian Desire Line

Three footpath links have been indicated through the grass verge between Scholarstown Road and Scholarstown Park. The three footpath links terminate at the Scholarstown Park carriageway with no measures provided for pedestrians to cross to the footpath on the opposite side of Scholarstown Park.

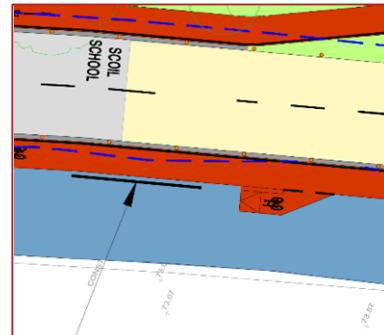
A guardrail is located at the edge of the carriageway on the western side of Knocklyon Road adjacent to Gaelscoil Chnoc Liamhna which is proposed to be retained. The guardrail is located close to the ramp from the northbound cycle track such that it may present an obstacle to cyclists, particularly schoolchildren, exiting the cycle track and entering the shared path.

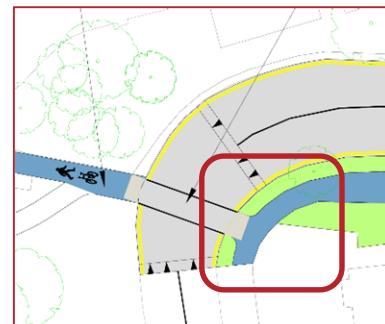
It is proposed to retain the existing footpath on the western side of Boden Heath in its current form but to convert it to a shared path and, similarly, to widen the existing footpath on the western side of Boden Park Green to 3m and convert it to a shared space.

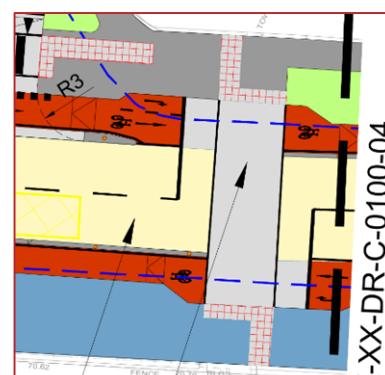
Right-turn pockets have been indicated within the cycle tracks at the proposed Toucan crossing on Knocklyon Road adjacent to its junction with Delaford Avenue and within the eastbound cycle track at the proposed Toucan crossing on Knocklyon Road at the Knocklyon Lodge Creche & Montessori.

It is unclear, however, at this early design stage if push-button units for cyclists will be provided within arm's reach of a cyclist stopped in the right-turn pocket to trigger a pedestrian/cyclist phase at the crossing.

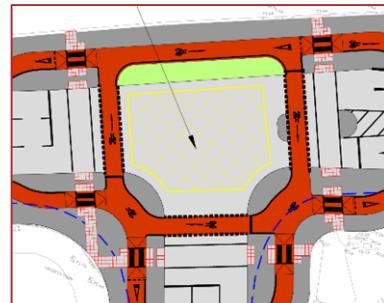
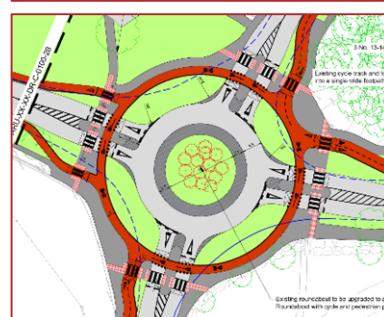
It is, therefore, unclear if the revised road layout at junctions, and the reduced carriageway space due to the amended kerbs, will sufficiently accommodate the swept path of all vehicles where turning drivers may be restricted by the revised kerb line, for example at the Firhouse Road and Knocklyon Road junction. If drivers cannot complete turning manoeuvres within the extents of the carriageway there is a risk of kerb strikes and vehicles potentially entering the cycle lanes or mounting the footpath, increasing the risk of collisions with items of roadside furniture or with other road users.

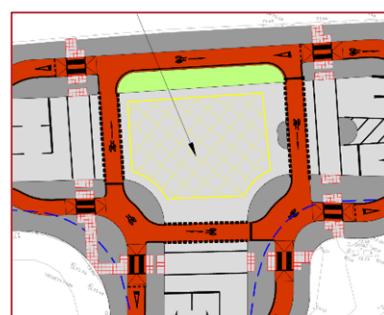
Information regarding the proposed traffic signal phasing at junctions, where the existing traffic lanes on the approach are to be removed/amended, has not been provided. The existing traffic signal phasing, if unchanged, may be insufficient to safely accommodate all movements at the revised junctions.

If the traffic signal phasing is not amended to reflect the new layout of the junctions there is a risk of road users being given a green signal during the same phase as opposing vehicle, or cyclist, movements which could lead to conflicts between left-turning vehicles and straight-ahead cyclists and also between straight-ahead vehicles and right-turning cyclists.

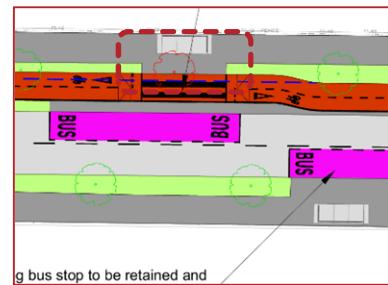
1. The eastbound bus stop on Firhouse Road to the east of the Firhouse Road/Knocklyon Road signalised junction.
2. The eastbound bus stop on Ballyboden Way to the east of the junction with Boden Park Green.
3. The eastbound bus stop on Scholarstown Road to the west of the roundabout junction between Scholarstown Road, Ballyboden Way and Templeroean Lawn.

The absence of tactile paving within the footpath at these Zebra crossings may lead to difficulties for visually impaired pedestrians in locating the crossing when boarding a bus resulting in them being unable to safely and independently navigate the road layout, or to them inadvertently entering the cycle track at the crossing and being struck by a cyclist.

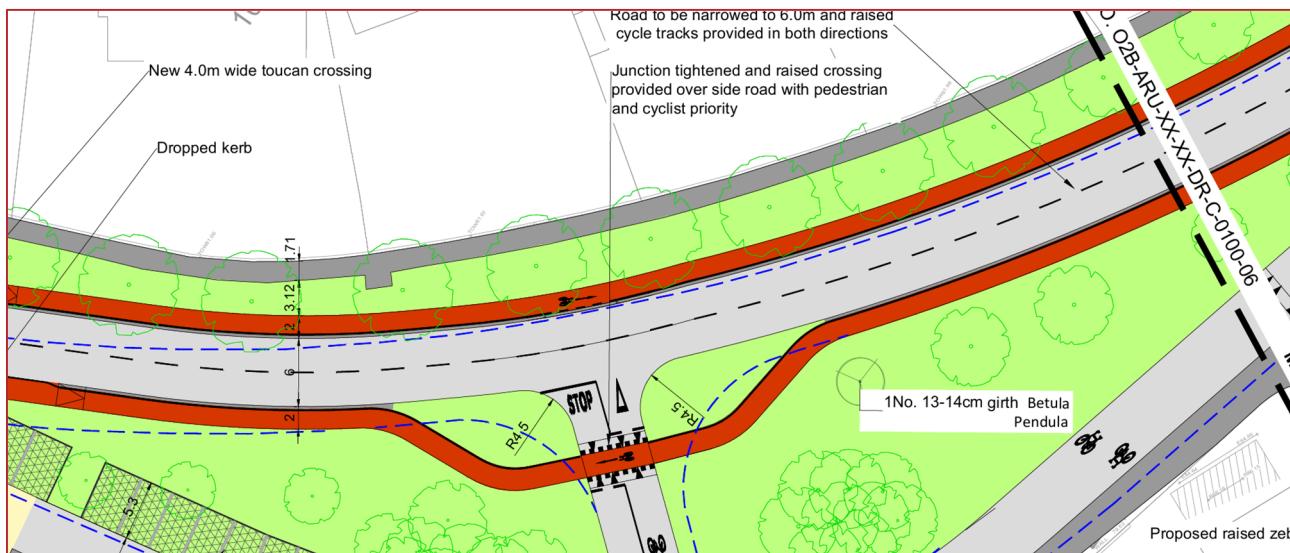
Summary: Horizontal curves have been indicated at some locations on Knocklyon Road and Ballyboden Way and it is unclear if large vehicles would be able to travel through these curves without encroaching into the opposing traffic lane.

Horizontal curves have been indicated at some locations on Knocklyon Road and Ballyboden Way. It is proposed to reduce the carriageway cross-section of these roads through the provision of widened footpaths and cycle tracks. Swept paths of large vehicles, such as buses and HGVs, travelling through these curves have not been provided to the Audit Team and it is, therefore, unclear if these vehicles can travel through these curves without encroaching into the adjacent traffic lane where there would be a risk of side swipe or head-on collisions with opposing vehicles.

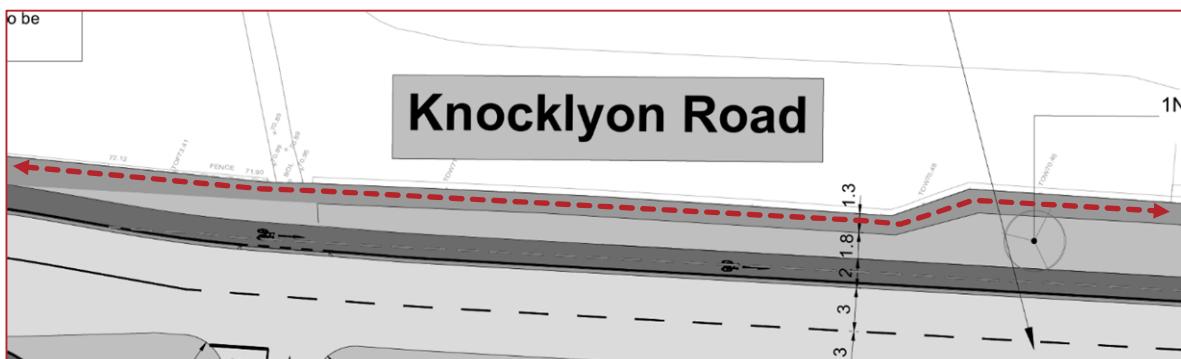
The footpath on the eastern side of Knocklyon Road opposite its junction with Delaney's Public House reduces in width at the commencement of the verge and continues with a relatively narrow cross-section for a short distance. This creates a pinch-point within the footpath which may lead to pedestrians having to enter the verge to pass opposing pedestrians where there is an increased risk of trips and falls, and personal injuries.

In addition, the footpath travels through two horizontal curves in quick succession within this narrow section such that the adjacent boundary hedge may restrict a pedestrian's forward visibility to oncoming pedestrians resulting in conflicts.

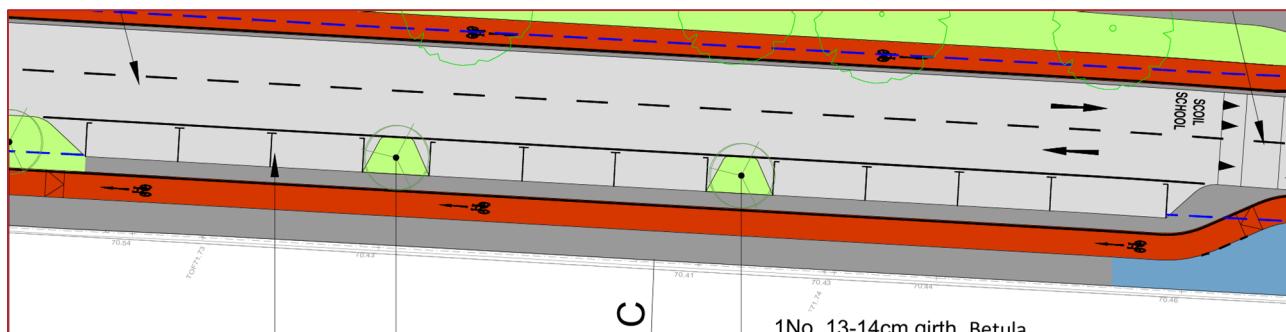
Summary: Measures have not been indicated for vehicle occupants to travel between the parking spaces at the school set-down area and the adjacent footpath on the southern side of Knocklyon Road at Gaelscoil Chnoc Liamhna.

Ten parking spaces have been indicated on the western side of Knocklyon Road at the school set-down area adjacent to Gaelscoil Chnoc Liamhna. The proposed northbound cycle track is indicated between the set-down area and the footpath at this location. No connection between the footpath and the set-down area has been indicated across the cycle track at this location which may lead to vehicle occupants, particularly schoolchildren, experiencing difficulty when travelling from their vehicle to the footpath, resulting in a potential increased risk of pedestrian-cyclist collisions.

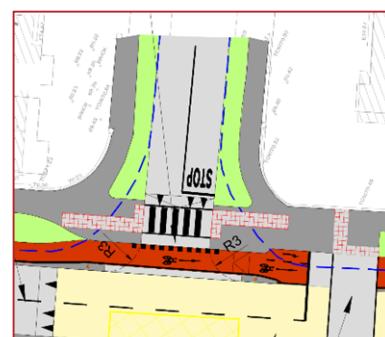
A raised Zebra crossing is proposed on Delaford Avenue at its junction with Knocklyon Road such that the Stop line would be setback into Delford Avenue. It is unclear if sufficient visibility would be available for drivers exiting Delaford Avenue from the setback Stop line due to the boundary walls and hedges of the properties on the corners of the junction. If sufficient visibility is not available from the Stop line this could lead to drivers entering Knocklyon Road when it is unsafe to do so and an increased risk of side-on collisions.

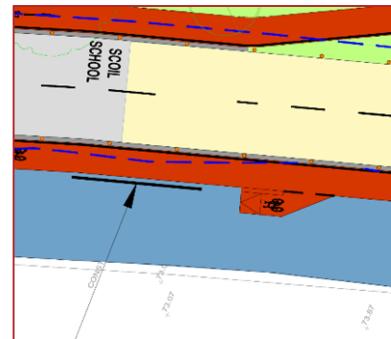
Summary: *The guardrail may present a hazard to cyclists as they move from the carriageway to the shared path at Gaelscoil Chnoc Liamhna.*

A guardrail is located at the edge of the carriageway on the western side of Knocklyon Road adjacent to Gaelscoil Chnoc Liamhna which is proposed to be retained. The guardrail is located close to the ramp from the northbound cycle track such that it may present a hazard to cyclists, particularly schoolchildren, exiting the cycle track and entering the shared path. This could lead to cyclists colliding with the guardrail, and suffering personal injuries, or losing control of, and falling from, their bicycle.

If the guardrail is not required, it should be removed. If it is required, it should be relocated where it would not present a hazard to cyclists.

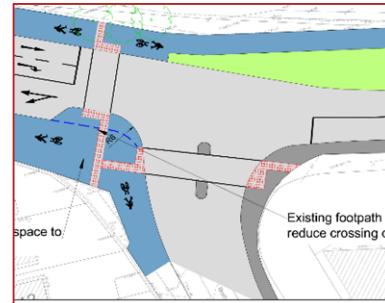
Knocklyon Road intersects Scholarstown Road at a signalised junction at the Knocklyon Shopping Centre. Travelling westbound, the nearside kerb lines on Knocklyon Road on either side of the junction do not align with each other. This may lead to westbound drivers continuing into the widened footpath on the western side of the junction, particularly during the hours of darkness, resulting in an increased risk of kerb strikes and material damage, or vehicles mounting the kerb and collisions with items of roadside furniture or pedestrian/cyclists waiting at the crossing.

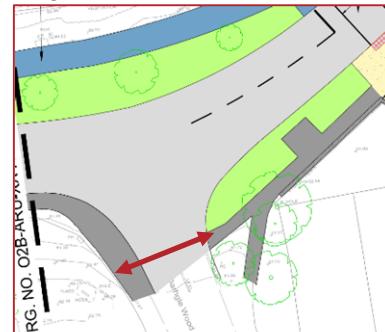
Summary: No pedestrian crossing, including dropped kerbs and tactile paving, has been indicated across the Dargle Wood side road.

No pedestrian crossing, including associated infrastructure such as dropped kerbs and tactile paving, has been indicated across the Dargle Wood side road at its junction with Knocklyon Road. This may lead to pedestrians having to mount/dismount a full height kerb when crossing the side road resulting in difficulties, particularly for mobility impaired pedestrians, where there is an increased risk of trips and falls and personal injuries.

A pedestrian crossing, including dropped kerbs and appropriate tactile paving, should be provided across the Dargle Wood side road.

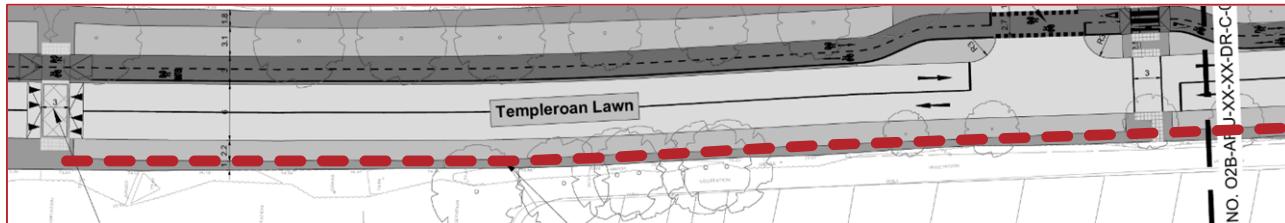
A 1m wide footpath has been indicated on the western side of Templeroan Lawn between the existing uncontrolled pedestrian crossing and just upstream of the entrance to Dargle Wood. 1m is not a sufficient width for pedestrians to travel safely within the footpath. This could lead to wheelchair users, or pedestrians pushing prams/strollers, experiencing difficulty in travelling on the footpath, or to pedestrians having to enter the adjacent verge to pass opposing pedestrians resulting in an increased risk of trips and falls and personal injuries.

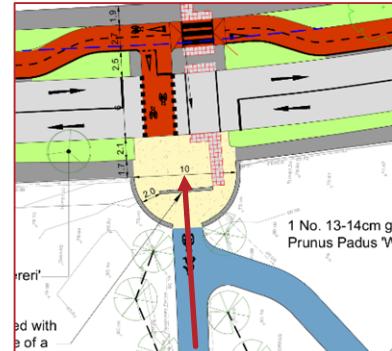
3.19 Stone Wall may be a Hazard

Summary: A stone wall has been indicated within the footpath on the western side of Templeroan Road at the exit from Dargle Wood Park, however the details of the wall (height, colour etc.) have not been indicated and it is, therefore, unclear if it will present a hazard to cyclists exiting the park.

The properties of the stone wall (i.e. its height, colour, material, etc.), however, have not been indicated and it is unclear if the wall would present a hazard to cyclists exiting the park. If cyclists cannot clearly see the wall on approach it may lead to them approaching at speed and colliding with the wall, however if the wall is too high, such that cyclists cannot see the carriageway and crossing on the other side, it may appear to them that they are presented with a cul de sac leading to confusion.

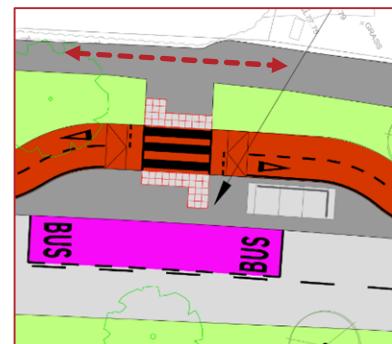
This may lead to visually impaired pedestrians continuing past the tactile paving and failing to detect the crossing, and thus the bus stop, resulting in them being unable to safely and independently navigate the road layout.

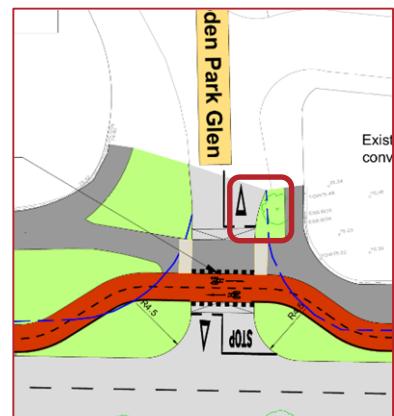
It is proposed to reduce the width of the Boden Park Green carriageway at its junction with Ballyboden Way through the provision of a kerbed build-out at the junction. The tie-in between this proposed narrower cross-section and the wider existing cross-section on Boden Park Green, upstream of the junction, is unclear and this could lead to drivers being insufficiently aware of the carriageway narrowing at the junction on approach, particularly during the hours of darkness, resulting in a risk of kerb strikes and material damage.

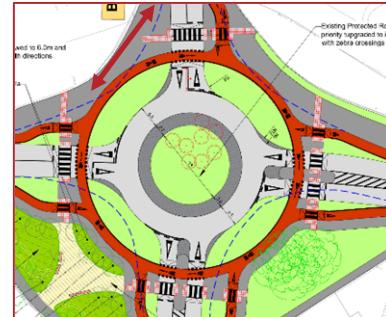
This may lead to visually impaired pedestrians, approaching from the south on Ballyboden Road, continuing past the tactile paving and failing to detect the crossing resulting in them being unable to safely and independently navigate the road layout.

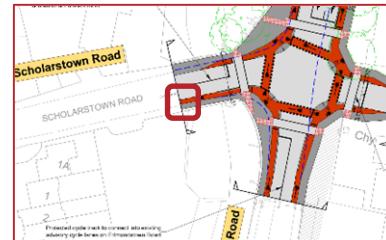
Summary: *The proposed and existing road layouts at the scheme tie-in on Scholarstown Road are not consistent.*

The scheme is indicated as tying-into the existing road layout on Scholarstown Road to the west of its junction with Edmondstown Road and Ballyboden Road. The proposed road layout includes an advisory westbound cycle lane however there is currently no cycle facilities, in either direction, on Scholarstown Road at this location. This may, therefore, lead to westbound drivers on Scholarstown Road being insufficiently aware of a cyclist suddenly entering the traffic lane resulting in an increased risk of vehicle-cyclist collisions.

Measures should be provided to gradually merge westbound cyclists into the westbound traffic lane at the tie-in and to increase a westbound driver's awareness of cyclists joining the traffic lane on their nearside.

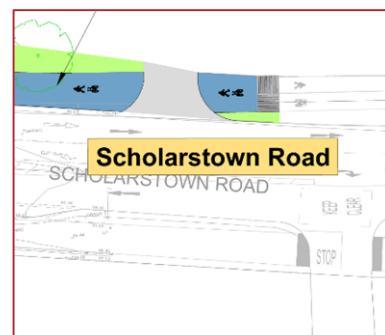
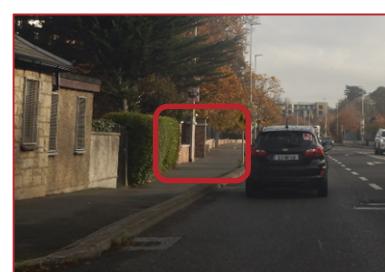
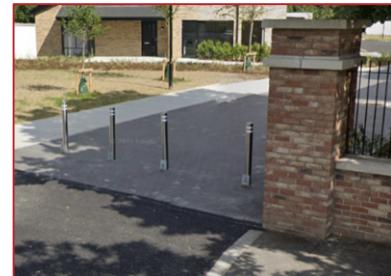
No tactile paving has been indicated on either side of the access to the recently constructed residential development on the northern side of Scholarstown Road opposite the Ballycullen Community Church and Olympian Gymnastics gym. The access does not appear to be currently in use by motorised vehicles due to bollards located within the development. Dropped kerbs are currently provided at the access however no tactile paving has been provided. It is unclear if it is proposed to amend this layout as part of the proposed scheme however no pedestrian crossing has been indicated at this location.

If the access layout is amended, this may lead to pedestrians having to mount/dismount a full height kerb when crossing the side road resulting in difficulties, particularly for mobility impaired pedestrians, where there is an increased risk of trips and falls and personal injuries.

If the access is retained in its current layout, the lack of tactile paving may lead to visually impaired pedestrians being insufficiently aware that they are crossing an access, which may be used by cyclists, resulting in an increased risk of pedestrian-cyclist collisions.

Should this access ever be open to motorised vehicles in the future, a pedestrian crossing, including dropped kerbs and appropriate tactile paving, should be provided across the access.

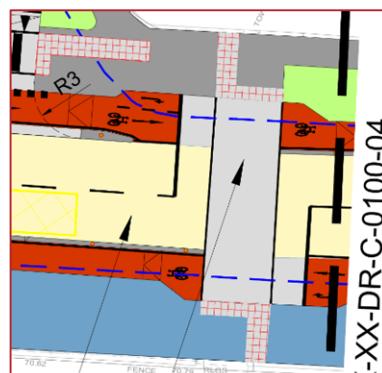
4.2 Right-turn pockets have been indicated within the cycle tracks at the proposed Toucan crossing on Knocklyon Road adjacent to its junction with Delaford Avenue and within the eastbound cycle track at the proposed Toucan crossing on Knocklyon Road at the Knocklyon Lodge Creche & Montessori. It is unclear, however, at this early design stage if push-button units for cyclists will be provided within arm's reach of a cyclist stopped in the right-turn pocket to trigger a pedestrian/cyclist phase at the crossing. During the detail design stage care should be taken to provide a push-button unit for cyclists at these crossings that can be easily reached from the right-turn pocket.

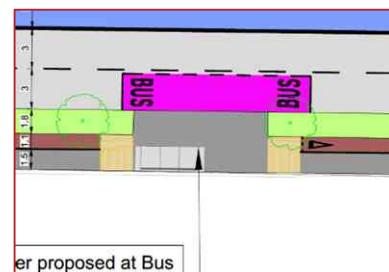
C.1.1 Bus Shelter

Bus shelters have been indicated within the proposed shared path at bus stops at various locations within the scheme. The type of bus shelter proposed is unclear however, and if it includes side panels it may restrict access for pedestrians when entering the shared path due to its proximity to the transition between the segregated footpath and cycle track and shared path.

Suitable bus shelters, that do not restrict access for pedestrians to the shared path at bus stops, should be provided during future design stages.

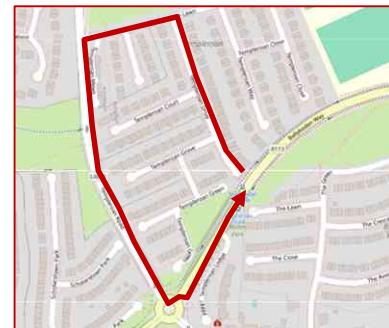
C.1.2 Pedestrian Connectivity between Ballyboden Way and Templeroan Drive

A pedestrian link has not been indicated between Ballyboden Way and Templeroan Drive where a boundary wall currently separates them. A failure to provide pedestrian permeability through the boundary wall at this location could lead to residents of Templeroan Drive having to walk for a minimum of one kilometre, or climb over the boundary wall, to access the immediately adjacent bus stops (Stop ID 7443 & Stop ID 7446) on Ballyboden Way.

Provide a pedestrian/cyclist link between Ballyboden Way and Templeroan Drive to facilitate pedestrian and cyclist access to the adjacent bus stops and cycle track on Ballyboden Way.

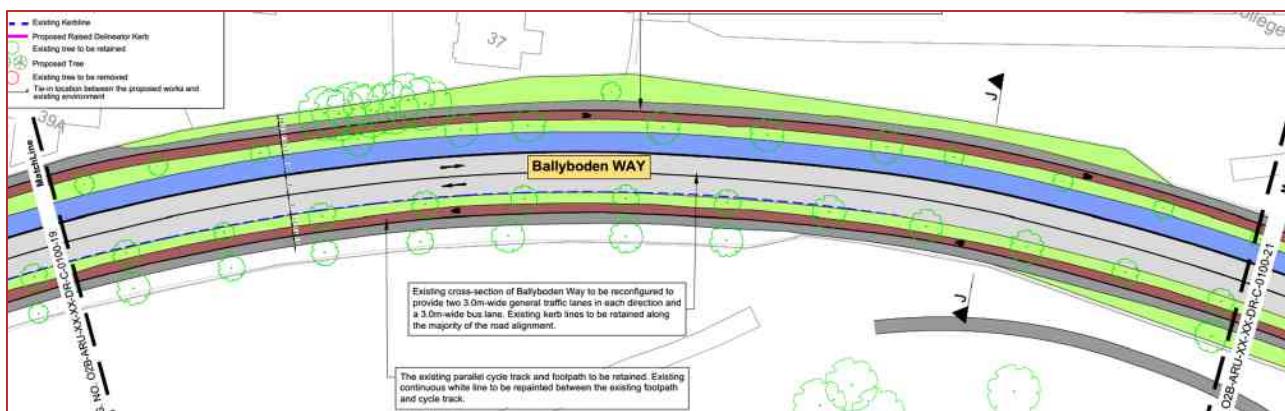
It is proposed to reduce the carriageway cross-section of Ballyboden Way through the provision of widened footpaths and cycle tracks. Swept paths of large vehicles, such as buses and HGVs, travelling through this curve has not been provided to the Audit Team and it is, therefore, unclear if these vehicles can travel through this curve without encroaching into the adjacent traffic lane where there would be a risk of side swipe or head-on collisions with opposing vehicles.
