Wellington Lane Cycle Scheme

Stage 1 Road Safety Audit

Document Ref:	P22-106-RSA-PD-RP-001
----------------------	------------------------------

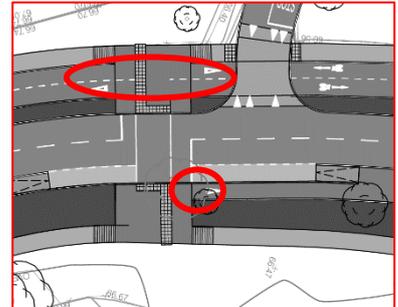
Location: Drawing 180201-1004 (P0) – Wellington Lane

Summary: Visually impaired pedestrians may inadvertently enter cycle lane

No tramline tactile paving has been shown within the cycle lanes at their interface with the shared surfaces at the proposed toucan crossing. This could result in visually impaired pedestrians inadvertently entering the cycleway, and from there entering the carriageway.

Recommendation

Ladder and Tramline tactile paving should be provided at the cycle track ramps at the interface with footpaths, ensuring the correct tactile paving specification (i.e. flat-topped cycle way paving) is used.

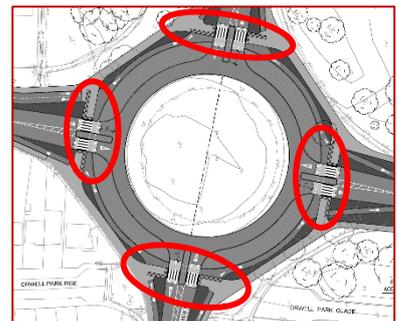
Location: Drawing 180201-1005 (P0) - Orwell Road Roundabout

Summary: Visually impaired pedestrians may inadvertently enter cycle lane

The cycle tracks on the approaches to the Osprey Road, Wellington Lane/Road and Orwell Road roundabout cross footpaths, or run adjacent to the footpath and share the raised-table at the proposed zebra crossings.

No Ladder & Tramline tactile paving has been indicated to warn visually impaired pedestrians of the cycle tracks and it is unclear if vertical separation can be maintained as the footpath and cycle track share the raised-table crossings.

This could result in visually impaired pedestrians inadvertently entering the cycleway, and from there entering the carriageway.

Recommendation

The cycle track and footpath should be segregated vertically and laterally at the roundabout.

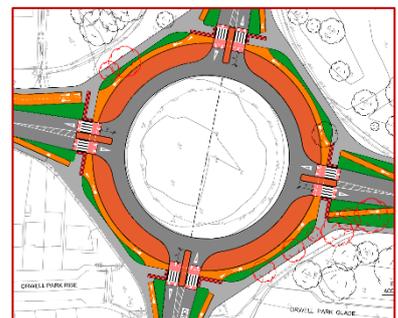
Location: Drawing 180201-1005 (P0) - Orwell Road Roundabout

Summary: Amendments to roundabout may not achieve sufficient speed reductions if not of an appropriate form.

It is unclear what form the proposed carriageway width reduction on the roundabout circulating carriageway will take. It is assumed that it will consist of kerbed build-outs.

However, if non-physical means (e.g. road markings) were intended then this arrangement is unlikely to achieve sufficient speed-reduction on the approaches to the exits from the roundabout and the zebra crossings at these locations, possibly resulting in overshoot into the crossings and vehicle/pedestrian collisions.

Recommendation

The changes to the roundabout circulating carriageway should be of a form which ensures that vehicle speeds are sufficiently reduced to allow drivers to safely come to a halt when required to do so.

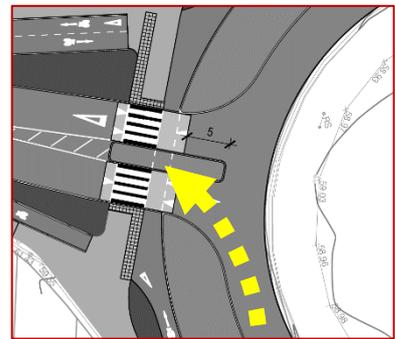
Location: Drawing 180201-1005 (P0) - Orwell Road Roundabout

Summary: It is unclear if large vehicles will be sufficiently able to enter/exit the roundabout without overhanging the waiting area at the crossings.

Information regarding the swept path of large vehicles (buses, refuse trucks etc.) has not been provided to the Audit Team. It is therefore unclear if these vehicles will have sufficient space on the entry to & exit from the circulating carriageway within the roundabout without overhanging footpaths.

The lane width & geometry on the entry to & exit from the circulating carriageway is such that it may be overrun, or portions of large vehicles could overhang into the pedestrian refuge island, or on the approach to the crossings, presenting a possible hazard to pedestrians.

Recommendation

Ensure the entry/exit at the roundabout have sufficient width to allow for the overhang of the larger vehicles, in particular buses.

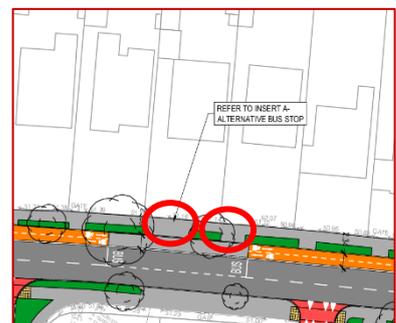
Location: Drawing 180201-1010 (P0) – Whitehall Road.

Summary: Proposed Bus stop location conflicts with existing vehicular accesses to adjacent properties.

It is proposed to provide an 'Alternative Bus Stop' layout at the northern bus stop on Whitehall Road. The location of the proposed bus stop in the northbound lane is likely to conflict with existing vehicular accesses to properties on the north-western side of the road.

The indicated Alternative Bus Stop layout includes a kerb height similar in height to the Kassel kerb (160mm), which may lead to difficulties for vehicles entering/exiting the adjacent residential property accesses, or to conflicts between pedestrians waiting at the bus stop and vehicles entering/exiting the adjacent residential property accesses.

Recommendation

Relocate the bus stop away from vehicular accesses or amend the bus stop extents to remove potential conflicts.

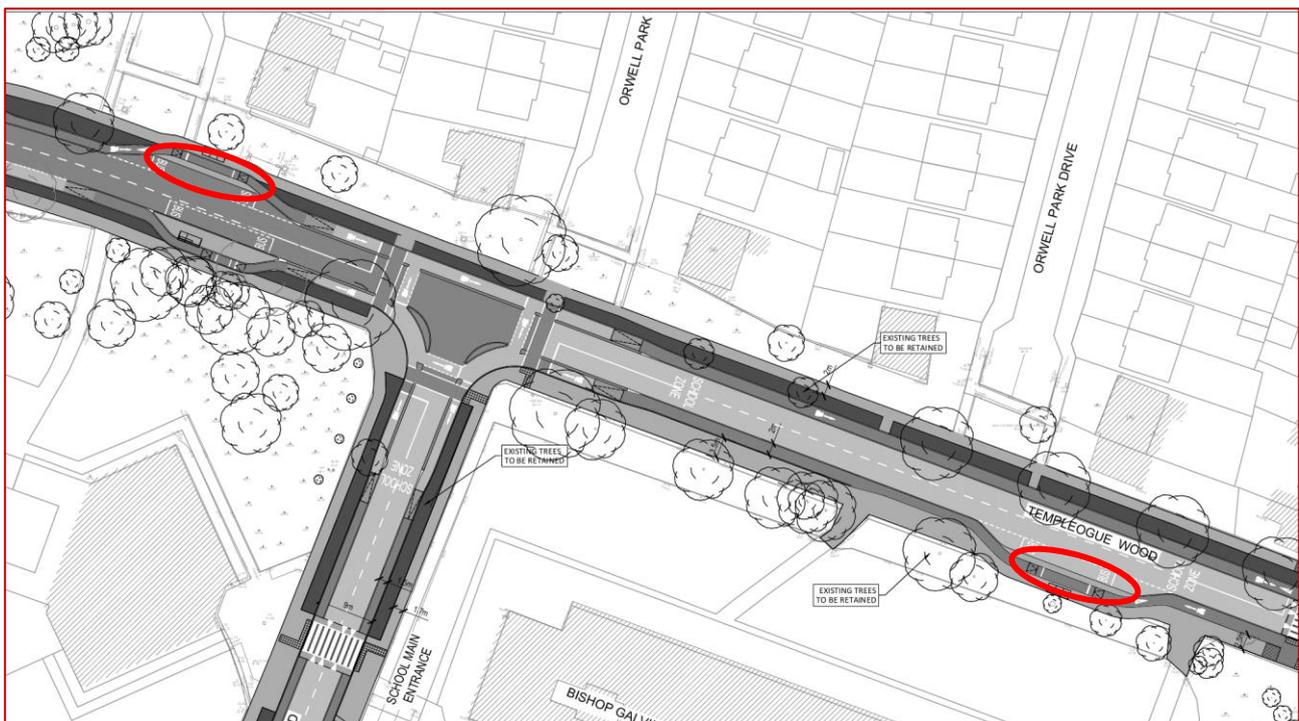
Location: Drawing 180201-1051 (-) – Orwell Road and Templeogue Wood

Summary: The proposed island bus stops along Orwell Road are narrow.

It is proposed to provide islands bus stop at the northern side of Orwell Road and on Templeogue Wood. The indicated width of the island is relatively narrow, and it may not accommodate the volumes of pedestrians waiting at the bus stop which may lead to waiting pedestrians encroaching into the cycle track, and blocking the path of a cyclist. In addition, the width of the island may result in difficulties for wheelchair users accessing public transport safely.

Recommendation

The island should be of adequate width (e.g. the National Cycle Manual recommends a minimum island width of 3m) to accommodate the expected volumes of waiting passengers.

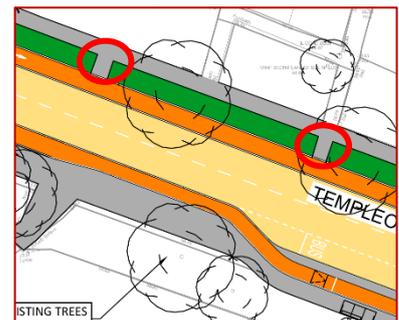
Location: Drawing 180201-1051 (-) – Orwell Road and Templeogue Wood

Summary: Retained footpath links at Templeogue Wood may encourage informal crossing and increase risk of pedestrians tripping and falling.

Footpath links have been indicated from the footpath on the northern side of Templeogue Wood to the kerb at the cycle track. This arrangement is likely to encourage pedestrians to cross at these locations, however with no gaps provided in the protected cycle lane kerbs at these locations there is a risk of pedestrians tripping and falling.

Recommendation

Remove the footpath links to encourage crossing at the proposed controlled crossings.

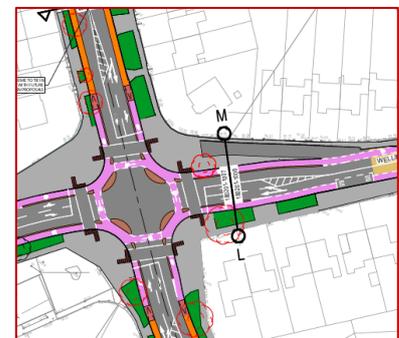
Location: General Problem

Summary: Tactile paving stem does not extend to/beyond the walking path line

At several locations where controlled crossings are proposed at signalised junctions the tactile paving stem does not extend to the back of the footpath. As a result, visually impaired pedestrians may not be able to locate the tactile paving and consequently the crossing point itself.

Recommendation

Tactile paving should extend to the back of the footpath all controlled crossings, or a sufficient distance so as to be encountered by visually impaired pedestrians on the approaching paths.

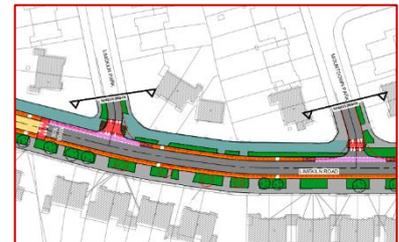
Location: Drawing 180201-1041 (-) – Limekiln Road

Summary: Ladder and Tramline tactile paving has not been indicated either side of the proposed shared surface.

It is proposed to provide a shared surface along Limekiln Road in the vicinity of the school. However, Ladder and Tramline tactile paving has not been indicated at the start and end of the shared surface where it meets the existing footpaths on the side roads (e.g. Limekiln Park and Mounddown Park).

This could lead to visually impaired pedestrians approaching the shared surface in the footpath being insufficiently aware that they are entering a shared area where cyclists may also be present which could result in an increased risk of pedestrian-cyclist collisions.

Recommendation

Provide Ladder and Tramline tactile paving at the interfaces between shared and segregated surfaces.

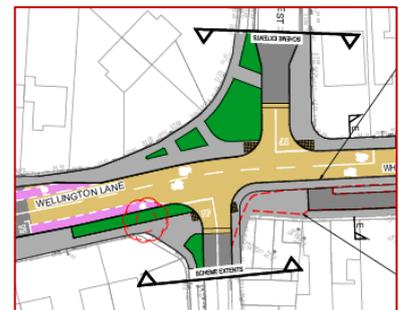
Location: Drawing 180201-1008 (P0) - Whitehall Road

Summary: Position of dropped kerbs on the corner of the junction could result in inappropriate/unsafe crossings.

The position of the uncontrolled pedestrian crossing of Whitehall Road West, on the corner of its junction with Whitehall Road, could result in southbound pedestrians travelling along the eastern side of Whitehall Road mistaking the tactile paving and dropped kerb as indicating a crossing of Whitehall Road at a location where crossings are not intended, and where drivers may not expect a pedestrian to cross, leading to unsafe/inappropriate crossings.

Recommendation

The location of the uncontrolled pedestrian crossing should be adjusted so that the direction of the crossing is clear to approaching pedestrians.

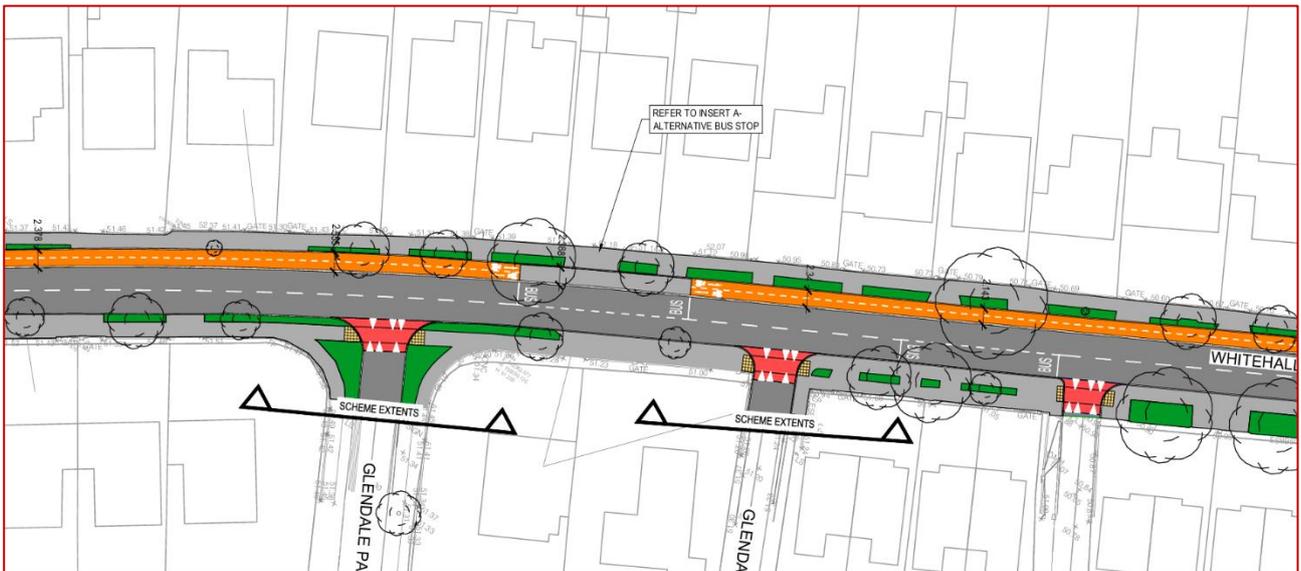
Location: Drawing 180201-1009 (P0) - Whitehall Road

Summary: Possible pedestrian desire crossing line not catered for within Whitehall Road

No pedestrian crossing has been indicated in the vicinity of the two bus stops on either side of Whitehall Road. It is likely that public transport users undertaking return journeys would need to cross the road on either their outbound, or inbound, journey.

This could result in unsafe crossing manoeuvres, particularly during peak times, with a consequent risk of vehicular/pedestrian collisions.

Recommendation

A review of likely pedestrian desire lines at this location should be undertaken, and appropriate & safe measures included to cater for crossing desire lines.

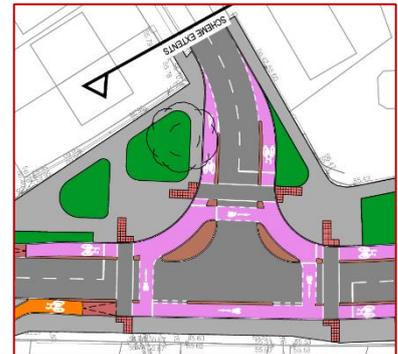
4.2 It is unclear if straight-ahead cyclists at the proposed signalised protected-junctions (e.g. at Wellington Green) are to proceed at the same time as traffic in the same direction of travel.

The offset of the cycle lane along the intersecting road, away from the through traffic in the same direction of travel as the cyclists could result in turning drivers believing that cyclists are at a crossing, and should give way to turning traffic.

To avoid potential confusion cyclists should have a separate traffic signal phase to vehicular traffic within these junctions.

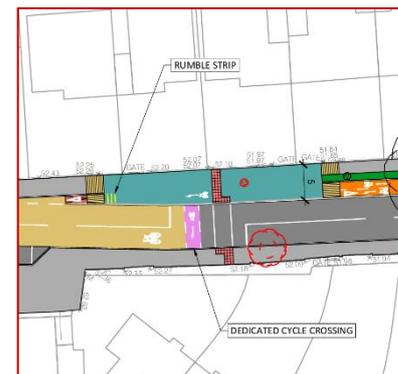
4.3 It is unclear if it is intended to provide a dropped-kerb at the dedicated cycle crossing of Whitehall Road. It is likely that some form of dropped-kerb would be considered necessary to facilitate cyclists use of the crossing. However, a dropped kerb raises the risk of visually-impaired pedestrian inadvertently straying into the carriageway, where they are at risk of being struck by a vehicle. All dropped kerbs should have a minimum upstand of 25 mm, or else tactile paving should be provided.

Alternatively amend the proposed arrangement such that the proposed pedestrian crossing and dedicated cycle crossing combined into a single toucan crossing.

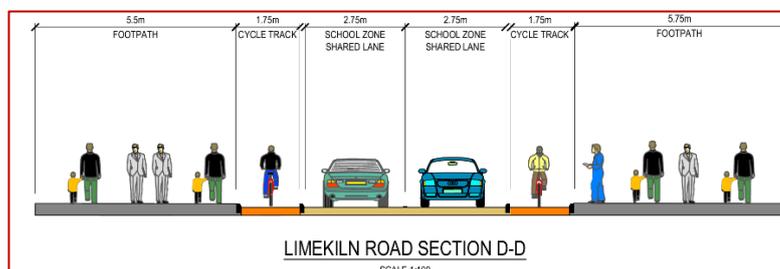
4.4 There is potential for the protected cycle lane kerbs within the "School Zone Shared Lane" to present a trip hazard if the area is intended to be shared with all users. It may be preferable to have a segregated carriageway through this area with School Zone Treatment.

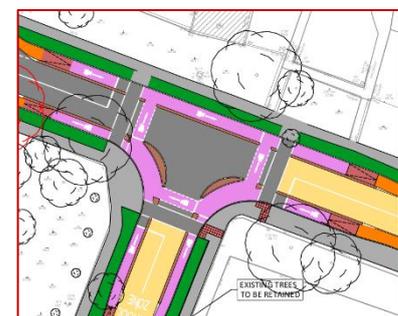
4.5 At a number of controlled and uncontrolled crossing along Orwell Road tactile paving has not been indicated.

This assumed to be CAD error, however the drawings should be amended to reflect the proposed layout.
