Tree Survey

Grange Castle
Clondalkin
Dublin

CLIENT: **South Dublin County Council**

DOCUMENT:
6393 – Tree Survey Report

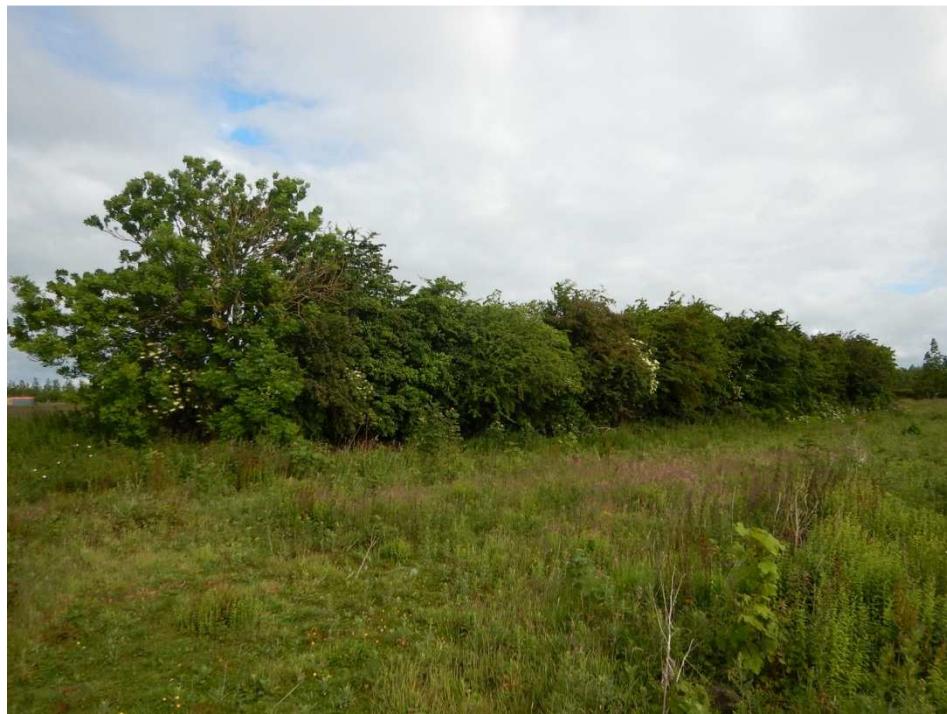
The survey site included a hedge extending north from the castle compound towards the internal business park road and the roughly circular ring of trees and scrub that follows the deep ditch network that surrounds the castle compound itself.

Photo 1. Hedge H1 extending north from the castle compound.

Tag	Species	Botanical Name	Age	Dbh	St	Ht	Cl	N	S	E	W	Cat	ULE	Condition/Comments	Preliminary Management Recommendations	RPA
H	1	Ash Hawthorn Elder	<i>Fraxinus excelsior</i> , <i>Crataegus monogyna</i> , <i>Sambucus nigra</i>	M	260	3	5.5	0	2	2	3	3	C2	10+	Fair. Average vitality. Old agricultural field boundary hedge - mostly mature multi-stemmed Hawthorn bushes. Thick ivy on stems and into crowns. No recent management works. Numerous Rabbit burrows into hedge base.	Trim side branching back into shape. Control Rabbits.	3

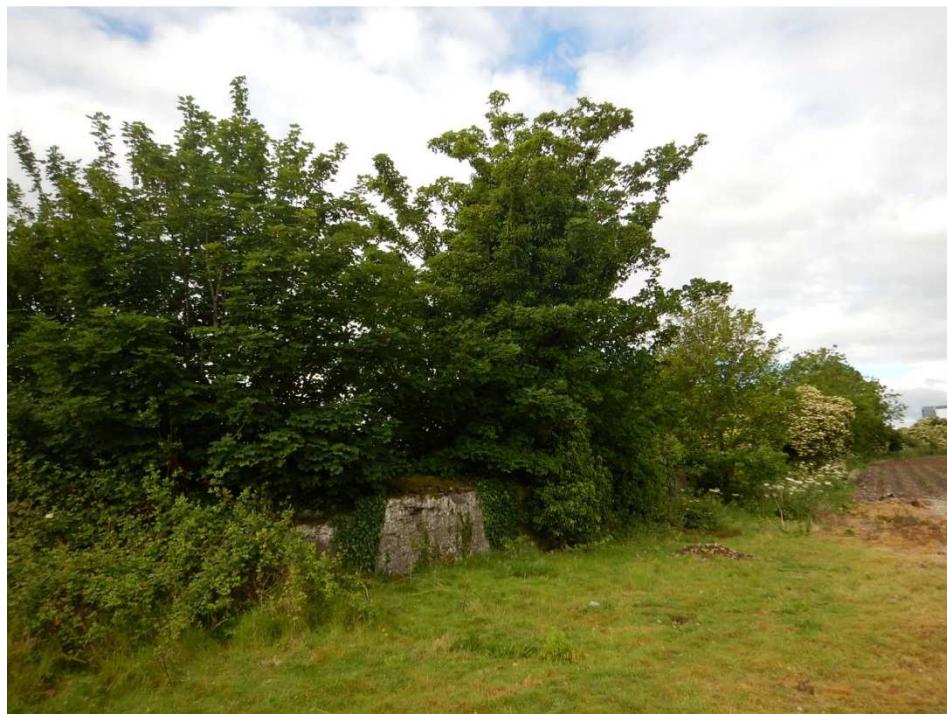
The younger self-sown Sycamore trees growing next to the old wall to the north of the compound are of poor quality and are now starting to impact on the masonry of the wall; this impact will become more significant if the trees are allowed to mature.

Photo 2. Semi-mature and early mature Sycamore trees growing out of or very close to the old masonry wall along the northern perimeter of the site.

The Sycamore trees that have colonised the ground adjacent to the old walls should be cut to stump and the stumps treated with herbicide to prevent any regrowth.

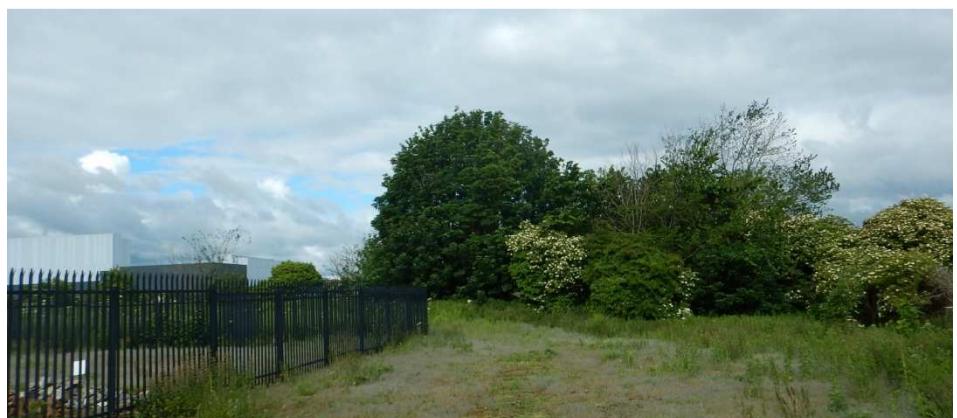
The Elm trees around the site are suffering badly from the effects of Dutch Elm Disease and are either infected or dead as a result; it is likely that the disease has been killing off Elms along the ditches for some time; creating more gaps in the tree-line.

Photo 3. Mature Sycamore coppice (T1005) in centre, with Elder scrub and dying Elms to right in the north-western corner of the site.

The Elm trees within the old tree-lines around the old castle are now dying as a result of Dutch Elm Disease. These trees should all be cut back to stump without undue delay; this will encourage new growth to sprout from the stump before the disease works its way down to the rootstock and kills the tree completely.

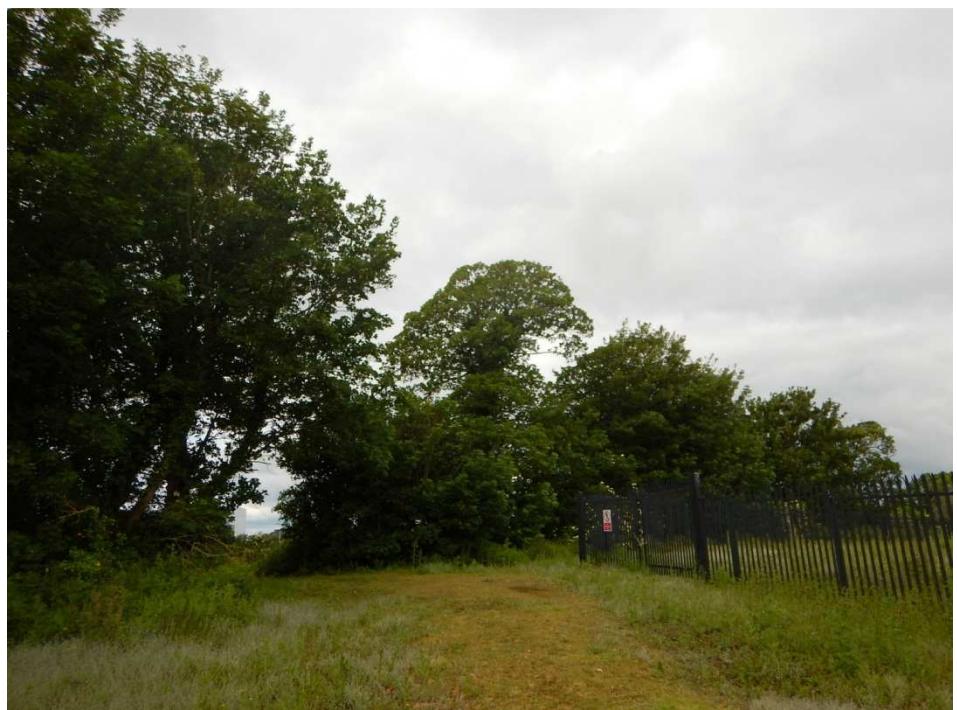
The older Sycamore trees show signs of repeated coppicing, with very wide old stool bases and multiple stems, these trees however have not been re-cut for some years and may become liable to stem break-out (as has happened to tree T1013). Most of the Sycamore trees showed signs of bark gnawing by Grey Squirrels; this has caused growth abnormalities and branch losses in many instances.

Photo 4. Mature tree-line along the south-western edge of the site (from right to left; T1006-1009, 1012-13)

Many of the Sycamore coppice stools located around the perimeter ditch should be re-coppiced over the next 5-10 years. Undergrowth should be cleared to allow re-enforcement planting of mixed species (preferably native such as Hawthorn, Hazel, Holly, Blackthorn, Oak etc.) to in-fill and re-establish the tree-lines along the ditches.

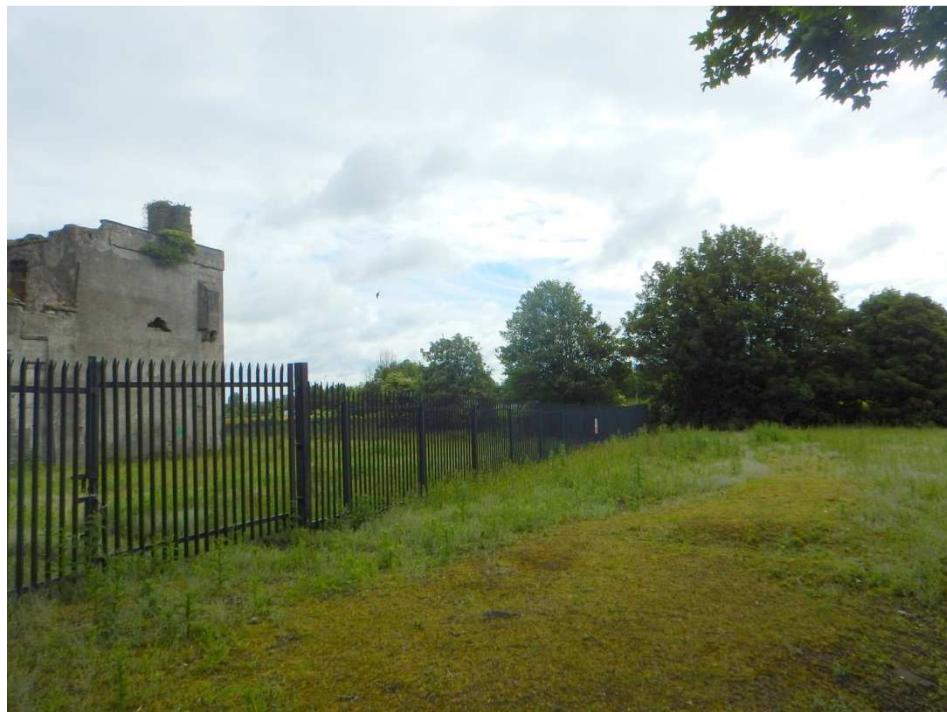
Photo 5. Trees 1019-1023 along the eastern boundary ditch.

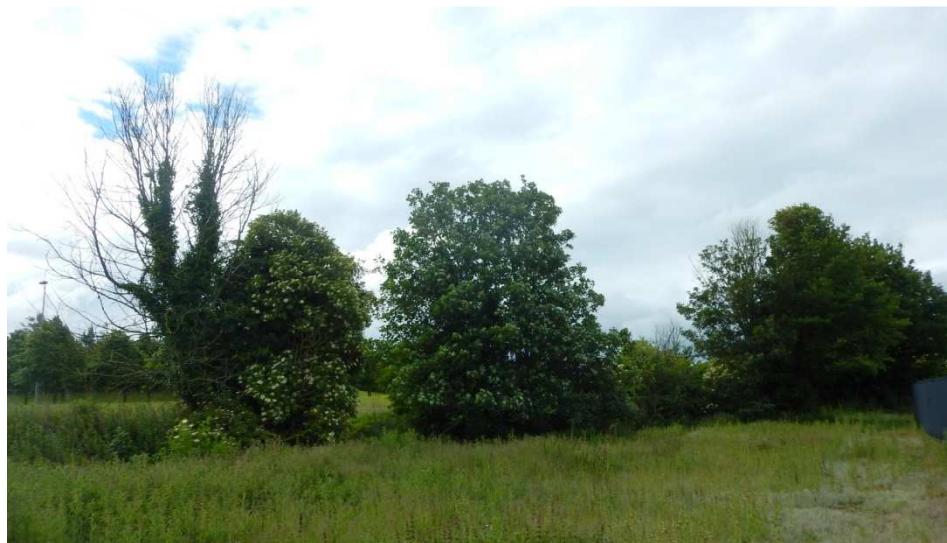
Photo 6. Sycamore tree T1023 in centre of picture; note dead and dying Elm trees to the left and right.

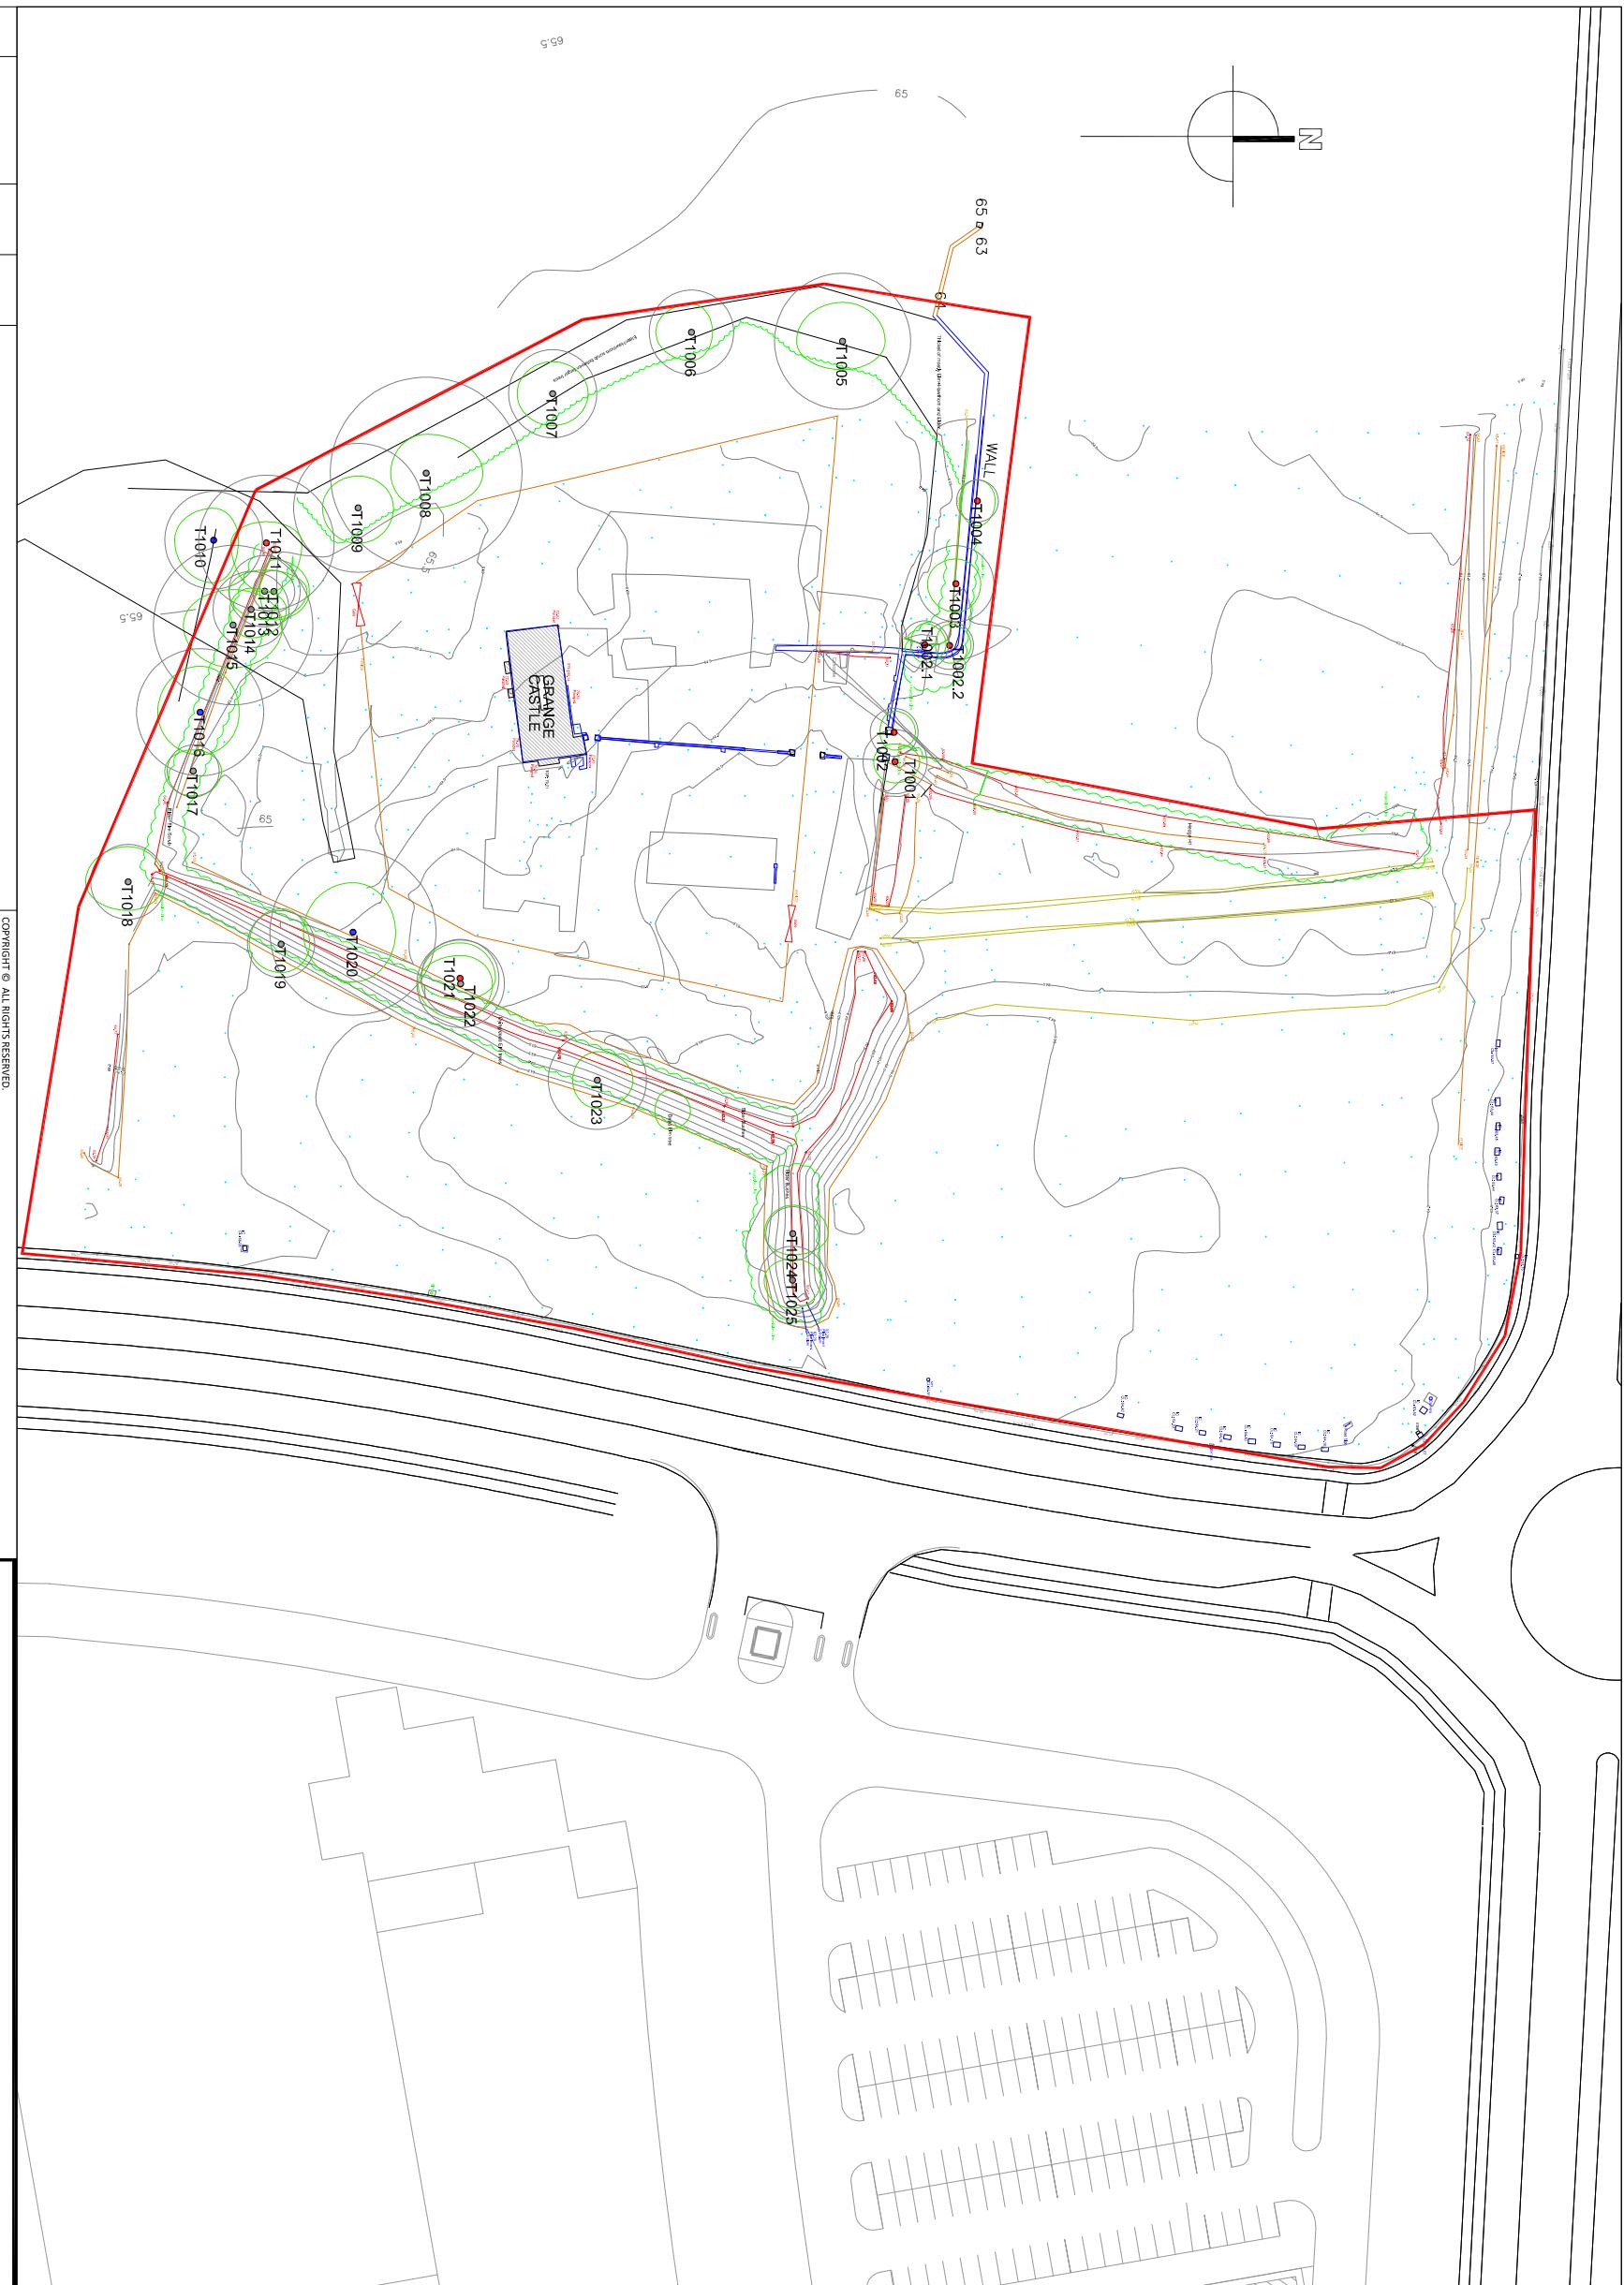
9 TREE SURVEY PLAN

The accompanying drawing 6393-305 shows the locations of the individual trees and hedges identified on the site during the survey.

Some of the trees included in the survey were not located by topographic survey methods and their positions on the site drawing should be regarded as indicative; this includes the trees labelled 1005-1010, 1012, 1018, 1024 and 1025.

Any major demolition or construction works should be carefully managed to prevent any unintended damage being caused to the trees intended for retention. The root protection areas of the trees are shown on the survey drawing and should be protected by effective barriers should any significant works be undertaken on the site.
