**TREE SURVEY**

**Lucan Demense,  
Lucan,  
Co Dublin.**

**May 2024**

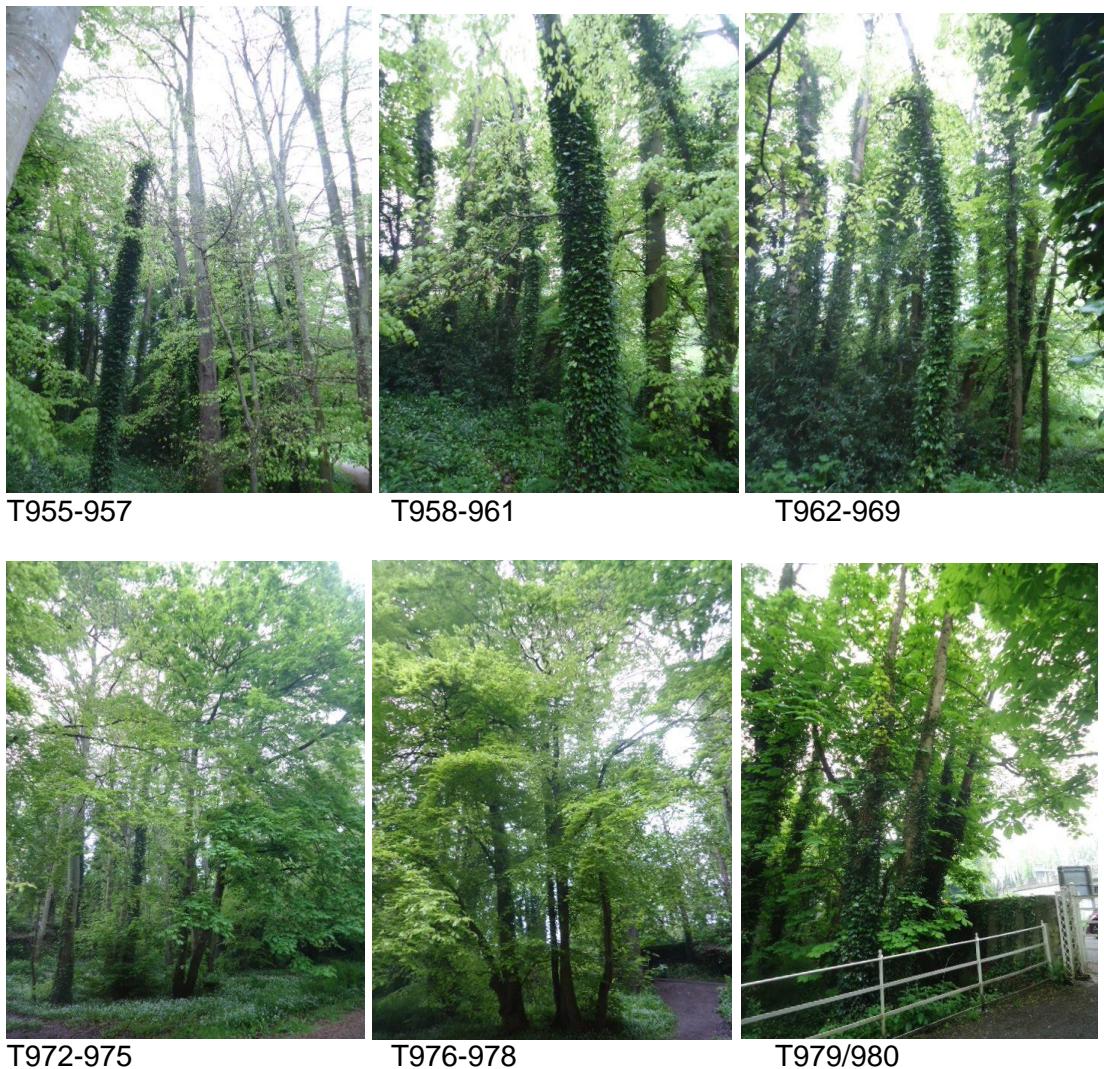
T947-954 (seen from car park)

2.3 The trees located within the site are typically of a moderate to high value, mixed deciduous species. Many are restricted for space and have developed in a phototropic manner competing for light, resulting in a tall thin form (typically trees in middle of woodland), and lopsided form (typically trees on woodland edge). The age profile of the trees is young to mature, with a good of mature and young sapling developing as light availability allows. There is one veteran tree (T1994) which is in decline and has been monolithed to a safe height.
