Arboricultural Report

Proposed Site: Sean Walsh Park

Client: South Dublin County Council

Project: Bowling Green

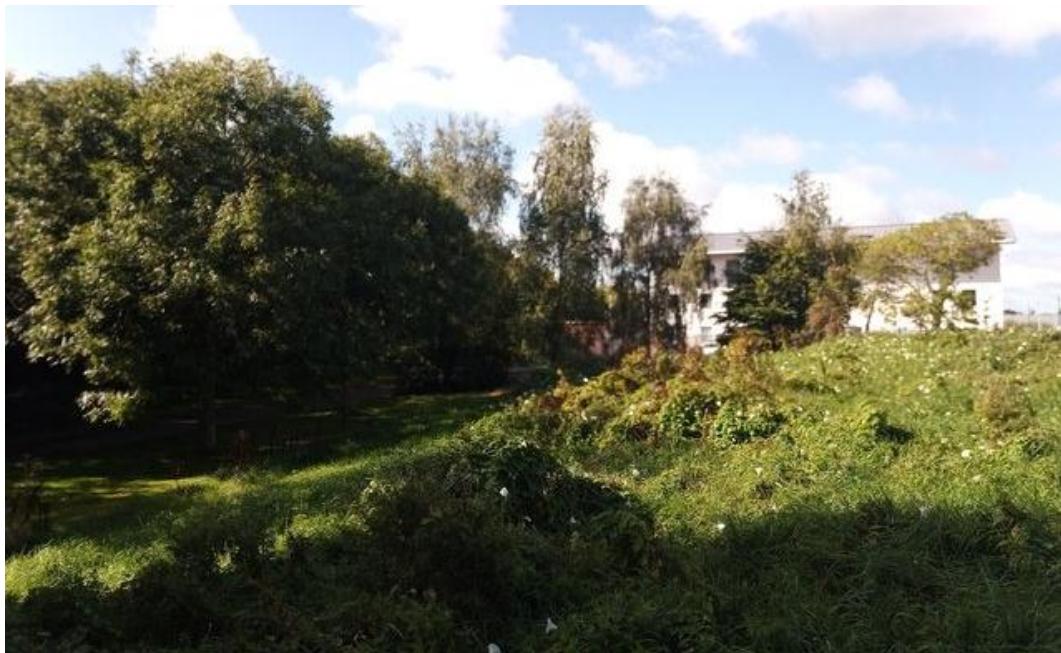
Figure 3: Site overview showing a variety of tree species and sloping grassland.

4.4 The proposed bowling green development is on a sloping grassland site (fig. 3) of approximately 37.0 m x 32.0m, located to the south of Old Bawn Community School Basketball Court and north of Whitestown Stream within Sean Walsh Park.

4.8 A row of ash trees, T2019 – T2022, line the southern boundary. These trees are in good condition, other than T2021, which has extensive dieback. Two shrubs are sited along the northern boundary, the grey willow T2024, and the buddleia T2025.
