# CONSERVATION REPORT

## Proposed Saggart Community Centre.

Conservation, renovation and extension at  
St Marys National School (protected structure)  
Slade Castle Walk  
Boherboy  
Saggart

20<sup>th</sup> February 2020

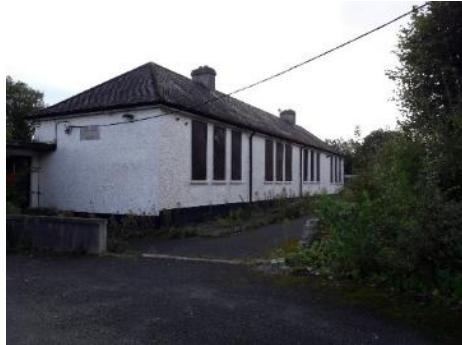
The roof structure is a simple coupled roof, a cut roof with a single tie at midpoint of each rafter. The roof structure is generally in good condition but the slate roof covering is deteriorating. The western roof pitch is the worst affected, probably because of its exposure to the prevailing wind. Many slates have slipped and many have fallen. Loose broken slates were on the ground around the building's perimeter and there is evidence of previous attempts to catch slipped slates - a strip of metal mesh fixed to steel brackets at eaves level. There is a tilting fillet above the eaves level of the main roof. The rainwater gutters are half-round cast iron, the rainwater down pipes are standard sleeve and socket, mostly corroded, some deformed also.

The main building, viewed from the north-west  
south

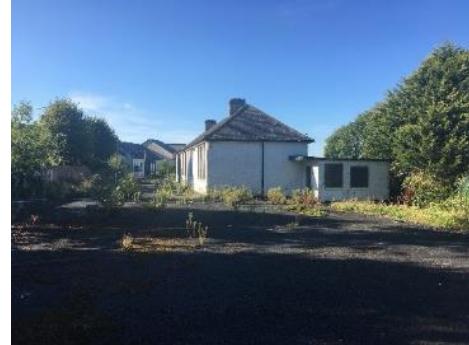
The main buildings and extension to the rere viewed from the
