**Grange Cottage (Beattie's Cottage), Grand Canal Way, Newcastle Road, Lucan, Co. Dublin K78 RW26**

**Architectural Heritage Impact Assessment**

October 2023

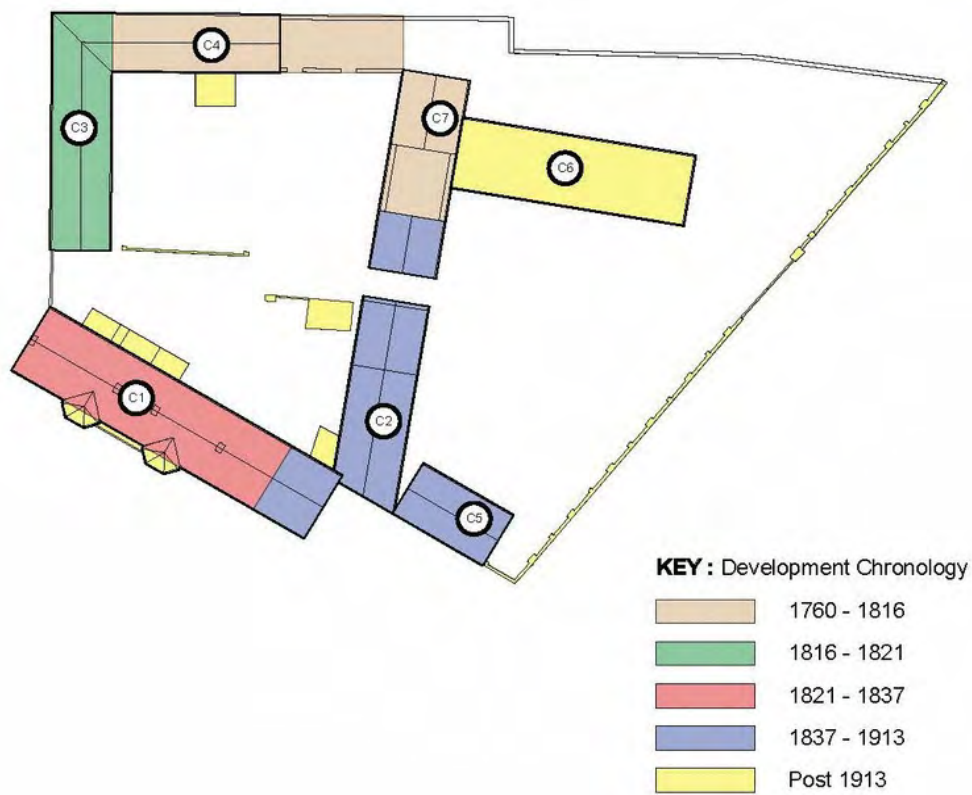
**Fig 1:** Site plan of Grange Cottage showing chronological development of site

- C1** Grange Cottage
- C2** Grange Cottage Courtyard Outbuilding - East Range (south)
- C3** Grange Cottage Courtyard Outbuilding - West Range
- C4** Grange Cottage Courtyard Outbuilding - North Range
- C5** East Courtyard - South Agricultural Building
- C6** East Courtyard - North Agricultural Building
- C7** Grange Cottage Courtyard Outbuilding - East Range (north)

The first record of Grange Cottage, from the cartographic sources that were available, is on the first edition ordnance survey map (1829 - 1837). The cottage plan is noticeably shorter than the current arrangement and a garden enclosure is recorded at the east side of the cottage. The mill building is recorded at the west side of the house. In the next ordnance survey map (1897 -1913) extensions are recorded at the east side of the cottage and the courtyard is nearly fully enclosed. Substantial building works are carried out to the cottage and outbuilding at this time. It is believed that much of the roofing on the cottage and outbuildings that can be seen on site today were most likely carried out at this time. The north range of the courtyard has been extended and infilled. A new outbuilding has been built at the east end of the Cottage and another barn building is visible on the east boundary of the of the garden area. Interestingly, the mill building which was recorded to the east of the cottage in the 1829-37 ordnance survey map has been demolished. It is most likely that the previous owners of the cottage, prior to the purchase of the cottage by the Beattie family, carried out these works and the stone and timber from the mill structure may have been used to extend the cottage and complete the infill construction works to the outbuildings.

In the ordnance survey map of 1938, the south boundary of the cottage has moved to the south and a new entrance drive is recorded on this map. This most likely coincides with the reorientation of the house where the new bays were added to the south elevation to make the new formal front entrance to the house. The agricultural building on the east boundary can still be seen on the ordnance survey map of 1938.

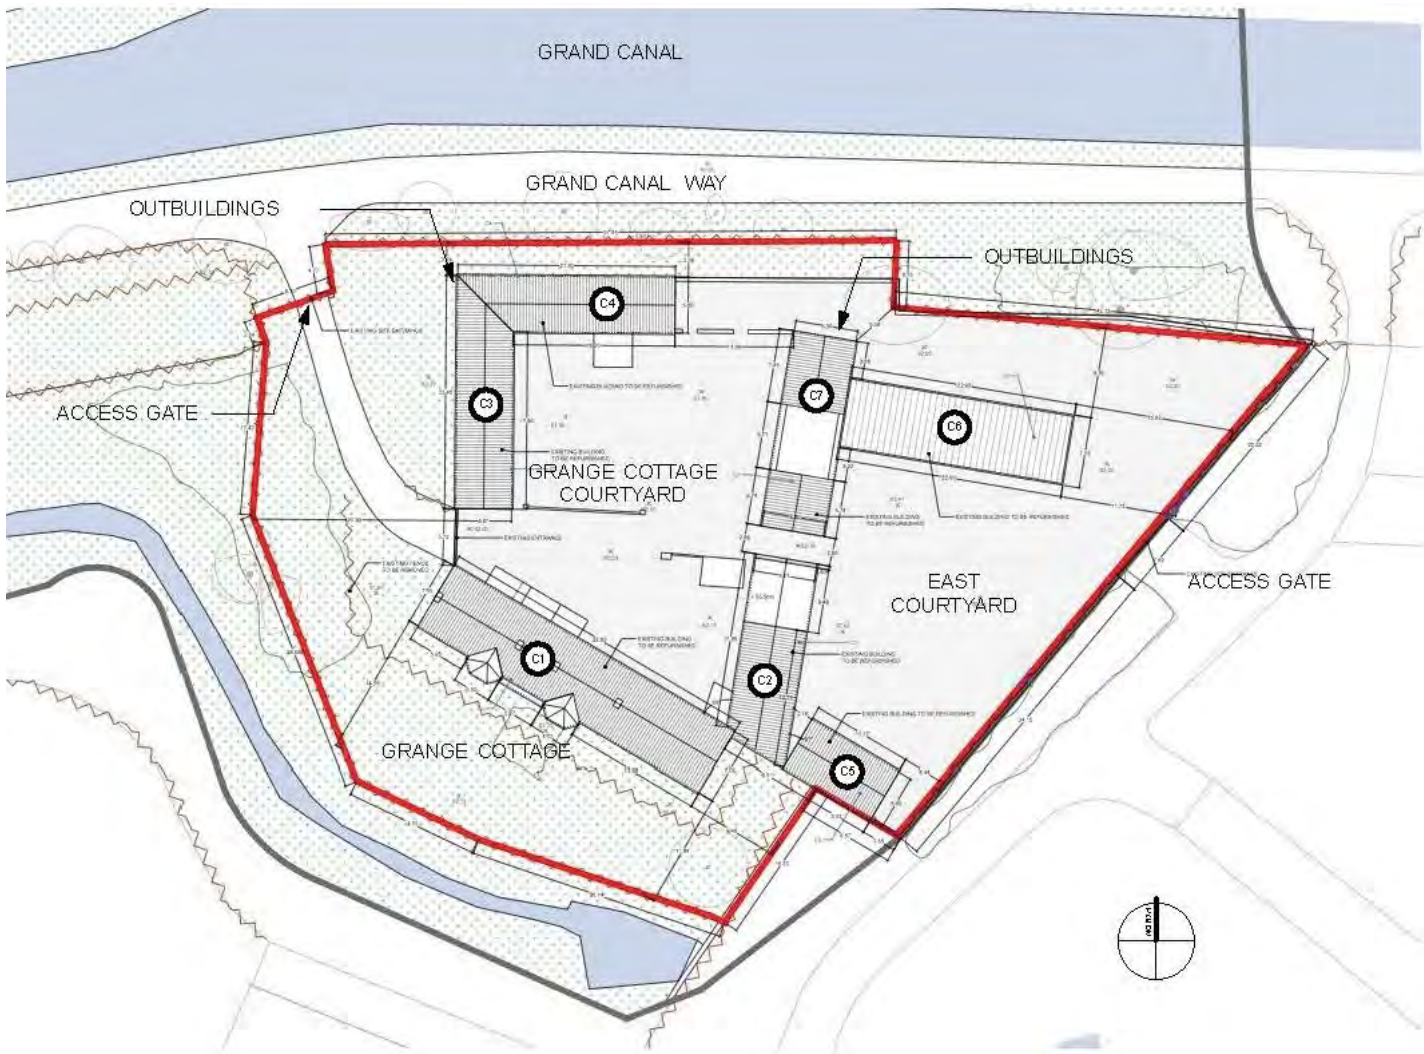
**Fig 8:** Site plan of Grange Cottage of and associated outbuildings

**Site Key: Existing Site Layout** (Site boundary in red)

- C1** Grange Cottage
- C2** Grange Cottage Courtyard Outbuilding - East Range (south)
- C3** Grange Cottage Courtyard Outbuilding - West Range
- C4** Grange Cottage Courtyard Outbuilding - North Range
- C5** East Courtyard - South Agricultural Building
- C6** East Courtyard - North Agricultural Building
- C7** Grange Cottage Courtyard Outbuilding - East Range (north)

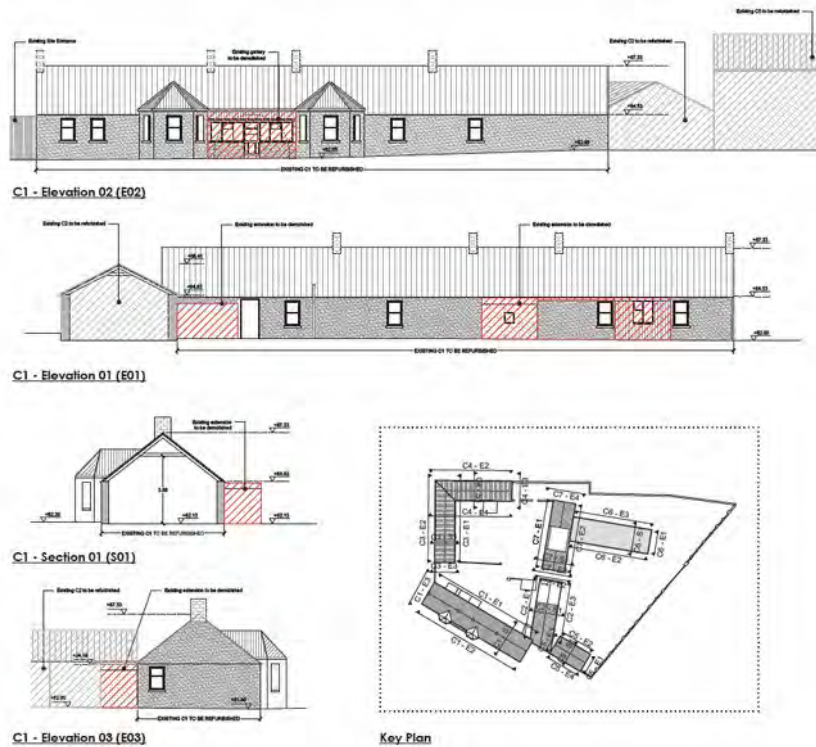
**Fig 10:** Existing Grange Cottage - existing elevations. Source: Stephen Foley Architects

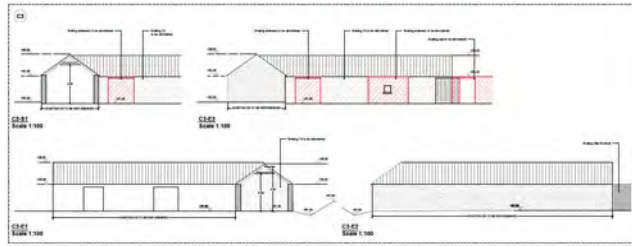
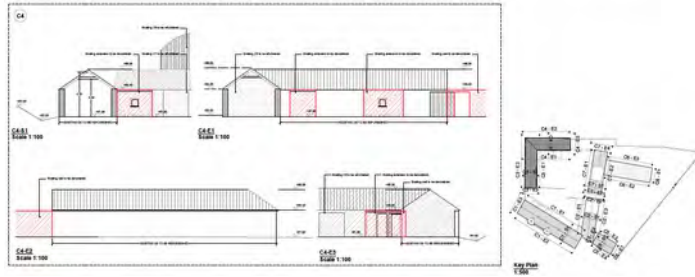
**Fig 11:** Existing Outbuildings - C3 & C4. Source: Stephen Foley Architects

The enclosing walls are rubble stone with a lime wash finish to both the internal and external faces. Two large full height openings are located on the east elevation of the block accessed from the courtyard. Small slot ventilation opes are located on the west wall. The original doors on the existing large openings have been removed. A cast iron hay rack is mounted on the west wall which would have been used for feeding horses. The opes on the east elevation are formed with timber lintels. Internally the floor is compacted earth with cobble stone in places. A small door at the northern end of the block which gives access the northern range. Refer to plate 11 for details.

The north range is one of the first buildings to have been built on the site in the late eighteenth century. The roof over the western half of the north range remains largely intact and dates from the late nineteenth century. A large section of the eastern end of the roof structure is missing and appears to have been missing for an extended period. Piped services are fixed to the internal face of the south wall and traverses to the north wall in the middle of the block. A single storey flat roof extension rendered concrete blockwork extension is built on the south elevation. The structure and assembly of the walls and roof is similar to that of the other courtyard buildings. The door openings are formed in red brick. The eastern side of the building is roofless and the original north and south rubble stone walls remain. Refer to plate 12 for details.

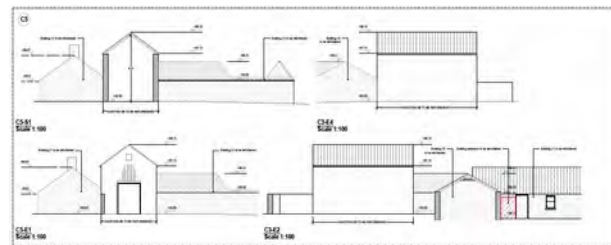
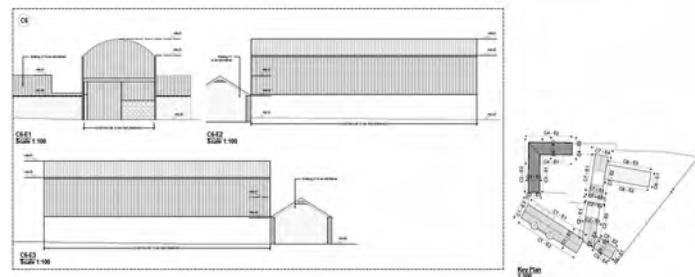
**Fig 12:** Existing Outbuildings - C5 & C6. Source: Stephen Foley Architects

The existing building is a double height structure with a pitched roof and was constructed between 1836 & 1913. There is a large door opening on the east elevation and tall, brick formed, vertical slot windows on the north and south elevations. A round headed window opening is located above the metal beam which forms the head of the main door opening. This window is covered with corrugated metal sheeting. A square window opening is located at high level above the round headed window. The original roof finishes have been removed and corrugated asbestos roof sheeting now covers the existing roof. The roof structure comprises thick cut timber rafters which abut a central ridge board and are fixed to a timber wall plate. The existing timber rafters are notched to receive the purlins which are fixed to the top. This roof assembly is not original. The walls are constructed in brick with a lime wash to the internal and external faces. The original door of the building has been removed. The ground floor construction comprises compacted earth. Refer to plate 13 for details.

The existing building is a double height structure and was constructed between 2006 & 2013 and is not a protected structure. The building is a modern agricultural steel portal framed structure enclosed with concrete walls at low level and corrugated steel sheeting on the upper level. A large sliding opening is located on the east elevation. The existing floor is concrete. Refer to plate 14 for details.

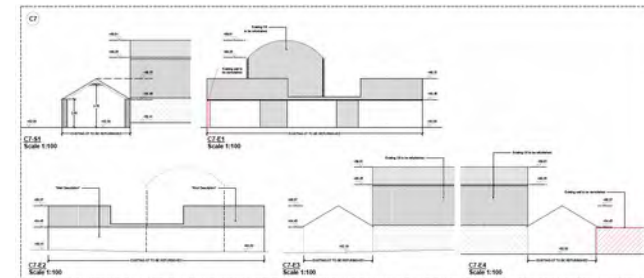
**Fig 13:** Existing Outbuildings - C7. Source: Stephen Foley Architects

The roof of the north end of the north range remains intact but the middle section of the existing roof has collapsed and is currently open and heavily overgrown. A large double opening formed with a timber lintel and opens into the Cottage Courtyard. The walls are rubble stone. The original doors have been removed. Refer to plate 15 for details.

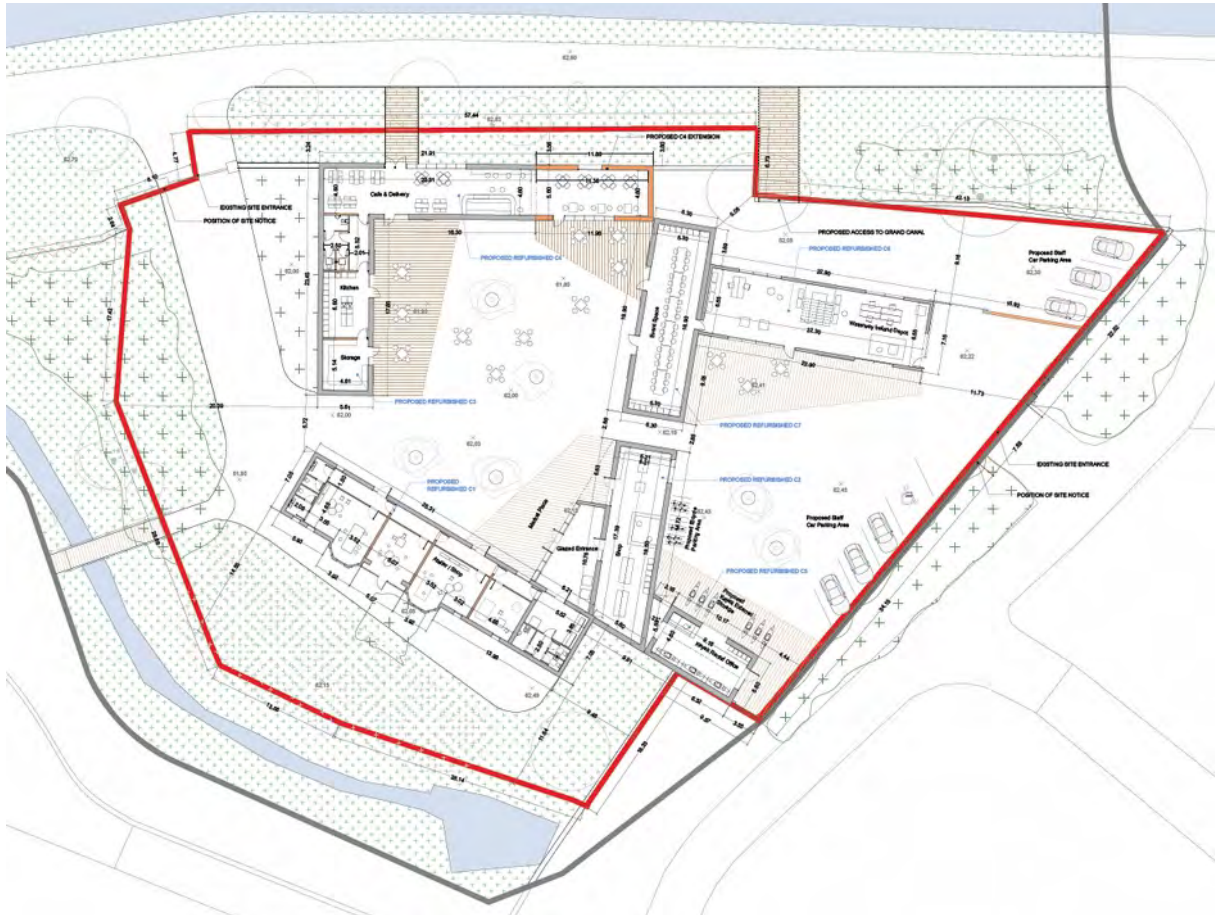
**Fig 15:** Proposed site plan. Source: Stephen Foley Architects

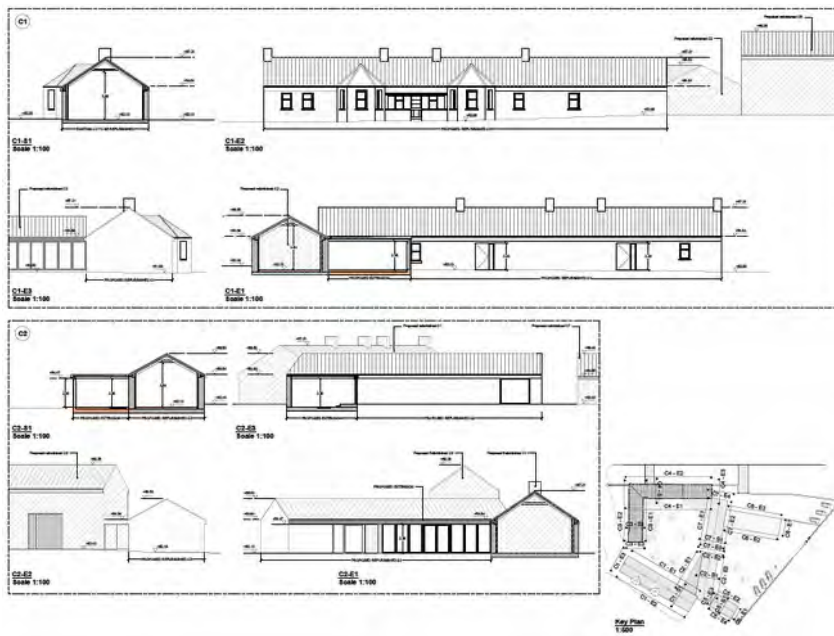
**Fig 16:** Proposed elevations C1 and C2. Source: Stephen Foley Architects

5.1.1 Layout Alterations: Existing non-original lean-to extensions at on the front and rear elevation are proposed for removal. Non original aluminium framed windows are to be removed and replaced with hardwood timber framed windows. The existing timber door and glass panel screen in living room 2 is to be removed and a large new timber framed semi-circular window is proposed in its place. New toilets are proposed in the east end of the house.

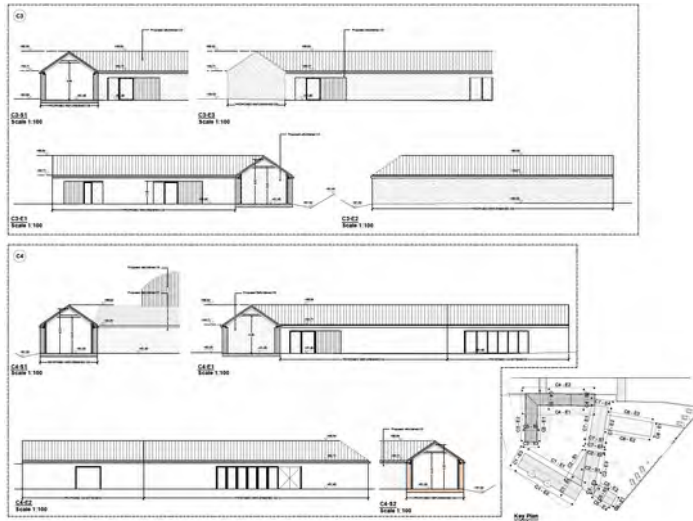
**Fig 17:** Proposed elevations C3 and C4. Source: Stephen Foley Architects

Raising the roof level will visually alter the appearance of the outbuildings and will have a moderate impact on the outbuildings. The new windows and doors are material changes to the elevations that would also be considered moderate impacts. Changes to the internal arrangement of the outbuildings would materially alter original fabric through the introduction of new floor constructions and servicing installations. These changes would also be deemed moderate changes in the context of the new development.

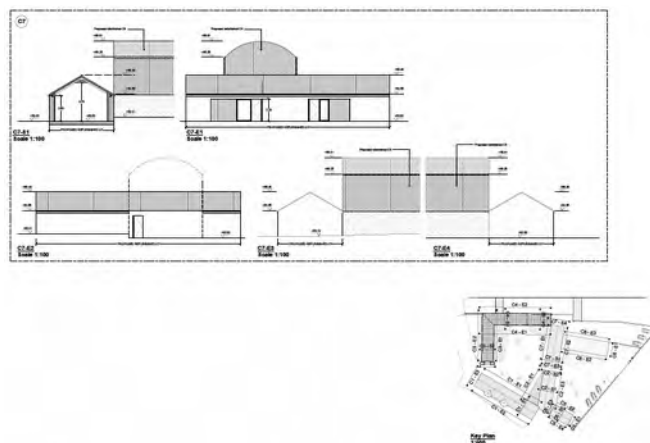
**Fig 19:** Proposed elevations C7. Source: Stephen Foley Architects

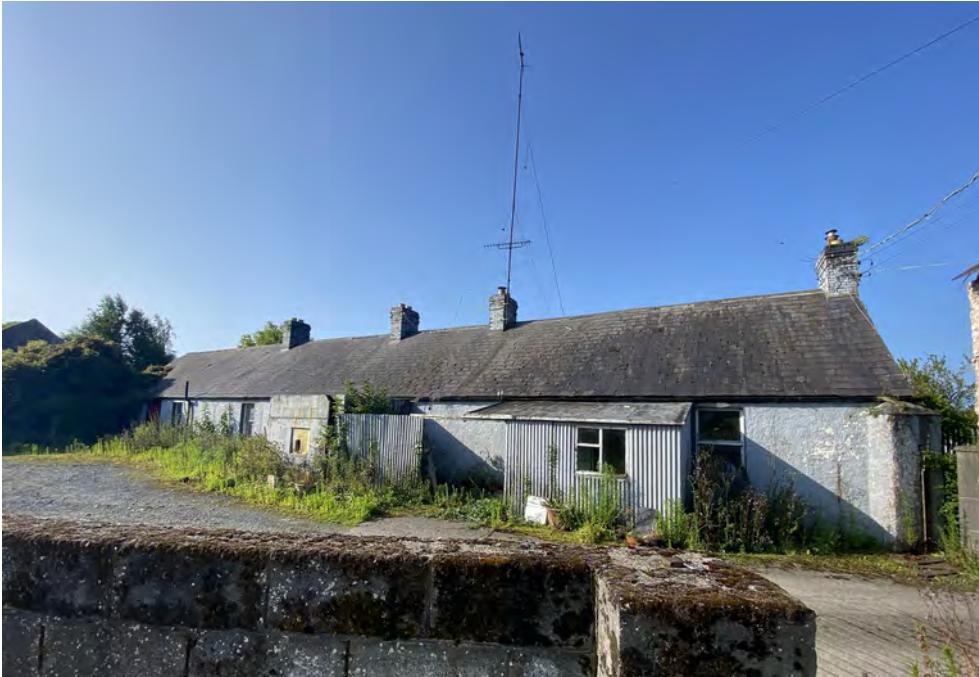
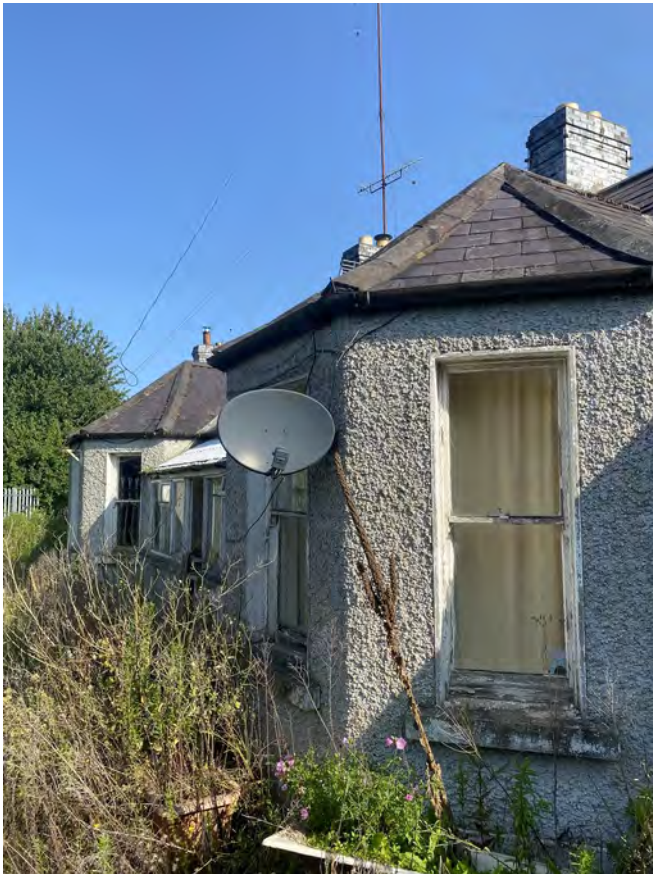
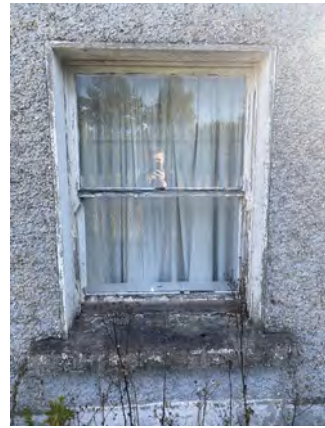
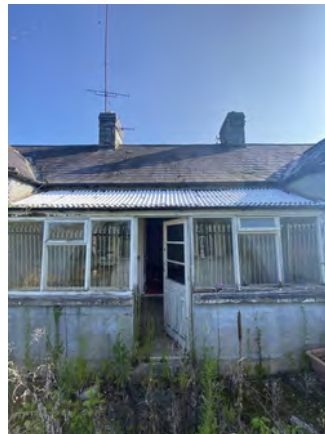
**Plate 1:** Clockwise from Top: North elevation of Grange Cottage, typical window arrangement, glazed extension to south elevation and south elevation

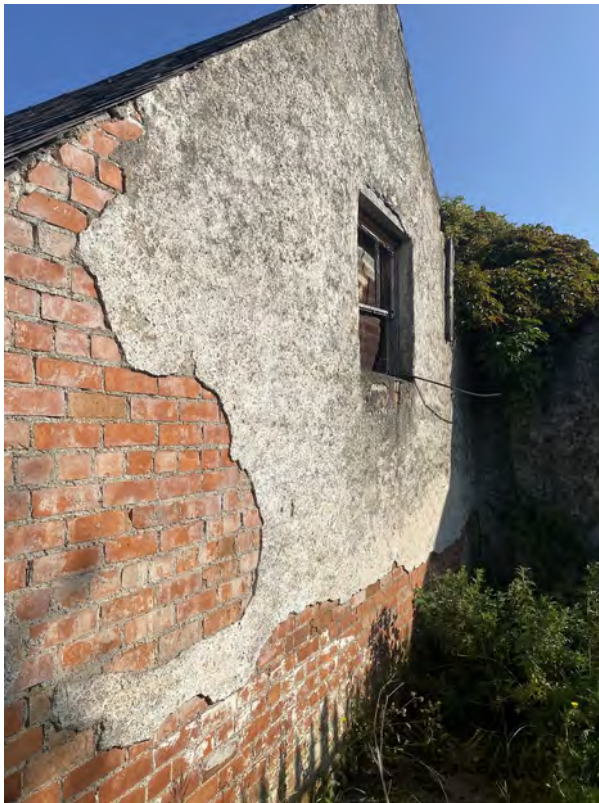
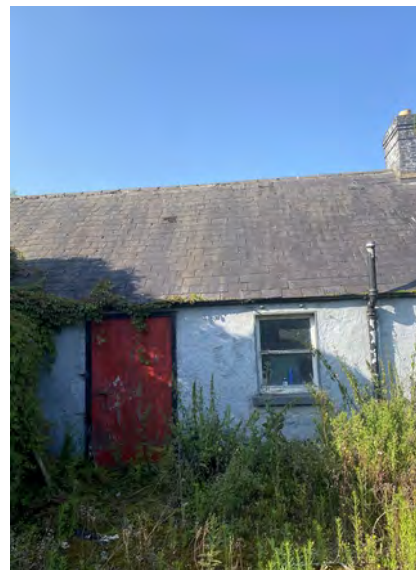
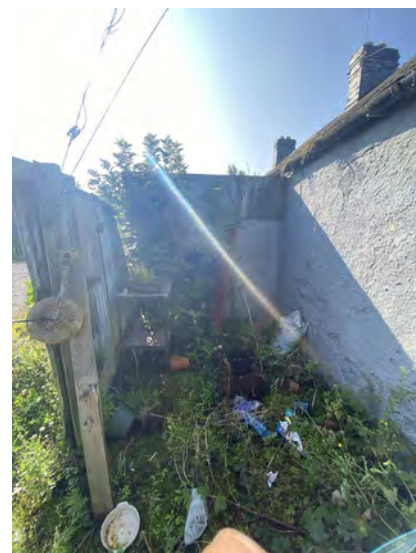
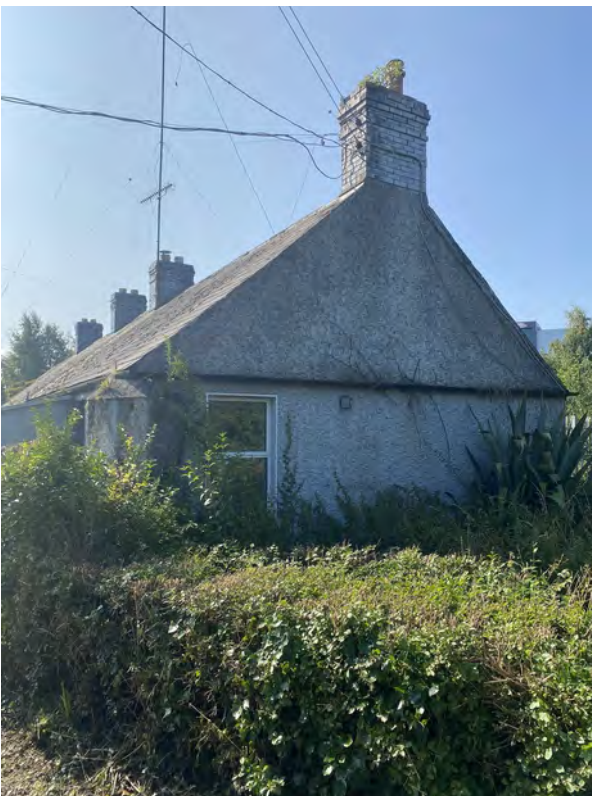
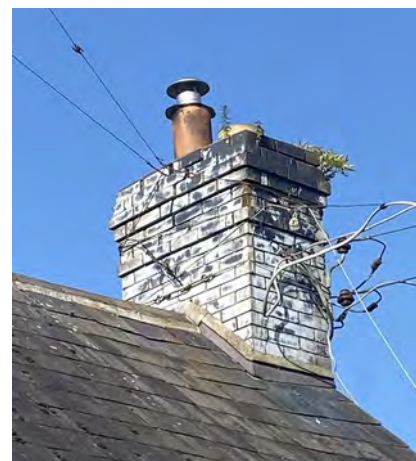
**Plate 2:** Clockwise from top left: East elevation, entrance to store at east end of Grange Cottage, view into main entrance open lobby area, typical brick chimney detail, west elevation

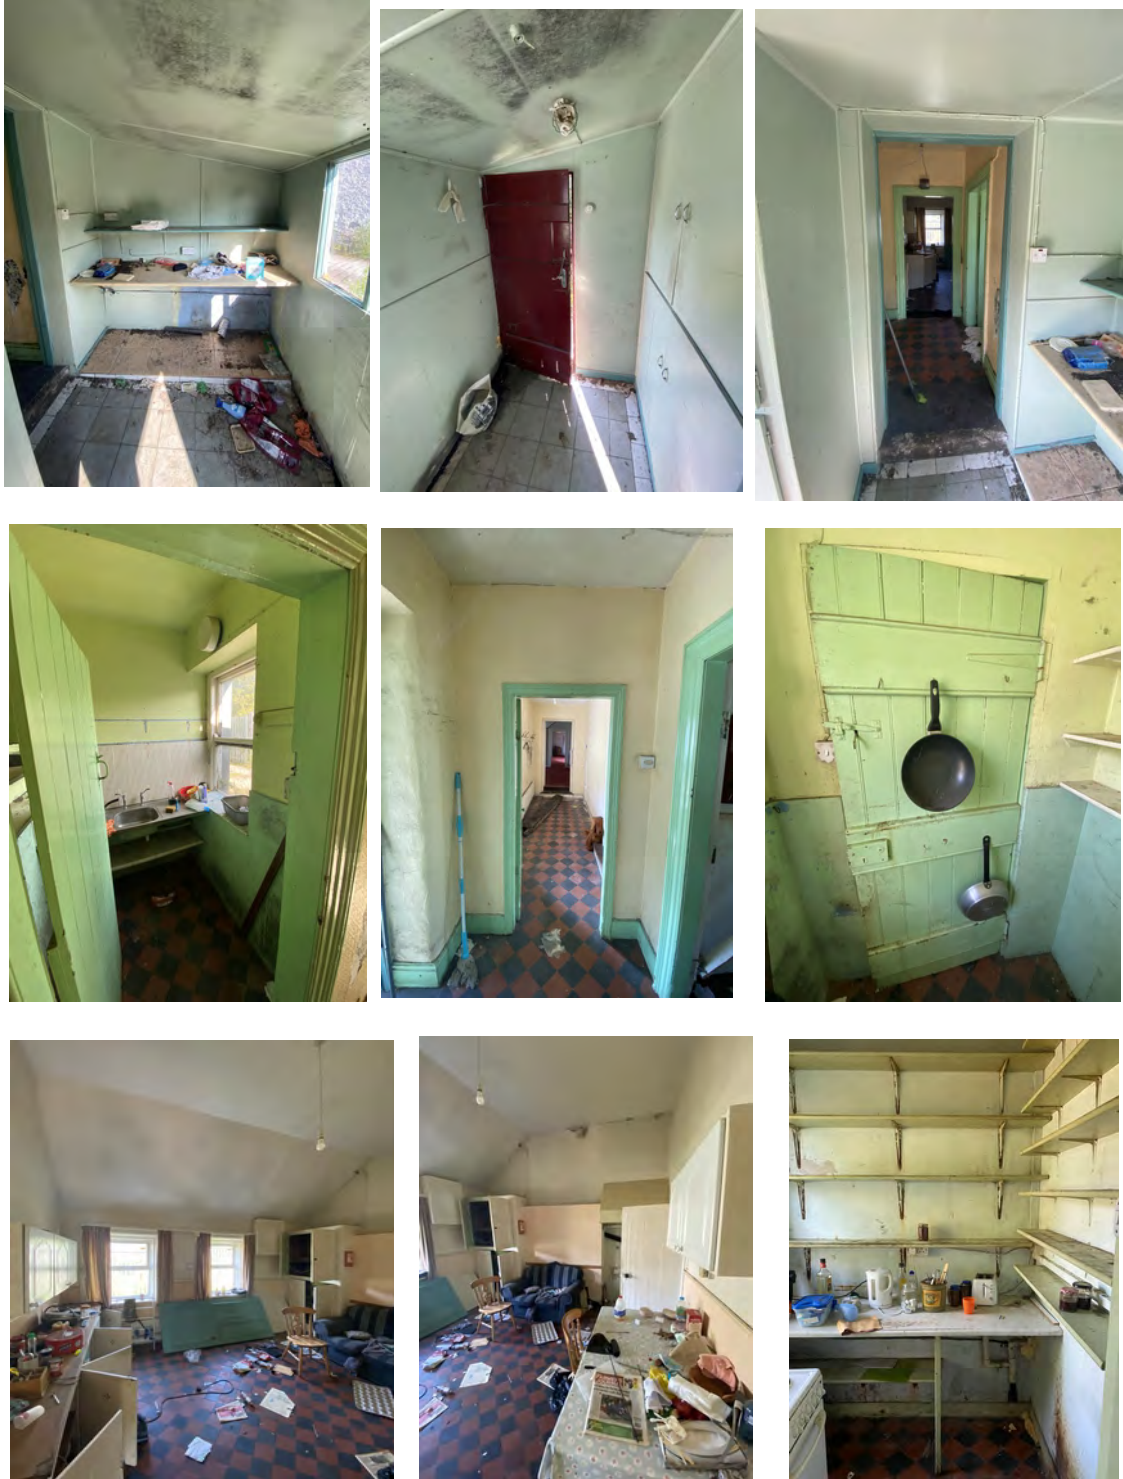
**Plate 3:** Top: Internal views of entrance lobby. Centre: Internal views of wash room and entrance corridor. Bottom: View of main dining area and kitchen.

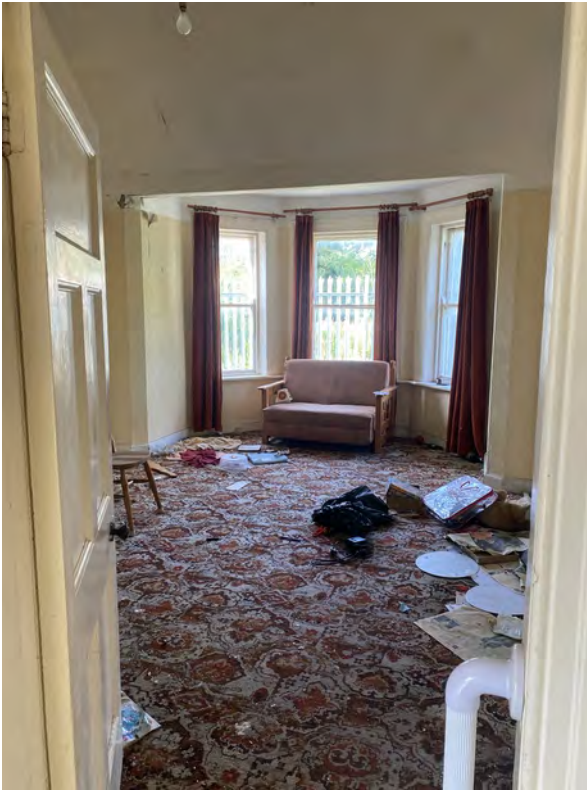
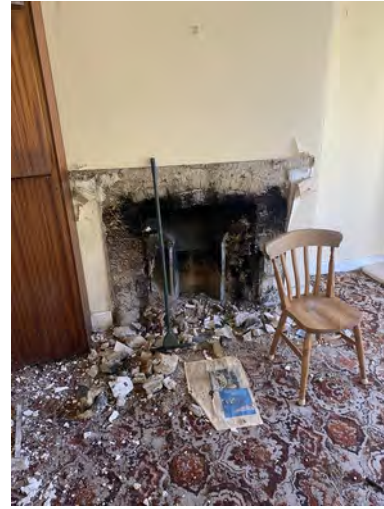
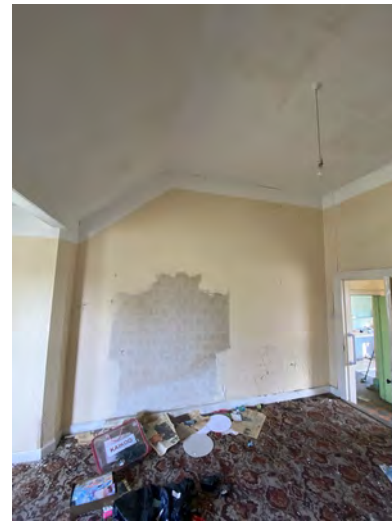
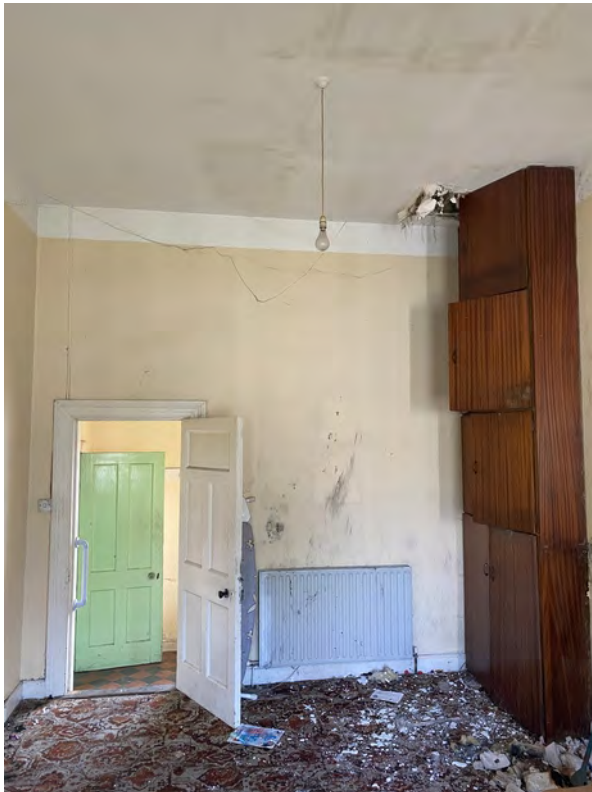
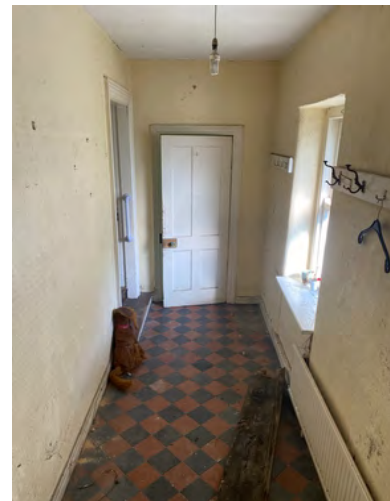
**Plate 4:** Clockwise from top left: Internal views of living room 01 – bay window, fireplace, dividing wall with kitchen, view of corridor 1 and view of corridor wall of living room.

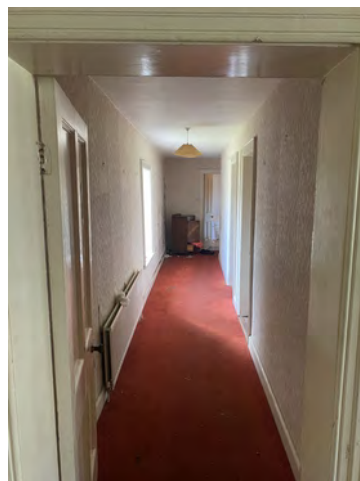
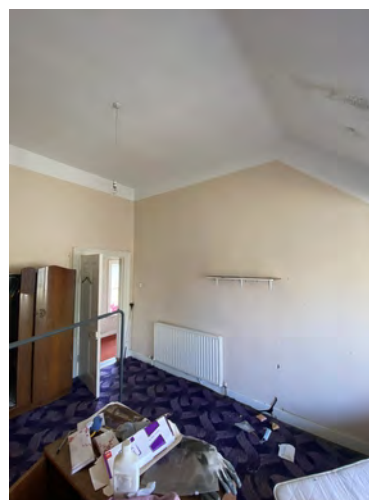
**Plate 5:** Clockwise from top left: Internal views of the second living room 02 - East dividing wall, fireplace, masonry arch into glazed porch, door to corridor 02, timber and glass panelled screen into porch

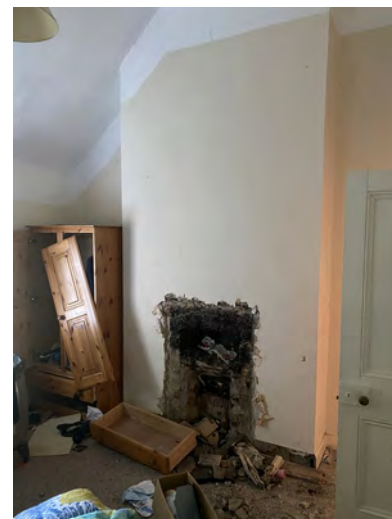
**Plate 6:** Clockwise from top left: Internal views of Bedroom 01 and Corridor 02 - Bay window, Corridor 02 looking east, door from living room 02 into corridor 02, east dividing wall and west dividing wall showing location of fireplace

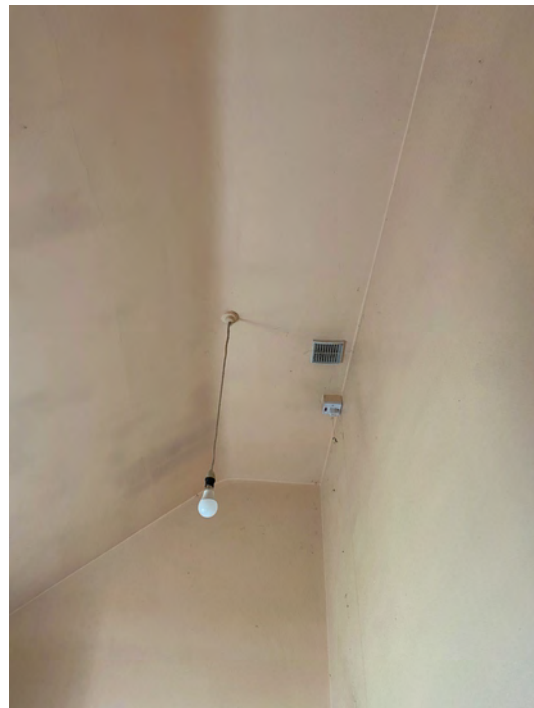
**Plate 7:** Clockwise from top left: Internal views of Bedrooms 02 & 03 - Existing sash window in Bedroom 02, existing fireplace in bedroom 02. Existing window in Bedroom 03, existing fireplace in Bedroom 03 and internal view of existing timber panelled door and dividing wall.

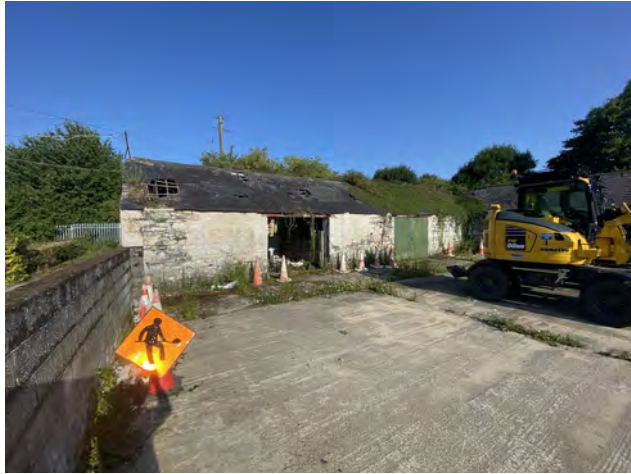
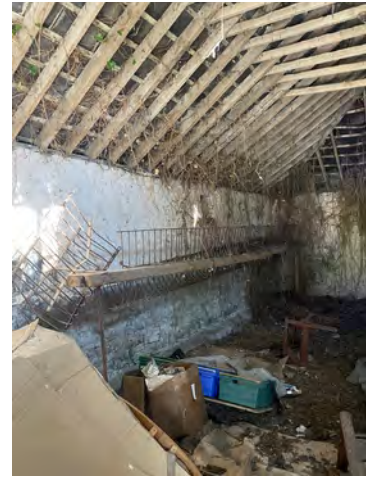
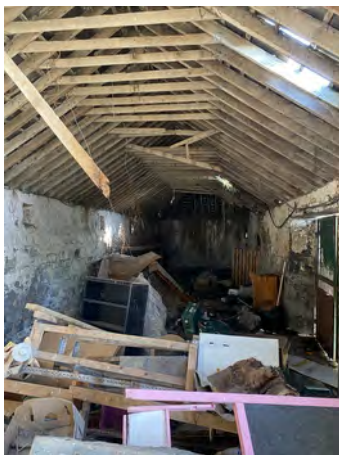
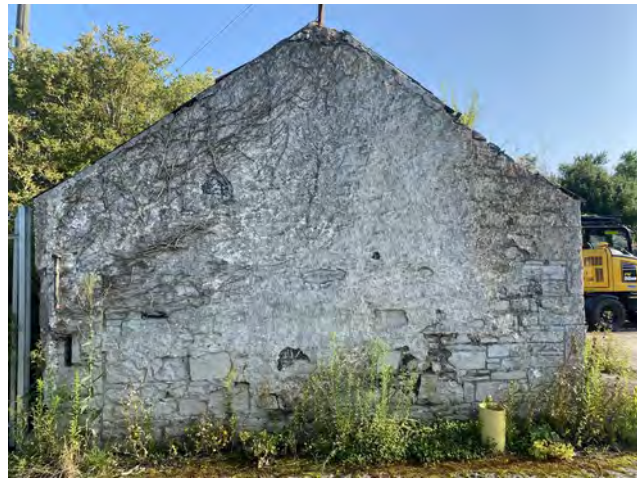
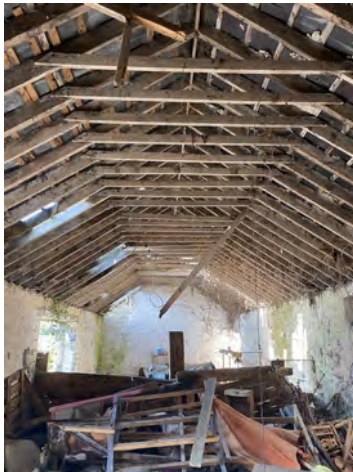
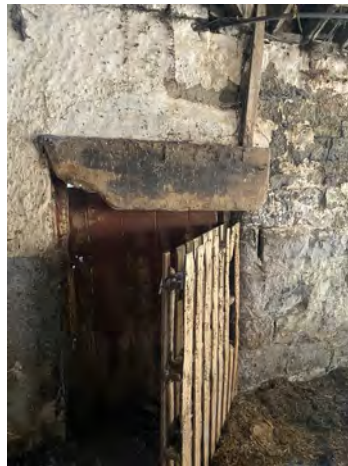
**Plate 10:** Clockwise from Top left: General views of Outbuilding C2 - North gable wall, north wall of blockwork extension, south elevation of blockwork extension, west elevation of C2, internal view showing collapsed roof, and east elevation of C2

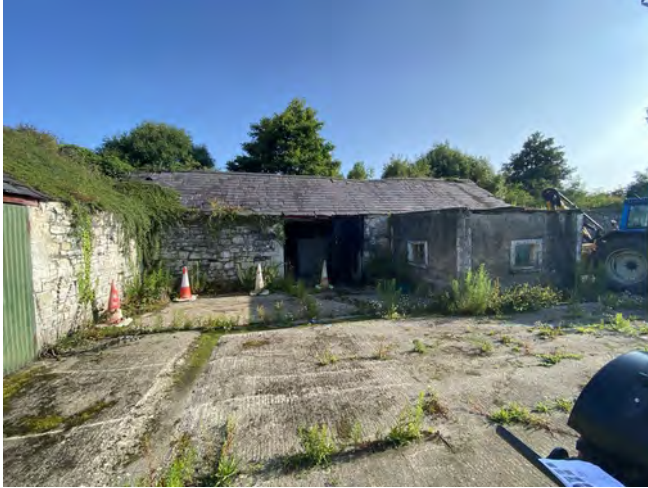
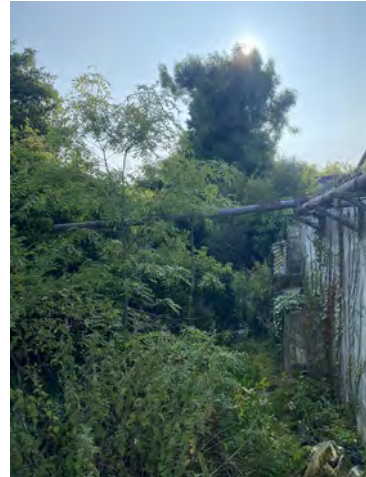
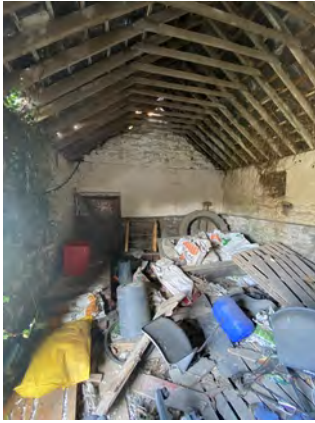
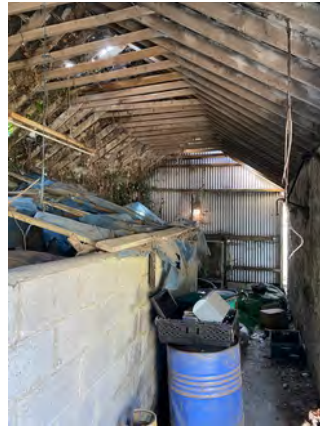
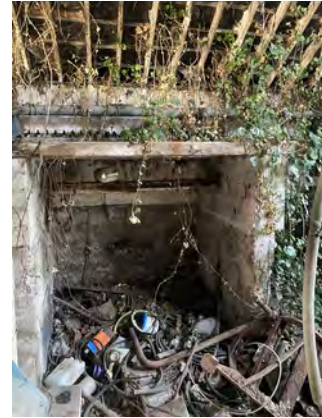
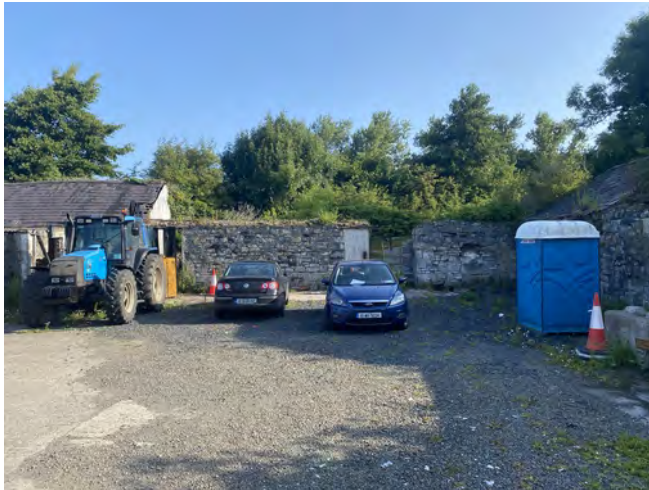
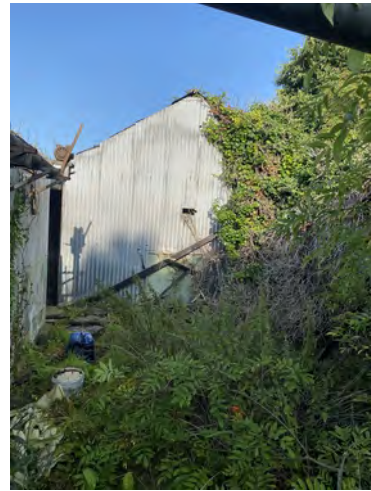
**Plate 11:** Clockwise from Top left: General views of Outbuilding C3 - East elevation showing existing entrances, existing feeding stands on west wall, south gable wall, existing cobble stones on floor, existing doorway through to C4, internal view looking south, and internal view looking north

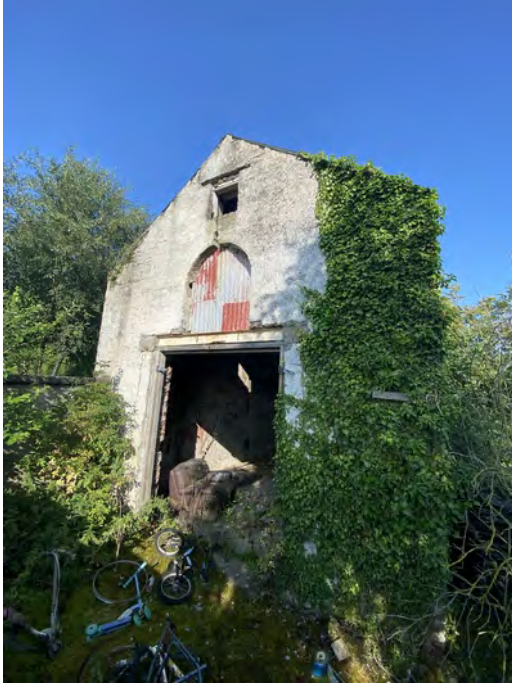
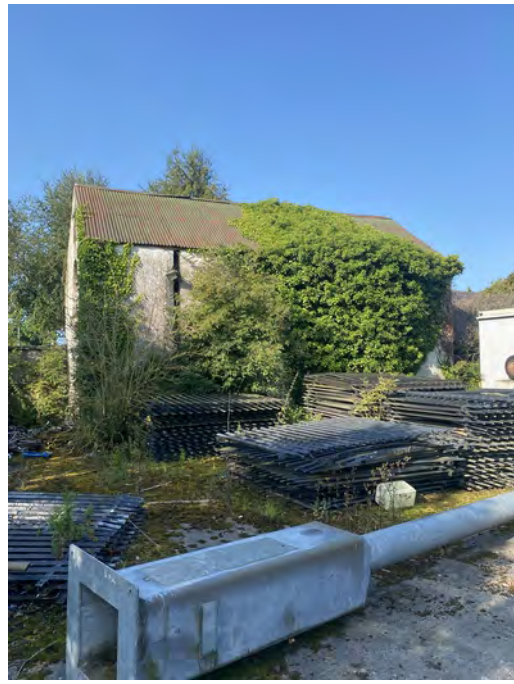
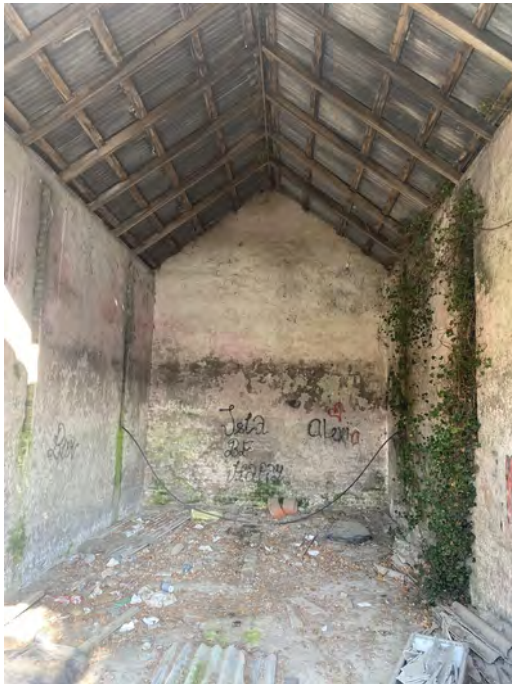
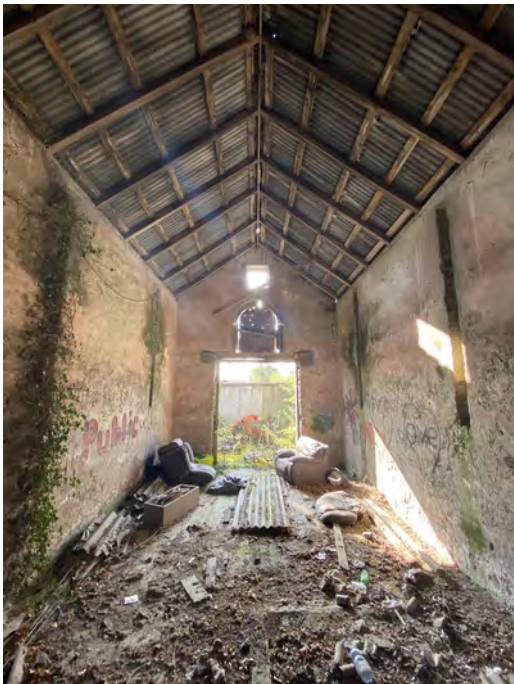
**Plate 12:** Top from left: General views of Outbuilding C4 -South elevation showing existing blockwork extension, internal view of roofless section of C4 looking east. Centre from left: Internal view of enclosed section of C4 showing roof structure and general internal arrangement. Bottom from left: South elevation (east end) and internal view of roofless section looking west

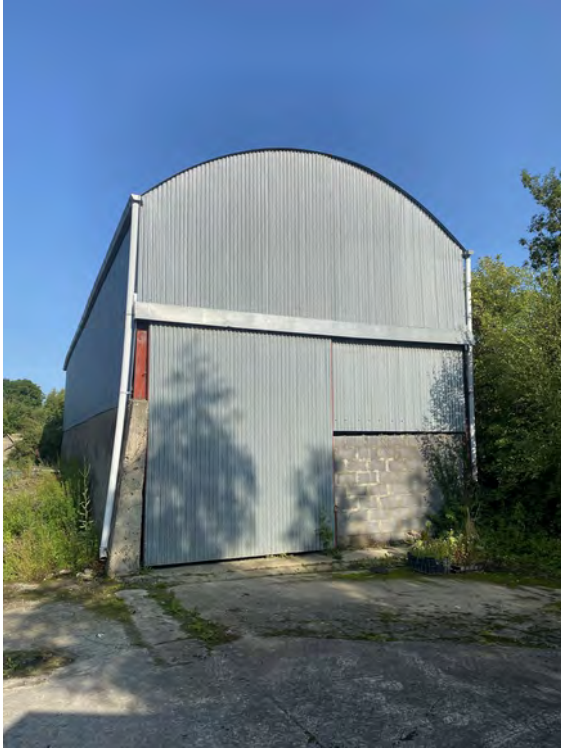
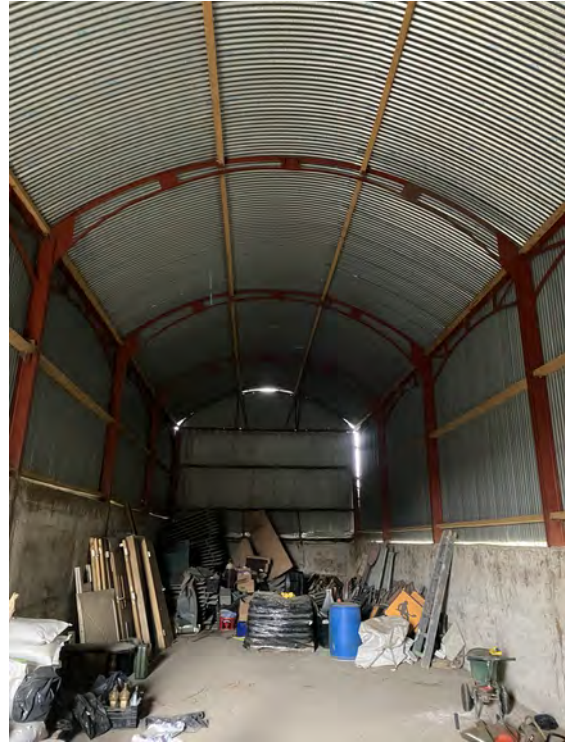
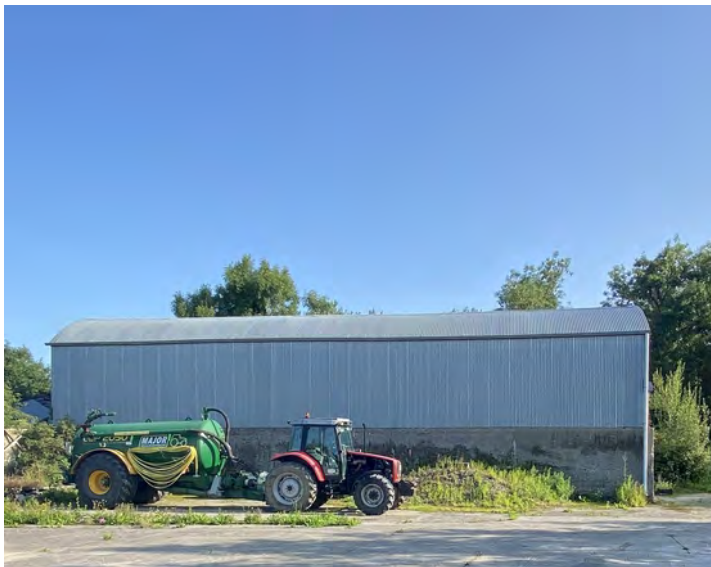
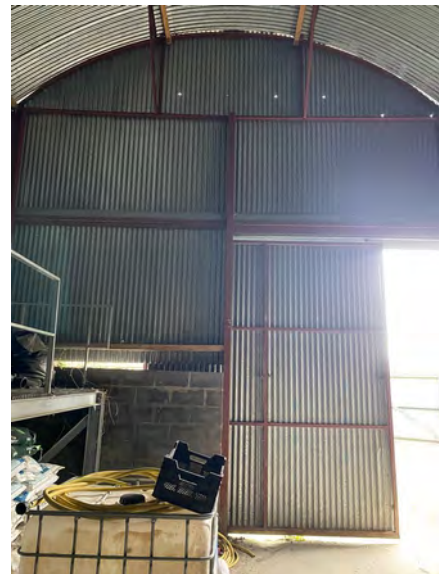
**Plate 13:** Clockwise from Top left: General views of Outbuilding C5 - East gable wall, north elevation, internal view looking west, and internal view looking east showing the entrance opening and the high level window openings on the east gable wall.

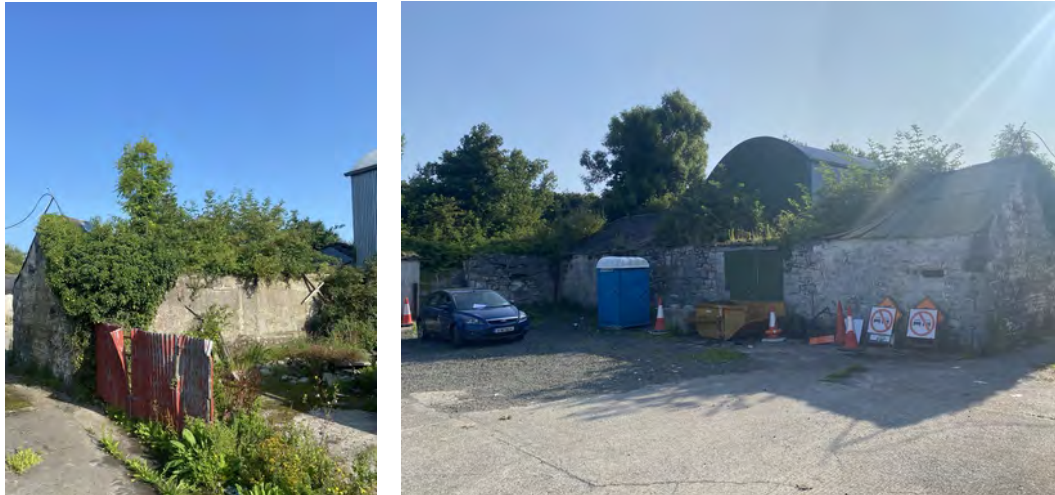
**Plate 14:** Clockwise from Top left: General views of Outbuilding C6 - East end wall, internal view looking west, internal view looking east, and south elevation.

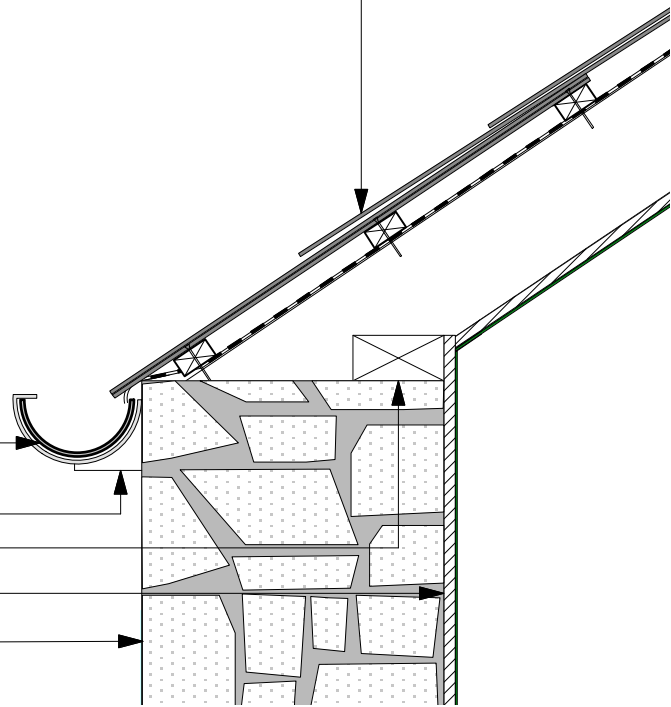
**Existing Roof:**

Existing natural slate (size tbc)  
on timber battens  
on bitumen sarking felt  
on timber rafters

Existing rubble stone wall:

The face of the wall is to be cleared of debris and organic growth where present. Face of wall to be cleaned down using air abrasive cleaning. Loose or powdery mortar in existing wall is to be raked out.

**New roofing works:**

Existing natural slates, where deemed fit for reuse, are to be re-laid on new roof build-up and fixed in place with copper nails  
on timber battens  
on timber counter battens  
on breather membrane  
on Rockwool insulation  
on vapour barrier

New cast iron bracket to hold gutter in place. Bracket is to be adjustable with stainless steel threaded bolt
