**Grange Cottage (Beattie's Cottage), Grand Canal Way, Newcastle Road, Lucan, Co. Dublin K78 RW26**

**Architectural Heritage Impact Assessment**

October 2023

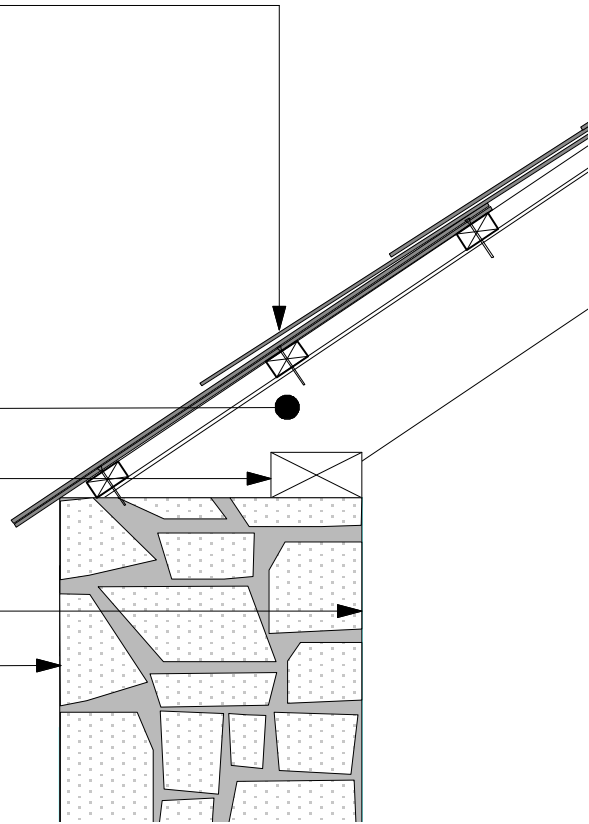
**Existing Roof:**

Existing natural slate (size tbc)  
on timber battens  
on timber rafters

Existing rubble stone wall:

The face of the wall is to be cleared of debris and organic growth where present. Face of wall to be cleaned down and loose or powdery mortar in existing wall is to be raked out.

**New roofing works:**

Existing natural slates re-laid (new blue bangors where replacements are required) fixed in place with copper nails on timber battens  
on timber counter battens  
on breathable sarking membrane  
on Rockwool insulation  
on vapour barrier  
on plywood sheeting on existing timber rafters.

Wet dash lime finish to external walls:

External finish to external wall face applied in 2 coats (8mm and 6 mm).  
External surface to be left in 'as cast' finish.

**New works to internal face of external walls:**

Exposed new timber rafters to structural engineer's specification and detail

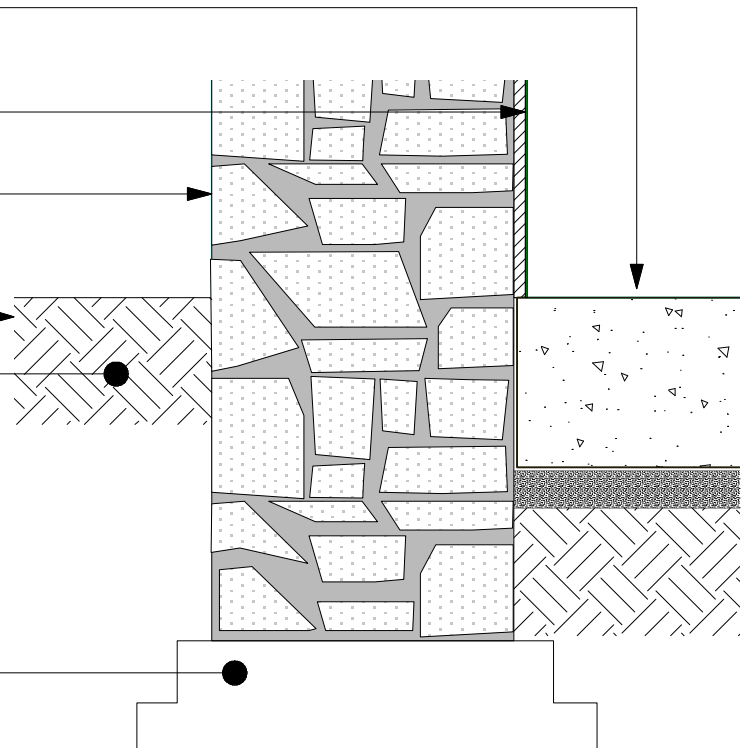
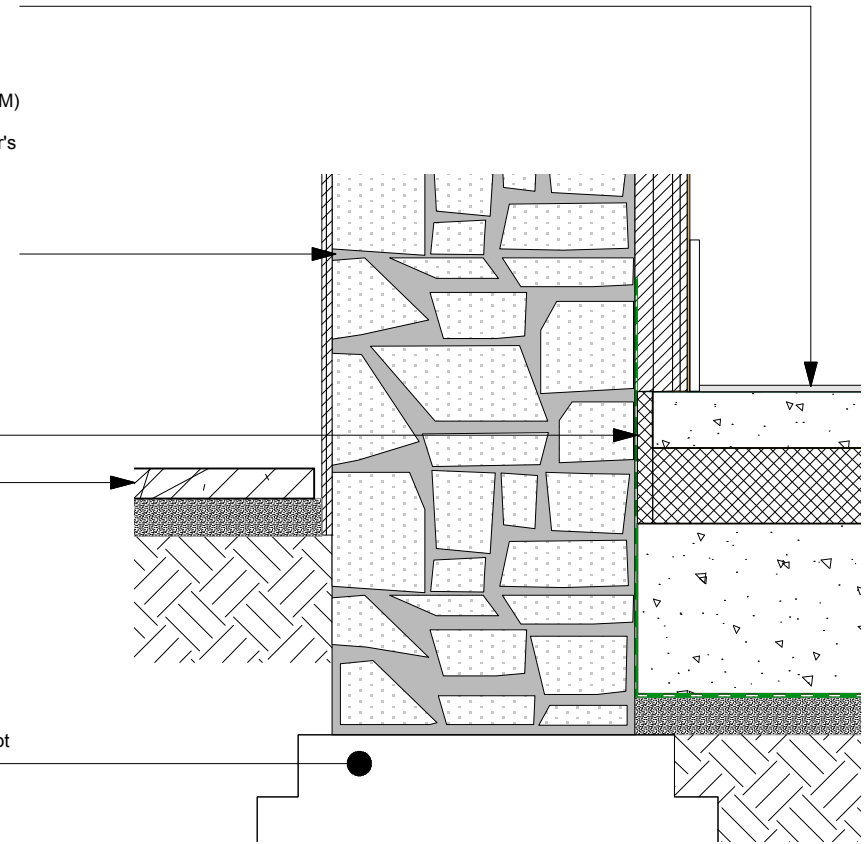
Floor - Existing - Grange Cottage  
 Scale: 1:10

Compacted earth

Level and arrangement of existing footings not known at this time

**New floor construction :**

proposed floor finish  
 on concrete floor screed  
 on rigid insulation  
 on concrete floor slab to structural engineer's specification and details  
 on Radon barrier/damp proof membrane (DPM)  
 on sand blinding  
 on compacted hardcore to structural engineer's specification and details
