WHITECHURCH STREAM FLOOD ALLEVIATION SCHEME

Arboricultural Assessment Report

MDW0825
Whitechurch Stream FAS -
Arboricultural
Assessment Report

An Arboricultural Assessment Of the Tree Vegetation located along the banks of the Whitechurch Stream Through St. Enda's Park and Along Whitechurch Road to the Junction with Ballyboden / Willbrook Road, Rathfarnham, Dublin 16.

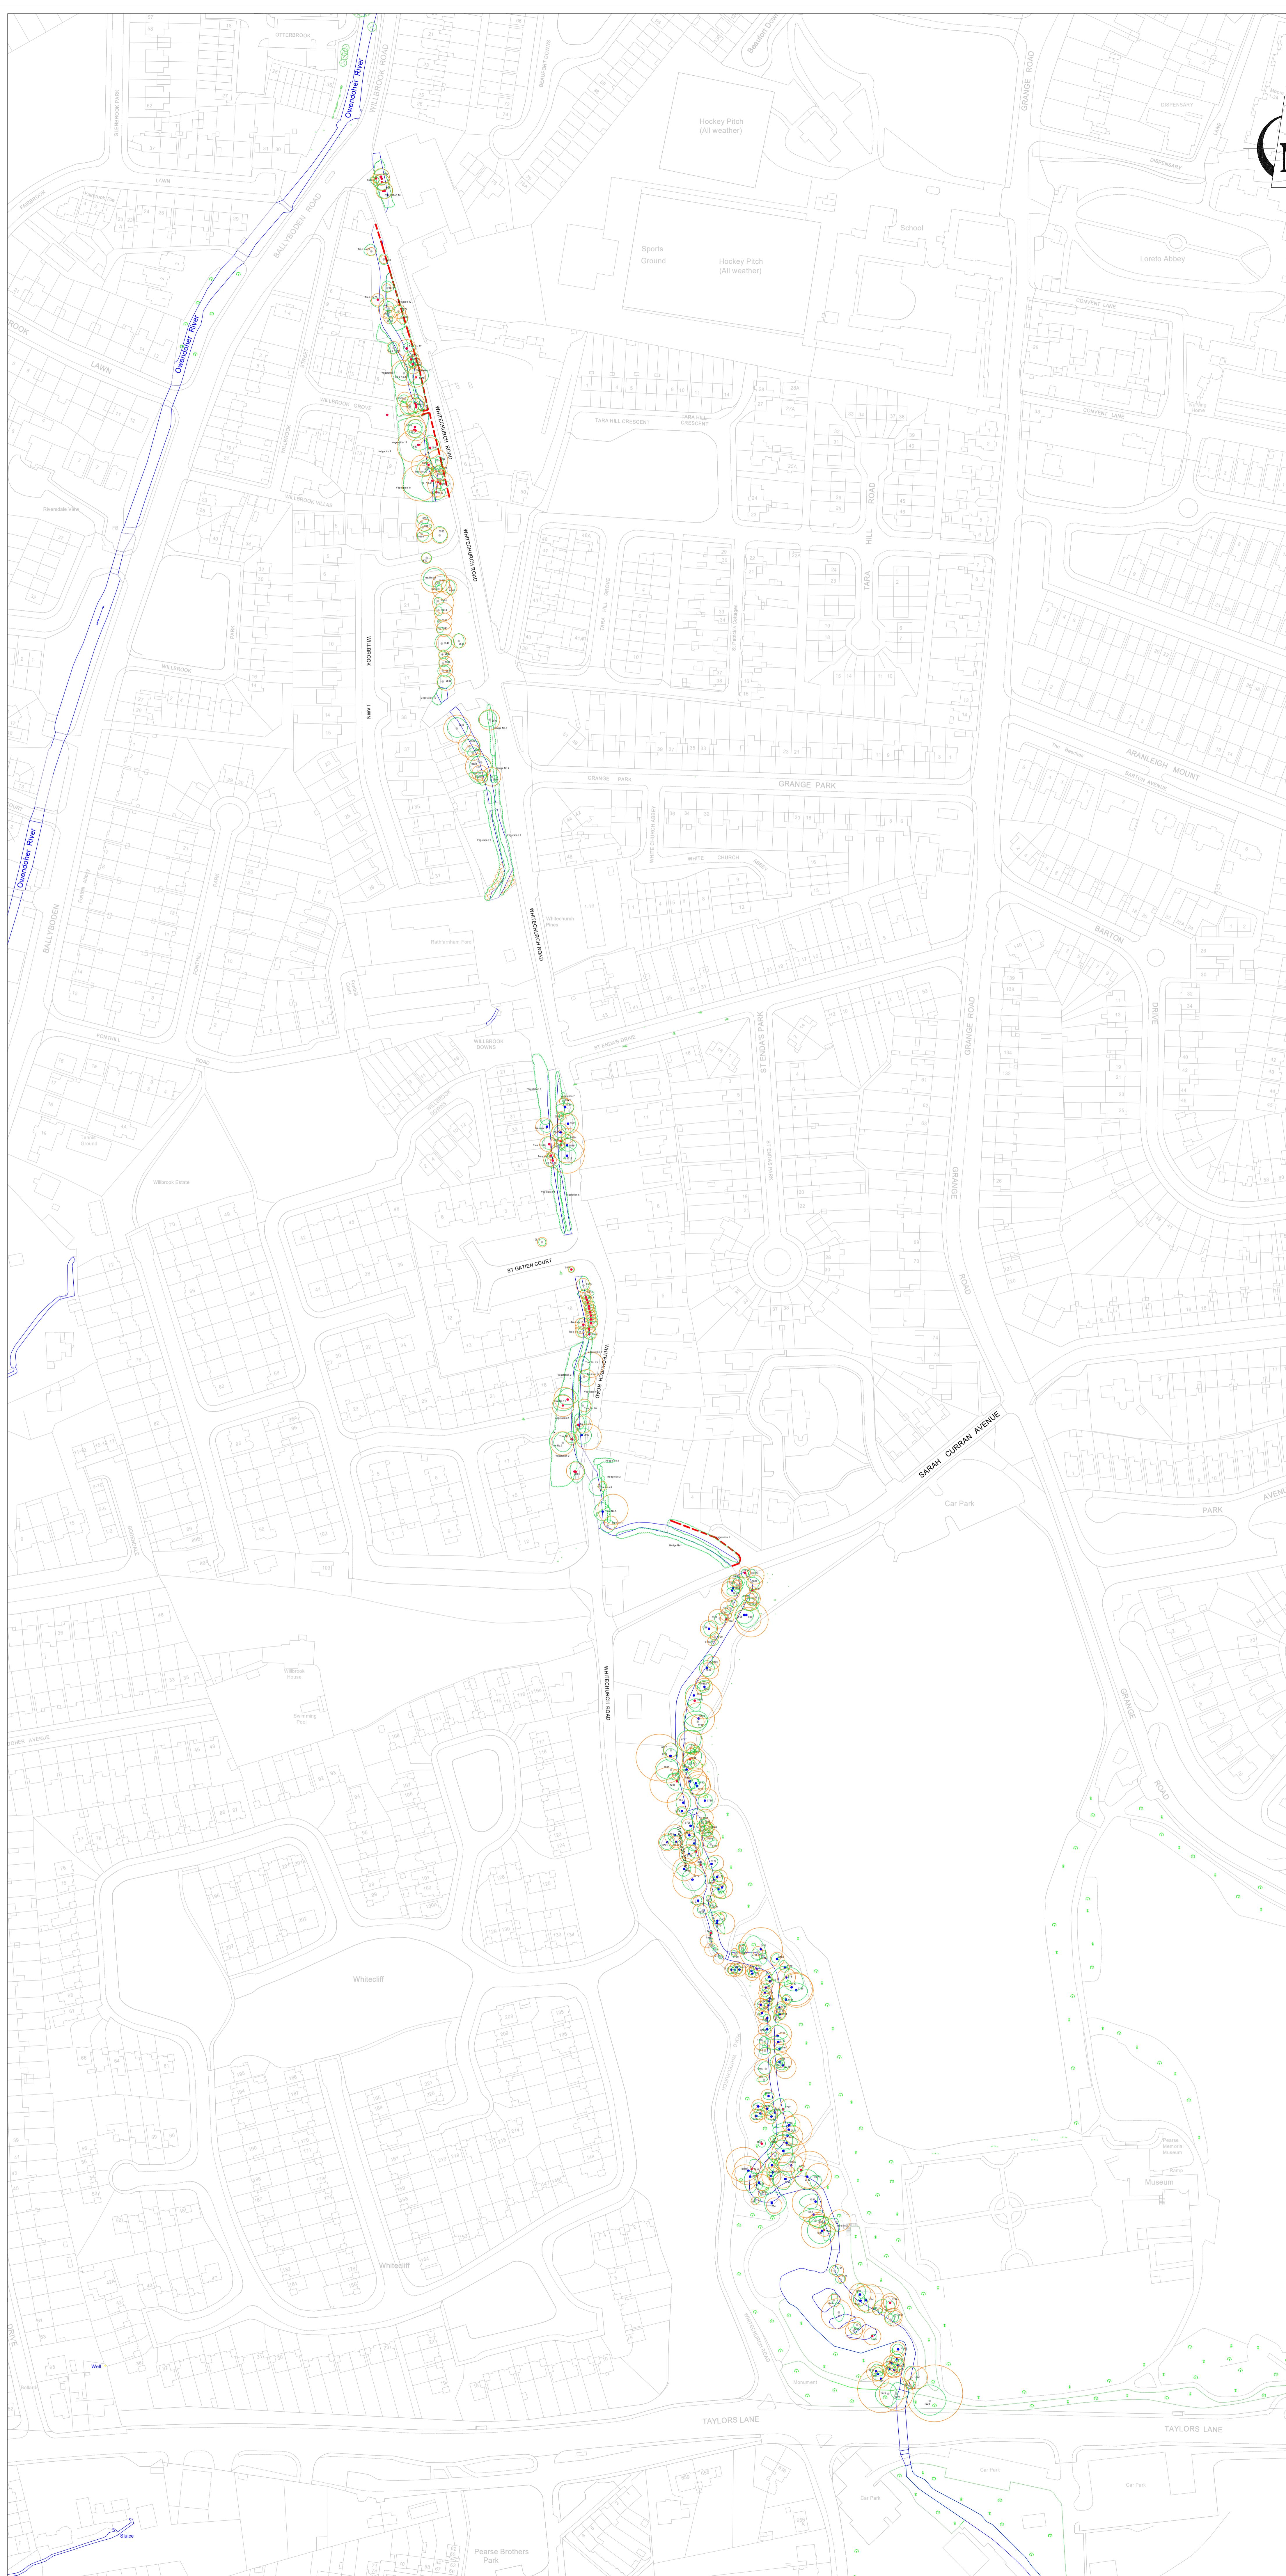
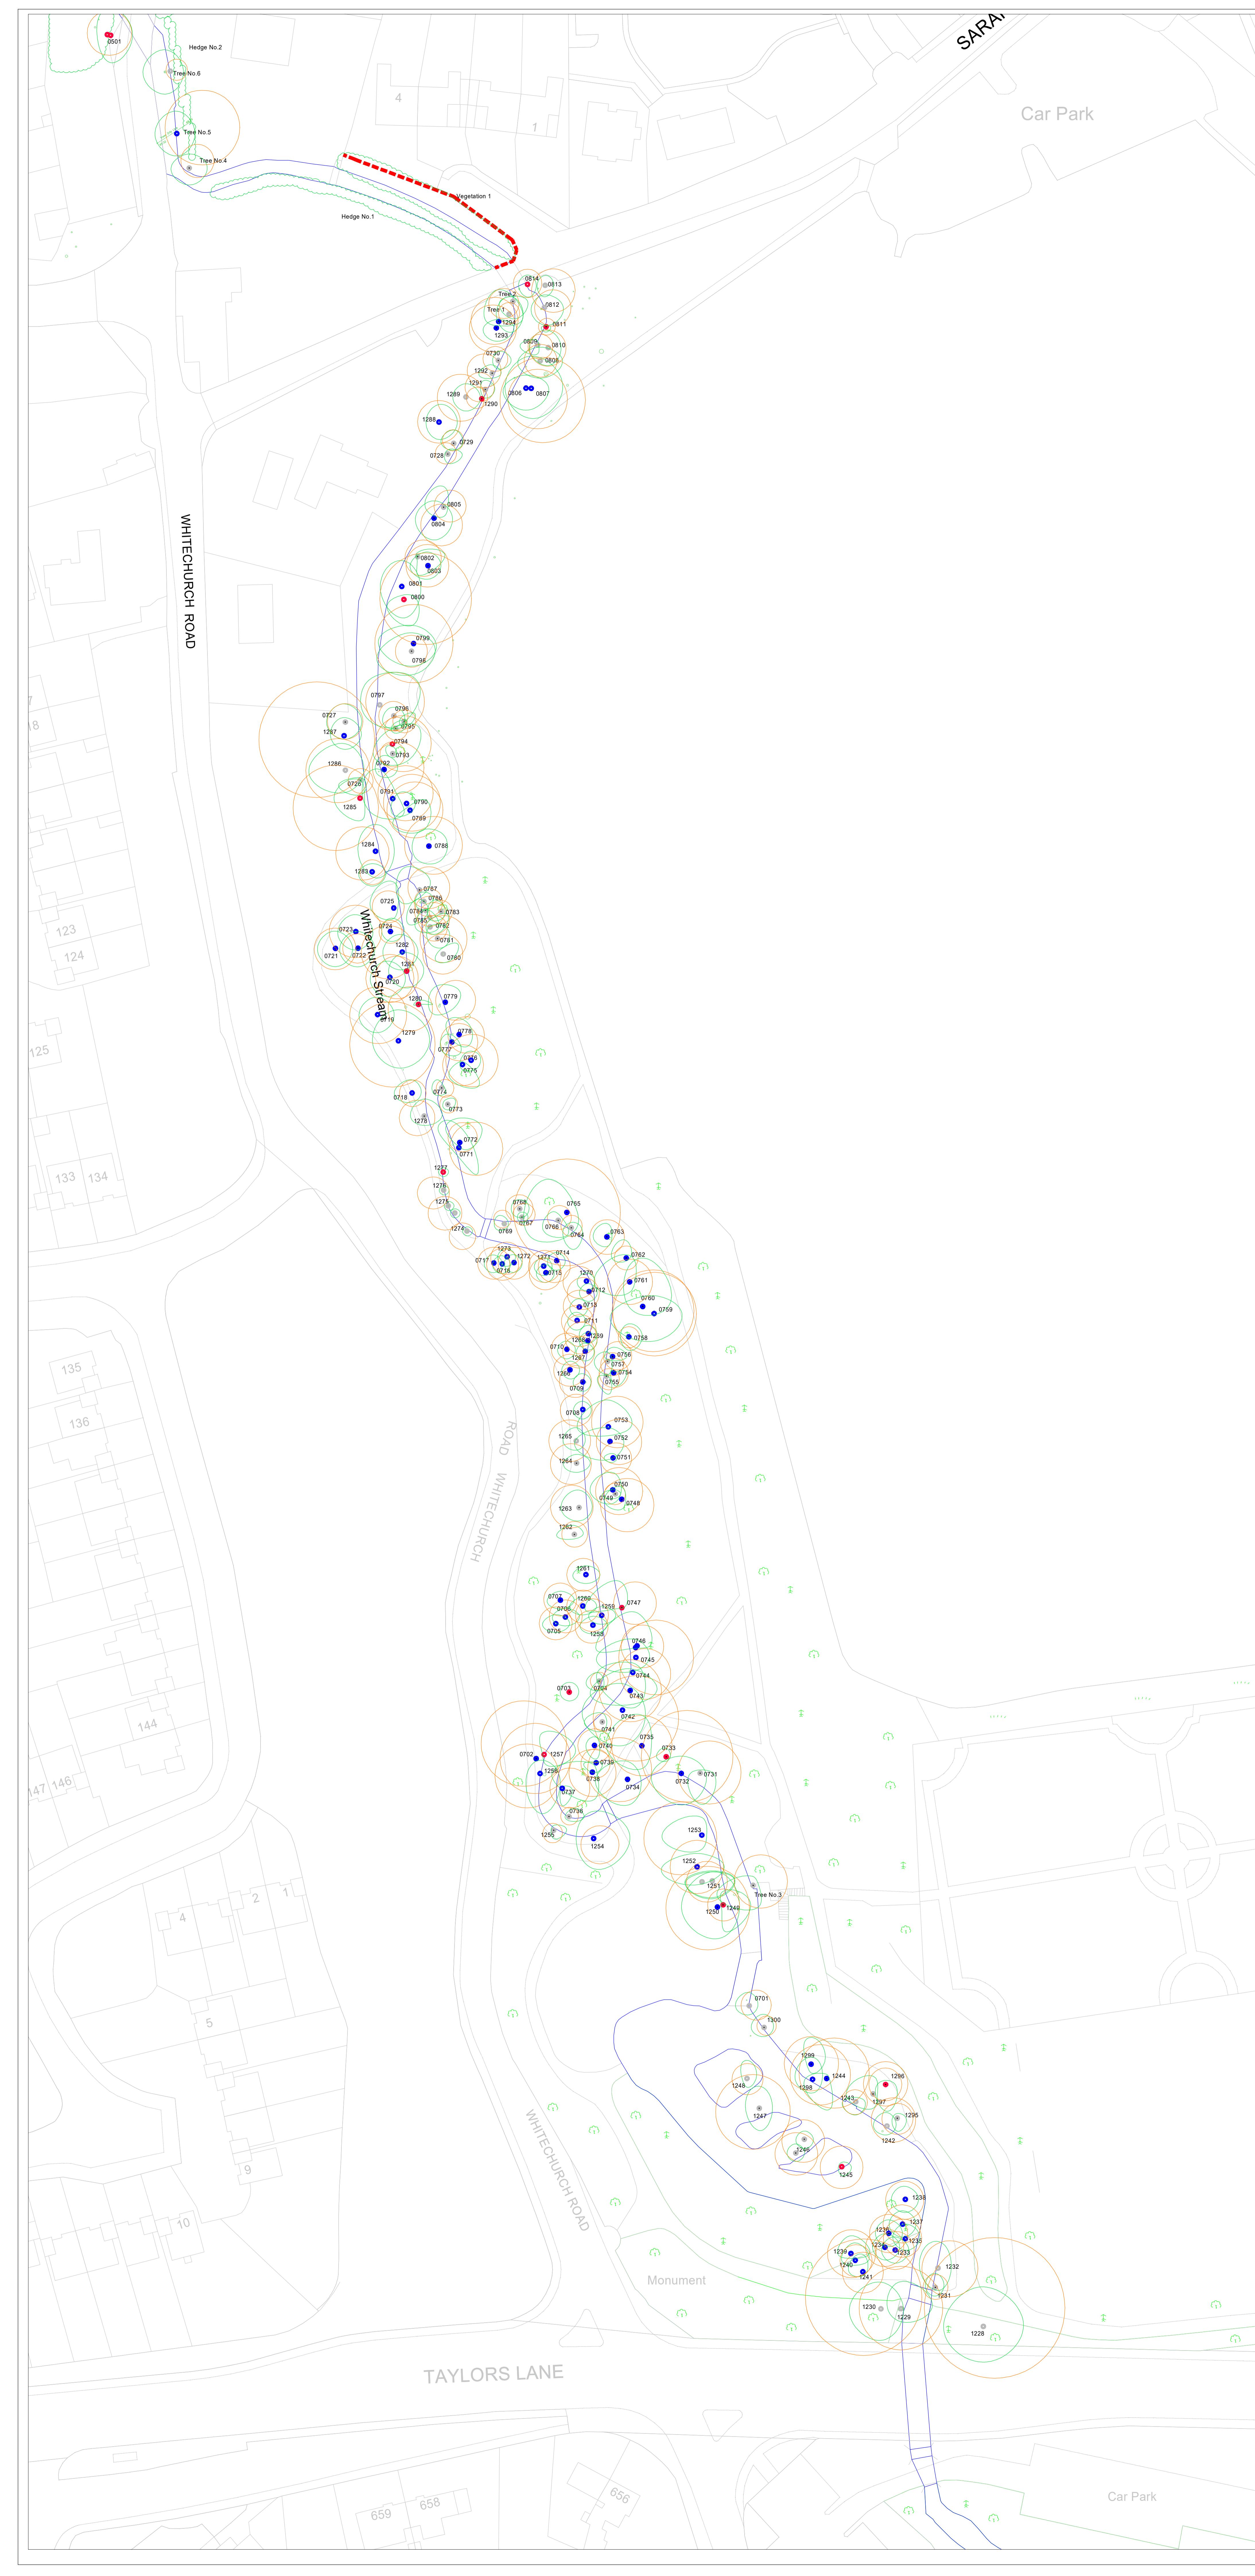
Note:

- Trees picked up by land Surveyors
- Trees positioned approximately

Overall Area

Scale 1:1250 A0

A - To assess the present condition of the tree vegetation within this corridor. See 'Appendix 1' for detail of my findings and drawing No.WCS001 which I have prepared as a constraints drawing to aid the design team.

These category 'U' trees have been identified on drawing No.WCS001 with a 'Red' donut around their trunk positions. Due to the condition of

3.6 Only some trees had been plotted onto the attached drawing (No.WCS001) by a land survey company with the remaining trees identified with a solid black trunk position and these have been positioned by ourselves to the best of our ability and their positions may not be fully accurate and need to be checked by a land survey company. This drawing has been developed as a constraint drawing to aid the design team in the final layout of the proposed flood relief works on this section of the stream and the tag numbers referred to in the condition tree report have been shown on this along with their crown spreads and their retention category colour coded as recommended by BS 5837 2012. The constraint (Minimum Root Protection Area) for
