#### NOTES: (Refer to Drawings L-101 to L-123 for Proposed Works)

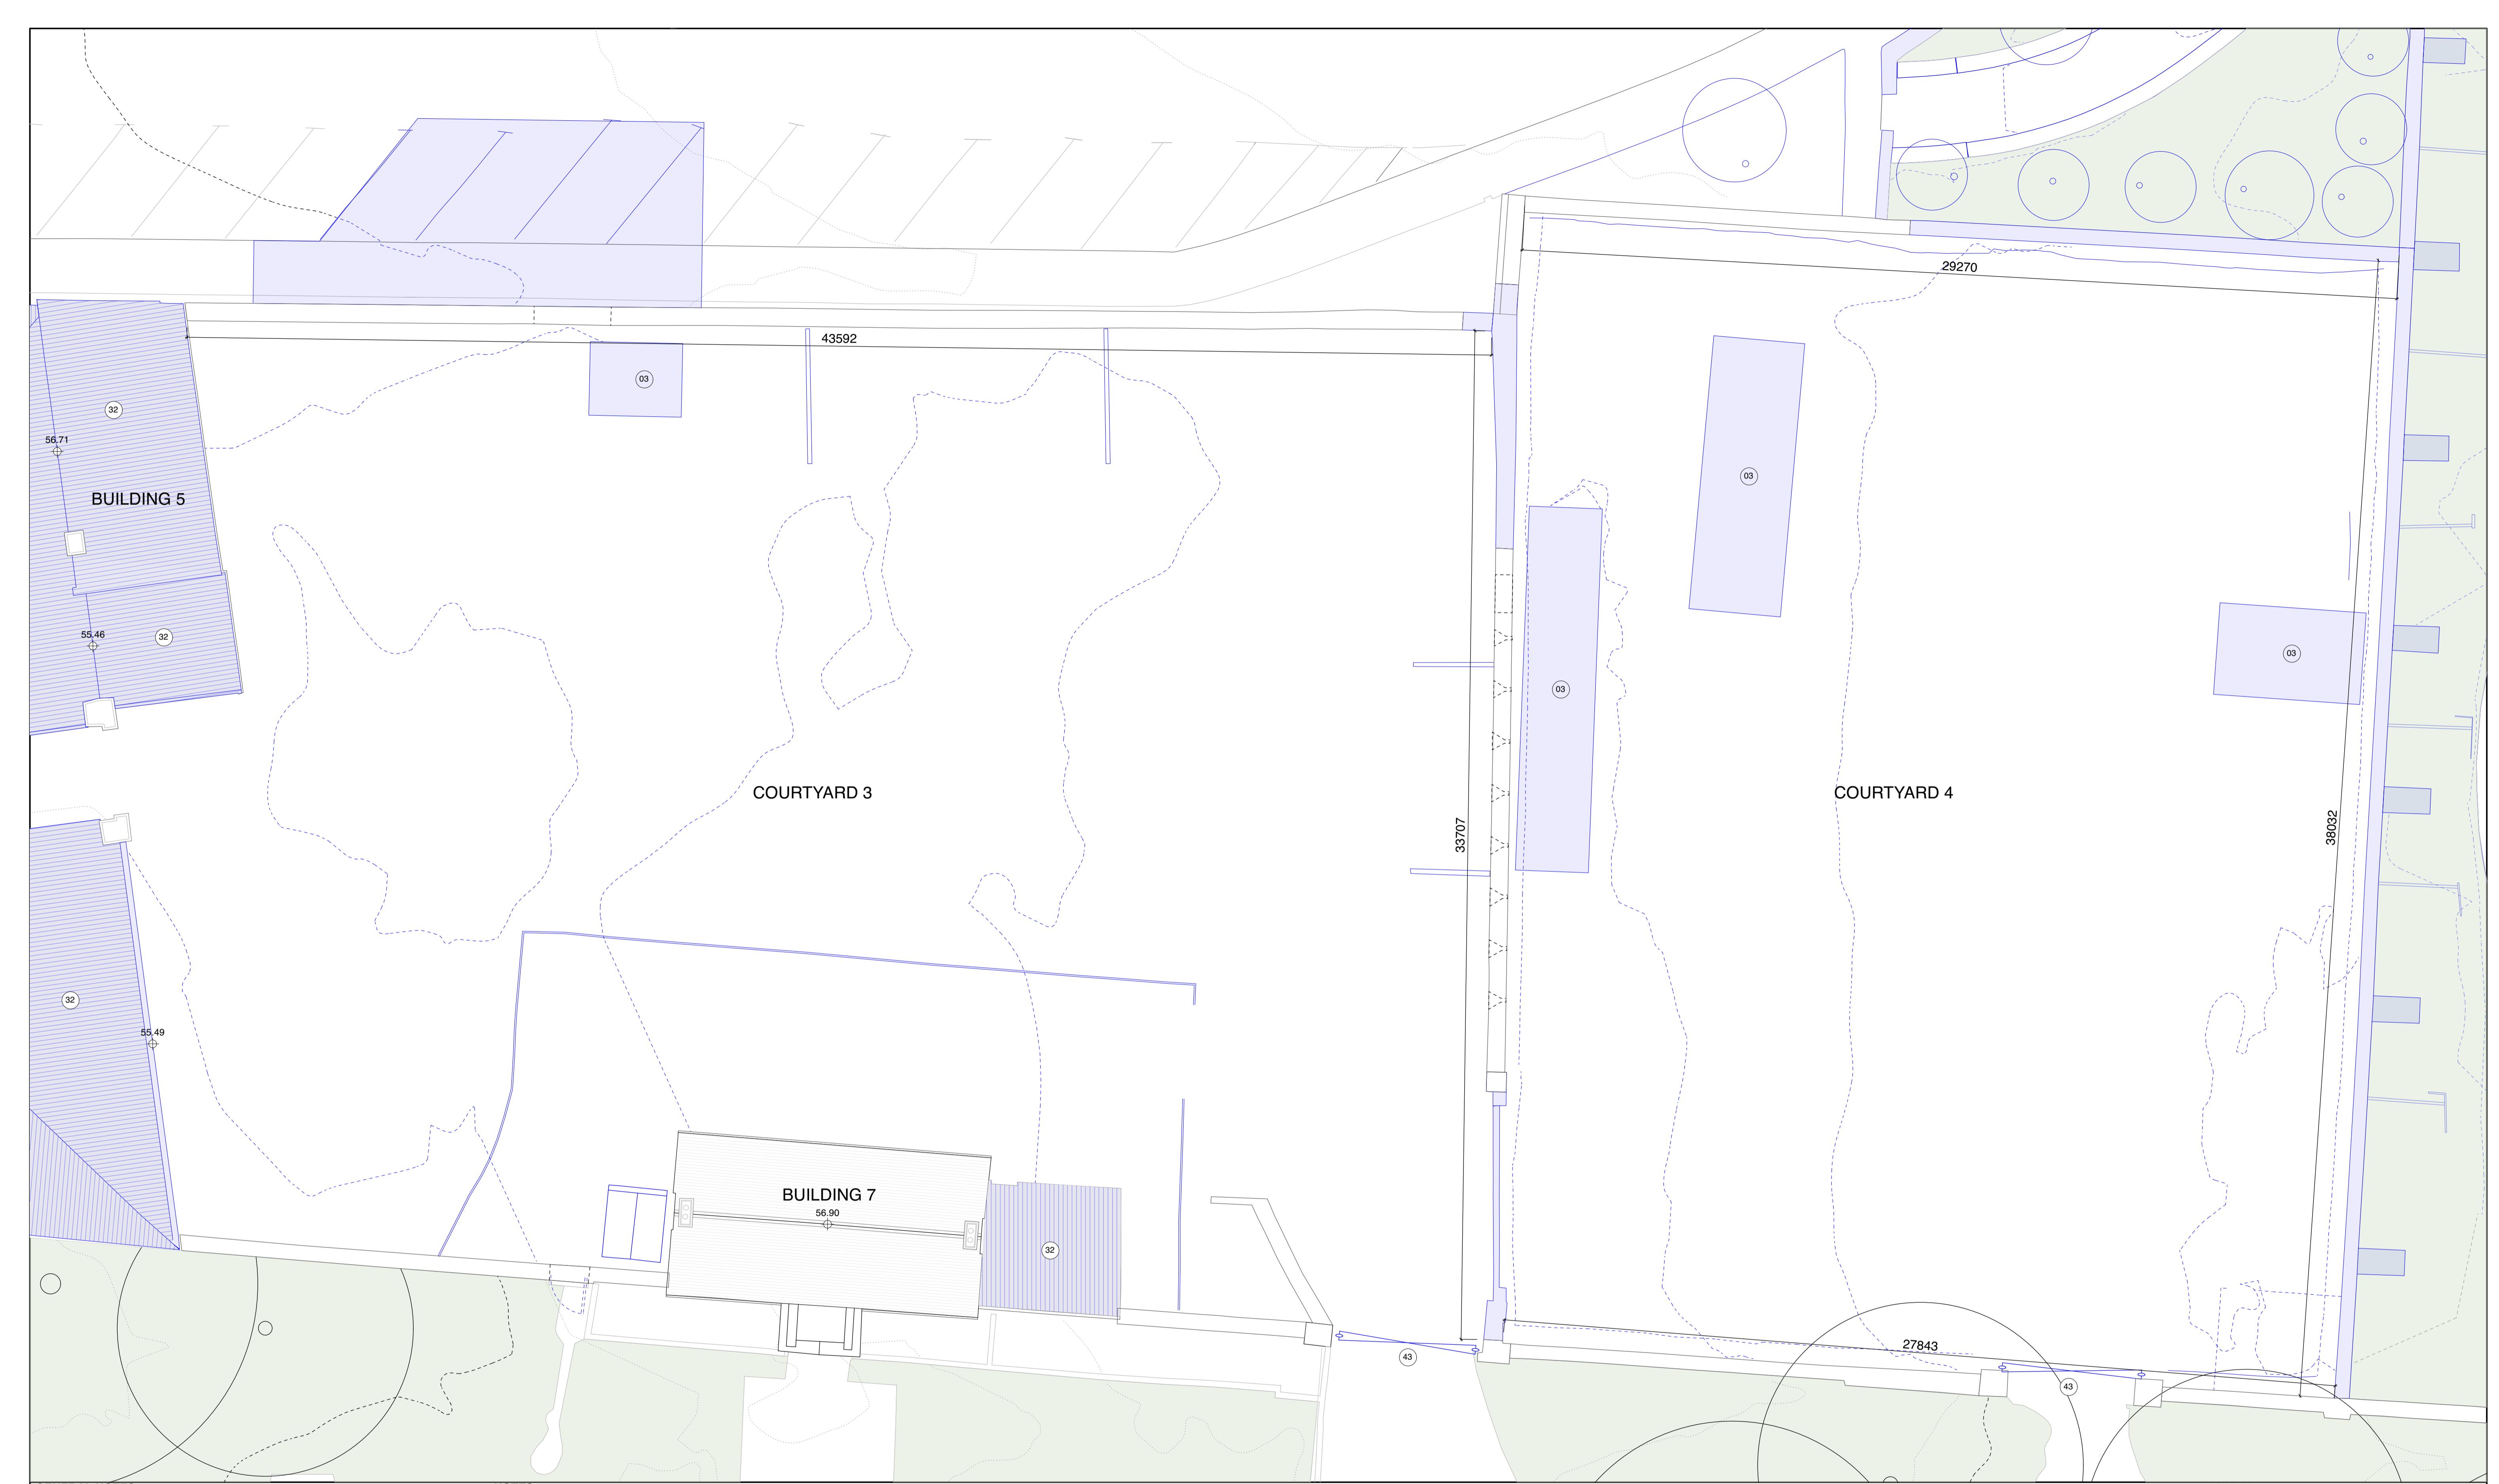
1. Existing perimeter wall, formed predominantly of rubble calp limestone with some brick infill to west of courtyard 4, to be partially taken down and rebuilt.

2. Existing perimeter wall, formed predominantly of rubble calp limestone with some brick infill to north of courtyard 4 to be carefully taken down and rebuilt.

3. Existing modern timber door to be removed.
4. Existing temporary cabin structures to be removed.
5. Existing temporary props and modern security railings to yard walls to be removed.

6. Existing concrete floor slabs to be removed.
7. Existing floor tiles to be carefully lifted and retained for reuse on site, existing floor slabs beneath to be removed.

8. Existing loose cobbles to be carefully removed and stored on site for future reuse.
9. Floor boards and non-historic solid floor slab to be removed.
10. Existing masonry dividing wall to be removed.

11. Blockwork infill to be removed from existing opening.
12. Existing plywood and blockwork crosswall to be removed.
13. Existing lime render to be removed.

14. Existing modern timber door to be removed.
15. Existing timber doors to be removed.
16. Existing dressed granite door surrounds to be cleaned and repaired as required.

17. Existing timber sliding sash windows to be repaired and reglazed.
18. Existing window frame & temporary timber sheeting and bracing to be removed.
19. Existing window frame to be removed.

20. Existing lime render to be removed.
21. Existing lime render to be removed with exposed brick/stone door and window reveals to be made good (with local repairs/renders) as required.

22. Existing lime rendered finish to the existing barrel vault, with local repairs as required.
23. Existing rubble calp limestone wall with areas of brick infill and evidence of former openings including brick arches. Pennystrock pointing to existing brick window and door reveals. Remnants of lime render to courtyard facing facades.

24. Existing rubble calp limestone walls with areas of brick infill and evidence of former openings, with brick door and window reveals and slightly projecting brick eaves courses. Remnants of lime render to courtyard facing facades.

25. Existing lime render to which existing lime render has been applied.
26. Existing exposed masonry wall, generally with the lower half formed of calp limestone and the upper half formed of brick.

27. Existing rubble calp limestone wall with some areas of brick infill.
28. Existing lime render to which existing lime render has been applied.
29. Modern concrete blockwork wall to be removed.

30. New opening within existing wall. Opening to follow existing coursed where possible.
31. Existing temporary intermediate/mezzanine floor structure to be removed.

40. Location repair to existing walls where former building elements have been removed.
41. Top of existing predominantly rubble calp limestone wall to be removed.

42. Existing lime render agricultural equipment including damaged troughs and stepped concrete floor to be removed.
43. Existing modern metal security railings and gates to be removed.

44. Existing lime render to be removed.
45. Existing modern pond and landscaping to be removed.
46. Existing timber partition wall to be removed.
47. Existing lime render to be removed.

48. Existing decorative brick chevron cornices.
49. Evidence of previous archaeological opening up works, repairs to be discussed and agreed with archaeologist.
