SECTION C-C
SCALE 1:50

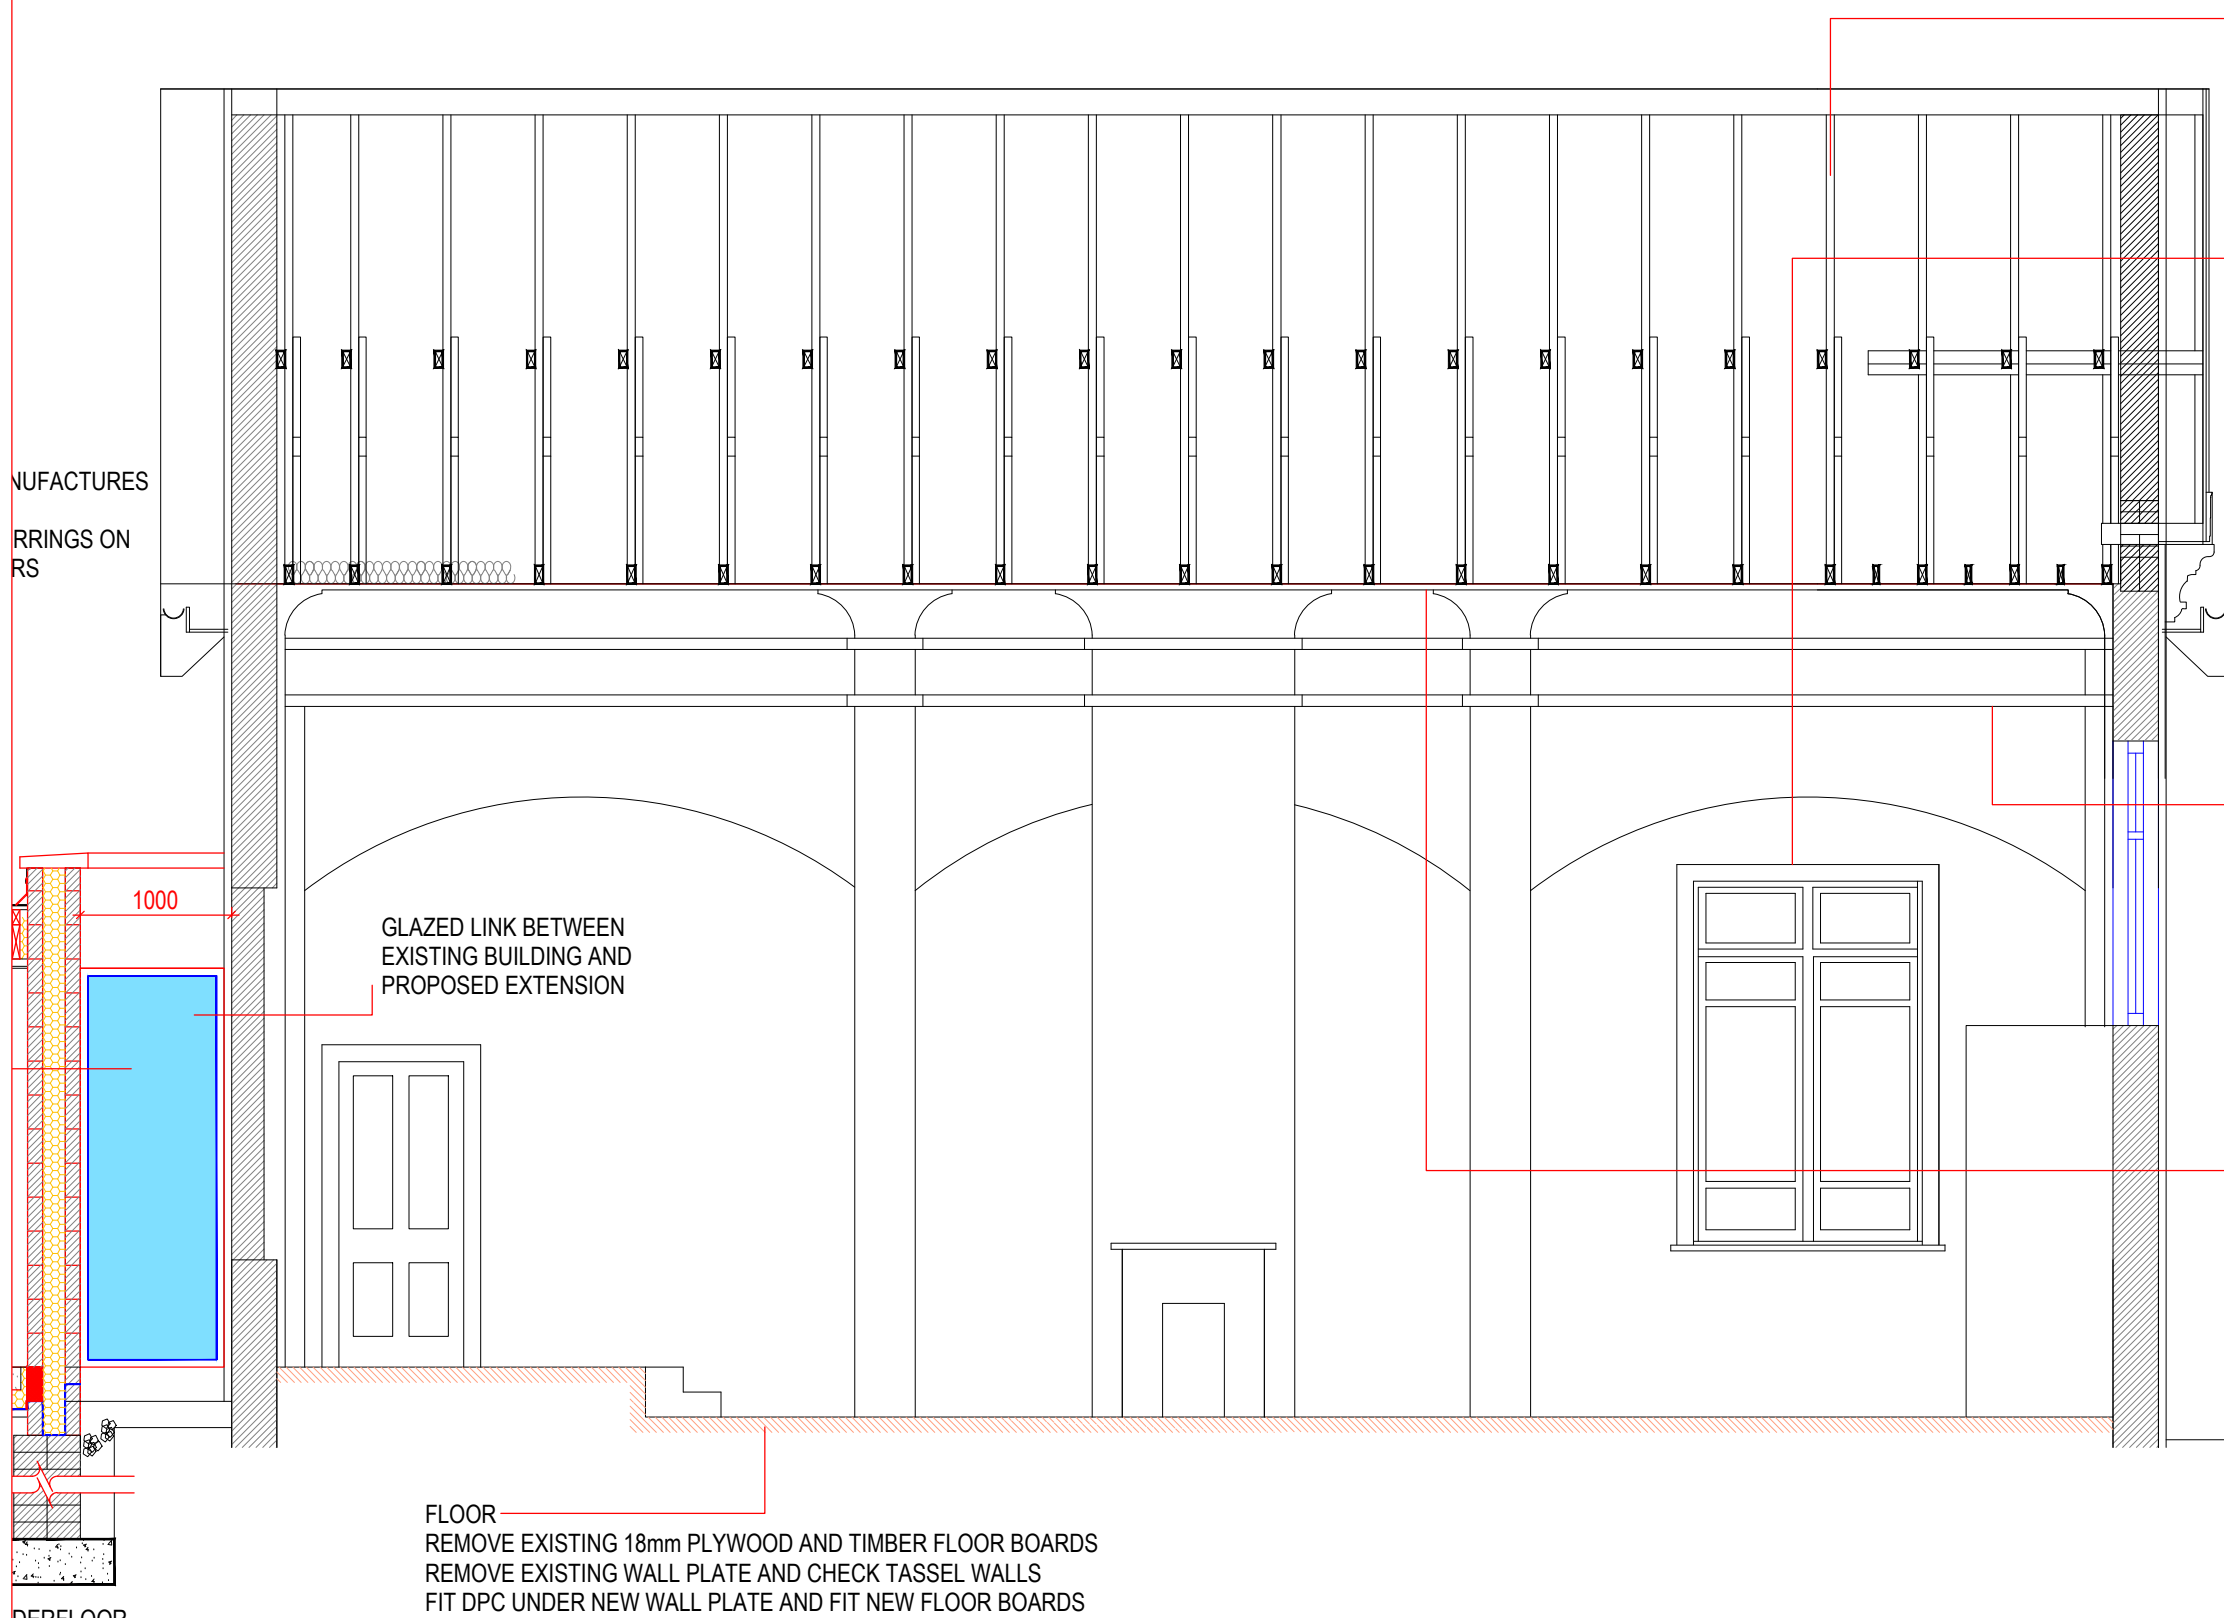
EXISTING ROOF
 REMOVE EXISTING FIBRE / CEMENT SLATES,
 BATTENS AND PARGING TO SLATES
 FIT NEW BREATHABLE ROOFING FELT
 TREATED SLATING BATTENS AND NEW
 FIBRE SLATES FIXED TO PATTERN TO
 MATCH EXISTING

ALL EXISTING DOOR AND WINDOWS TO
 BE LIGHTLY SANDED TO PROVIDE KEY
 FOR NEW 3 COAT PAINT APPLICATION.
 EARLY OR ORIGINAL IRONMONGERY TO
 BE RETAINED, LUBRICATED AND POLISHED,
 MODERN OR INAPPROPRIATE IRONMONGERY
 TO BE REPLACED NEW PERIOD PIECES TO
 MATCH EXISTING AS CLOSELY AS POSSIBLE.
 EXISTING SKIRTINGS TO BE LIGHTLY
 SANDED TO PROVIDE KEY FOR NEW 3
 COAT PAINT APPLICATION

THE DADO RAIL AROUND THE WALLS OF
 THE FORMER COURTROOM IS A SCROLL,
 MADE BY AN INLET MOULD RUN IN THE
 WALL PLASTER; THIS DECORATIVE
 FEATURE TO BE RETAINED AND
 PROTECTED FROM DAMAGE DURING THE
 PROPOSED WORKS.

THE CEILING OF THE FORMER JUDGE'S
 ROBING ROOM IS A MODERN
 PLASTERBOARD CEILING FIXED TO
 CEILING JOIST. THIS CEILING TO BE
 CHECKED FOR ITS STABILITY; ANY
 LOOSE OR INSECURED CEILING SLABS TO
 BE REPLACED / SECURED AND MADE
 GOOD AND ENTIRE CEILING DECORATED.

THE CEILING TO THE FORMER
 COURTROOM IS ALSO A MODERN
 PLASTERBOARD CEILING FIXED TO
 CEILING JOIST. THE CORNICE AROUND
 THE PERIMETER OF THE ROOM IS A
 LATHE-ON-PLASTER CEILING. (PROBABLY
 ORIGINAL)
 THIS CEILING TO BE
 CHECKED FOR ITS STABILITY; ANY
 LOOSE OR INSECURED CEILING SLABS TO
 BE REPLACED / SECURED AND MADE
 GOOD AND ENTIRE CEILING DECORATED.

THE CORNICE TO BE CHECKED FOR
 STABILITY, DECAY AND SECURITY AND TO
 BE CONSERVED AND REPAIRED
 ACCORDINGLY. REPAIR WATER DAMAGED
 CEILING AT SOUTH-EASTERN CORNER OF
 THE COURTROOM.

GLAZED LINK BETWEEN
 EXISTING BUILDING AND
 PROPOSED EXTENSION

FLOOR
 REMOVE EXISTING 18mm PLYWOOD AND TIMBER FLOOR BOARDS
 REMOVE EXISTING WALL PLATE AND CHECK TASSSEL WALLS
 FIT DPC UNDER NEW WALL PLATE AND FIT NEW FLOOR BOARDS
