Rev.	Date	Description	Dm.	Chk	Project
-	01/05/25	Part 8 Application Issue	IH	CC	Stables & Courtyards at Rathfarnham Castle Park
					South Dublin County Council
					Planning
					Site Plan - Existing / Demolition
					Project No. 0661
					Date 01/05/2025
					Scale 1:500 @ A1
					Drawing No. L-002
					Revision A

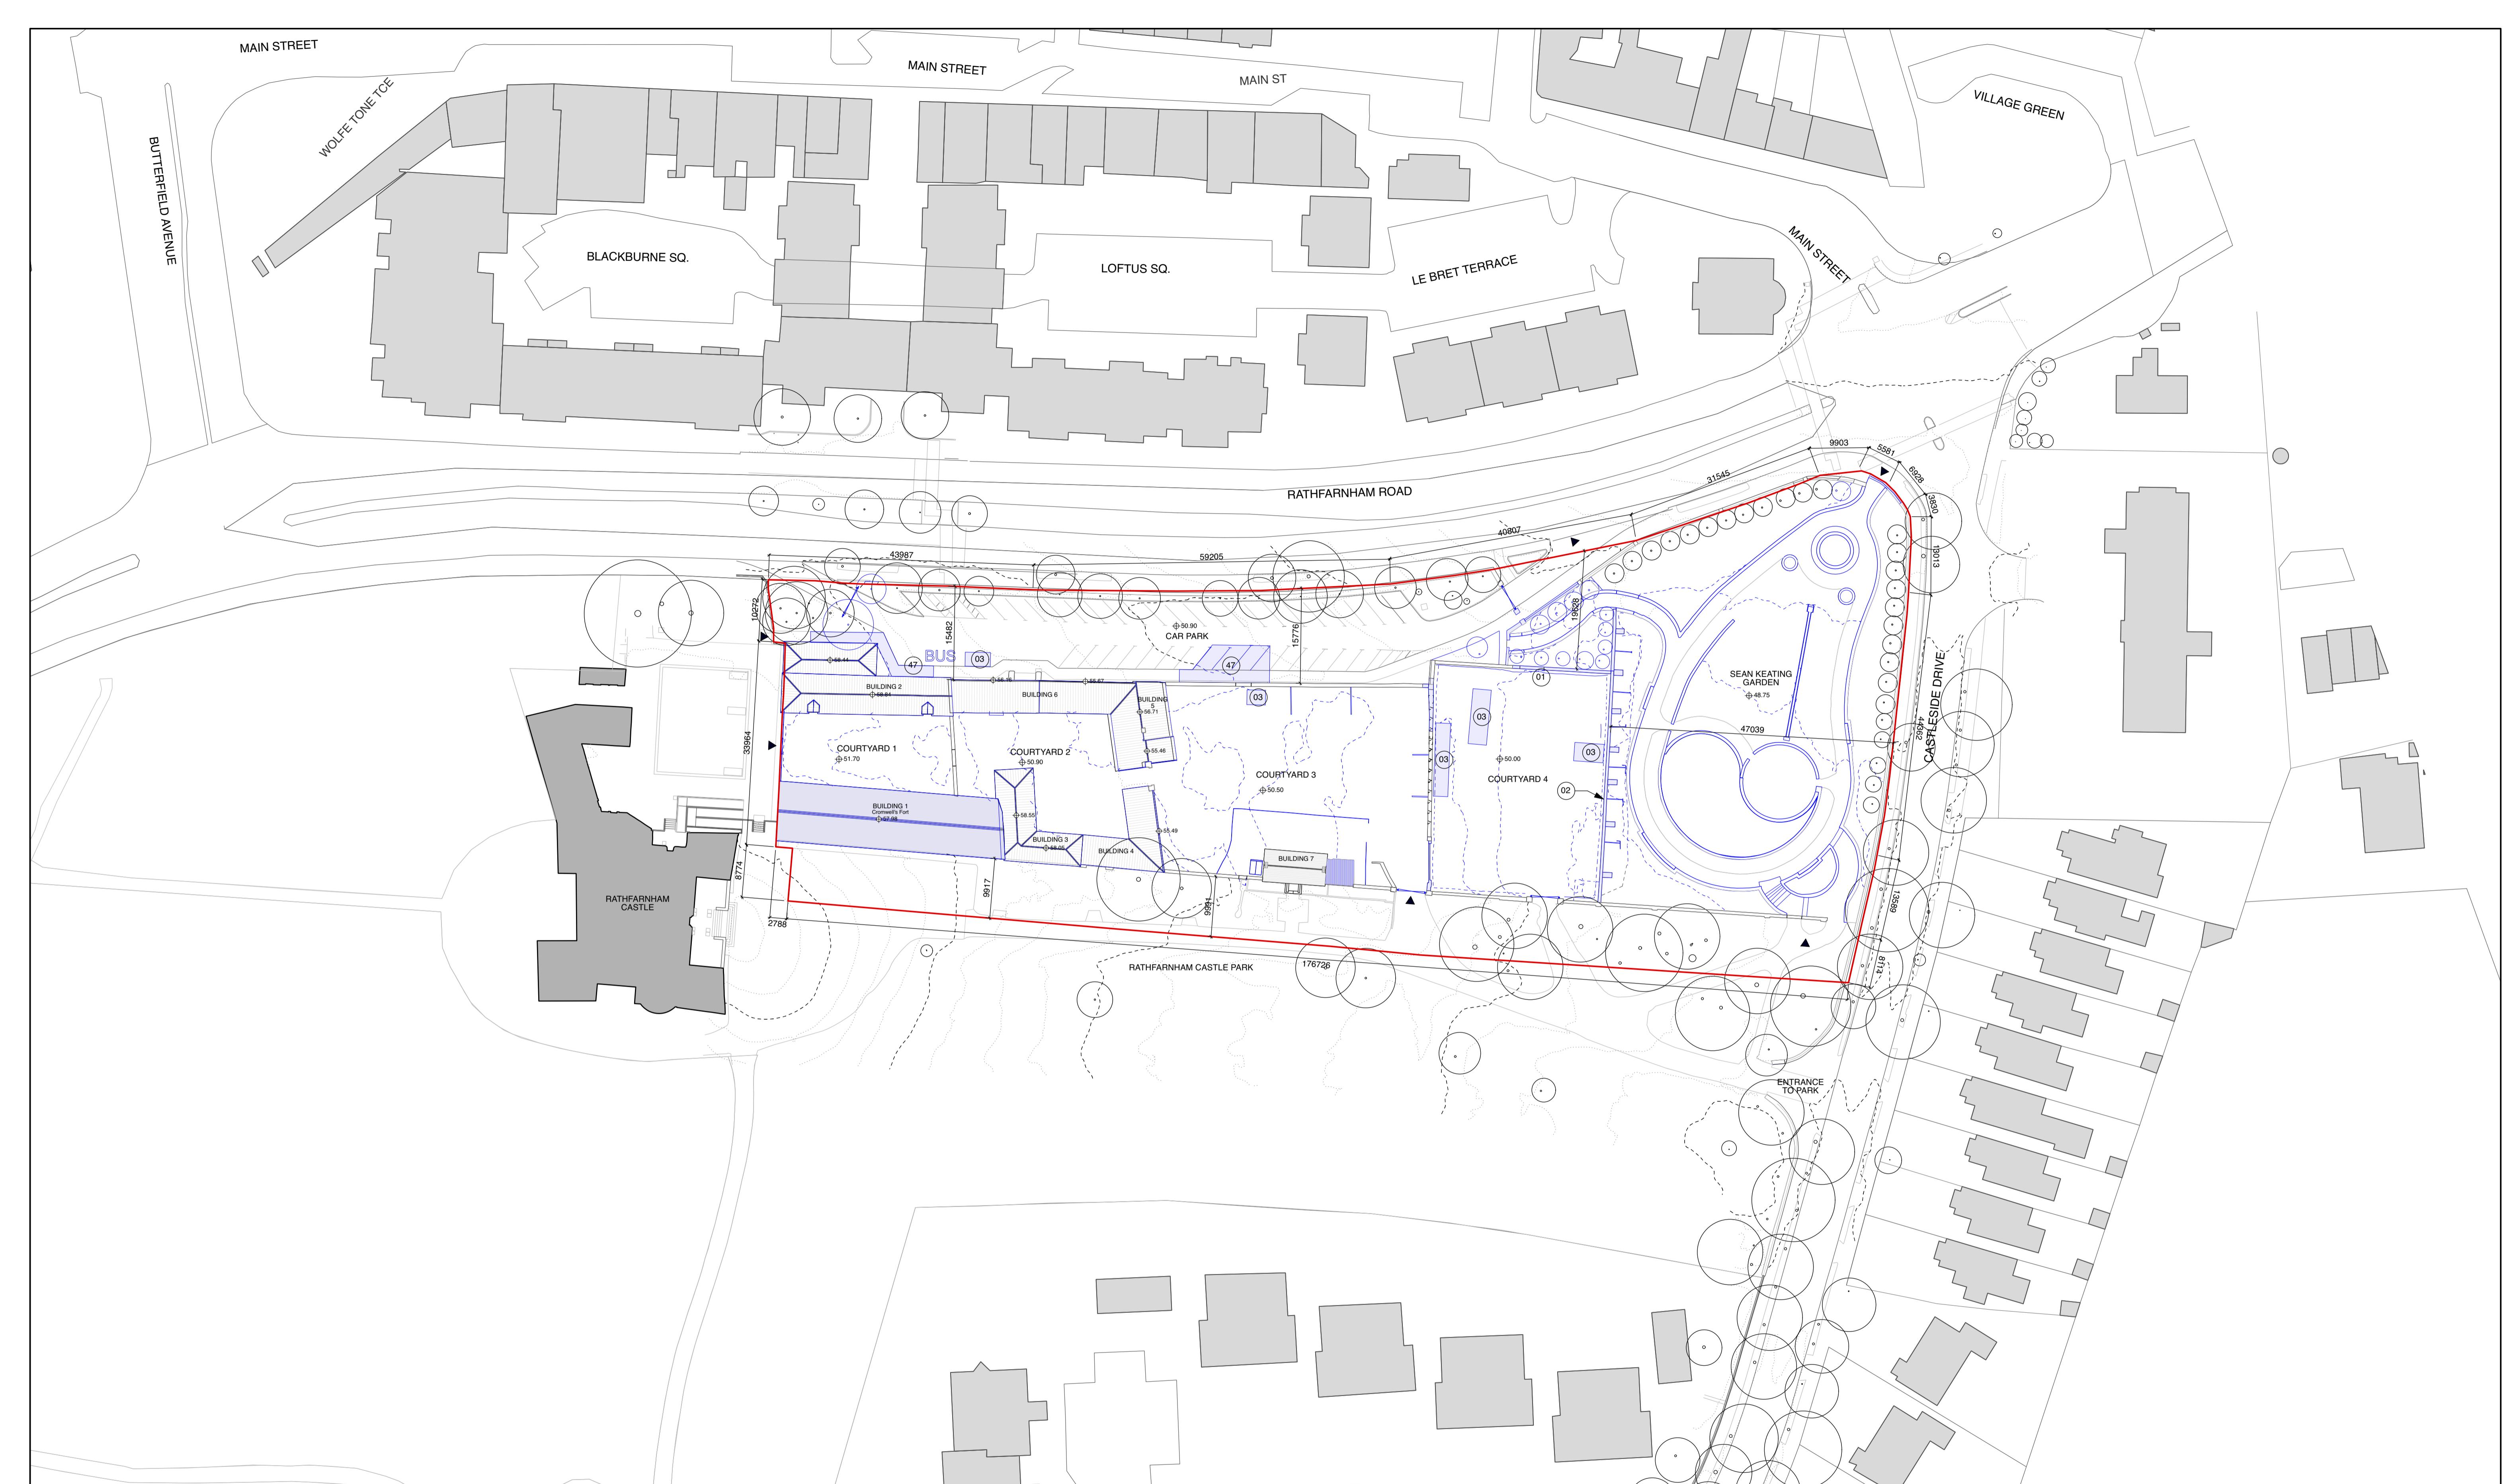
01. Existing perimeter wall, formed predominantly of rubble calp limestone with some brick infill to west of courtyard 4, to be partially taken down and rebuilt.

02. Existing perimeter wall, formed predominantly of rubble calp limestone with some brick infill to north of courtyard 4 to be carefully taken down and rebuilt.

03. Existing modern timber door to be removed.
04. Existing temporary cabin structures to be removed.
05. Existing temporary props and modern security railings to yard walls to be removed.

06. Existing cut stone floor slabs to be removed.
07. Existing floor tiles to be carefully lifted and retained for reuse on site, existing floor slab beneath to be removed.

08. Existing loose cobbles to be carefully removed and stored on site for future reuse.
09. Floor boards and non-historic solid floor slab to be removed.

10. Existing masonry dividing wall to be removed.
11. Blockwork infill to be removed from existing opening.
12. Existing plywood and blockwork crosswall to be removed.

13. Existing lime render to be removed.
14. Existing modern timber door to be removed.
15. Existing timber doors to be removed.
16. Existing dressed granite door surrounds to be cleaned and repaired as required.

17. Existing timber sliding sash windows to be repaired and reglazed.
18. Existing window frame & temporary timber sheeting and bracing to be removed.
19. Existing window frame to be removed.

20. Existing lime and lime brickwork vents.
21. Existing lime and lime brickwork with exposed brick/stone door and window reveals to be made good (with local repairs/rerender) as required.

22. Existing rendered finish to the existing barrel vault, with local repairs as required.
23. Existing rubble calp limestone wall with areas of brick infill and evidence of former openings including brick arches. Pennystrock pointing to existing brick window and door reveals. Remnants of lime render to courtyard facing facades.

24. Existing rubble calp limestone walls with areas of brick infill and evidence of former openings, with brick door and window reveals and slightly projecting brick eaves courses. Remnants of lime render to courtyard facing facades.

25. Existing lime and lime brickwork with lime render.
26. Existing exposed masonry wall, generally with the lower half formed of calp limestone and the upper half formed of brick.

27. Existing rubble calp limestone wall with some areas of brick infill.
28. Existing lime and lime brickwork with lime render.
29. Modern concrete blockwork wall to be removed.

30. New opening within existing wall. Opening to follow existing coursing where required.
31. Existing temporary intermediate/mezzanine floor structure to be removed.

32. Existing temporary profiled metal roof covering to be removed. Clay ridge tiles to be carefully removed and stored on site for reuse.
33. Existing fibreglass roof including fascias and flashings to be removed.

34. Existing temporary timber trussed rafter to be removed.
35. Existing temporary plywood sheeting to be removed from all openings.
36. Existing trussed rafters to be retained.

37. Existing lime and lime brickwork with lime render.
38. Existing PVC rainwater goods to be removed.
39. Exposed concrete/concrete blockwork to be made good in preparation for new opening.

40. Location to which existing lime render.
41. Top of existing predominantly rubble calp limestone wall to be removed.
42. Existing lime and lime brickwork including damaged troughs and stepped concrete floor to be removed.

43. Existing modern metal security railings and gates to be removed.
44. Existing lime and lime brickwork with lime render.
45. Existing modern pond and landscaping to be removed.

46. Existing timber partition wall to be removed.
47. Existing lime and lime brickwork with lime render.
48. Existing decorative brick chevron cornices.
49. Evidence of previous archaeological opening up works, repairs to be discussed and agreed with archaeologist.

Proposed demolition works shown in BLUE.
Includes elements to be rebuilt or salvaged for reuse.
