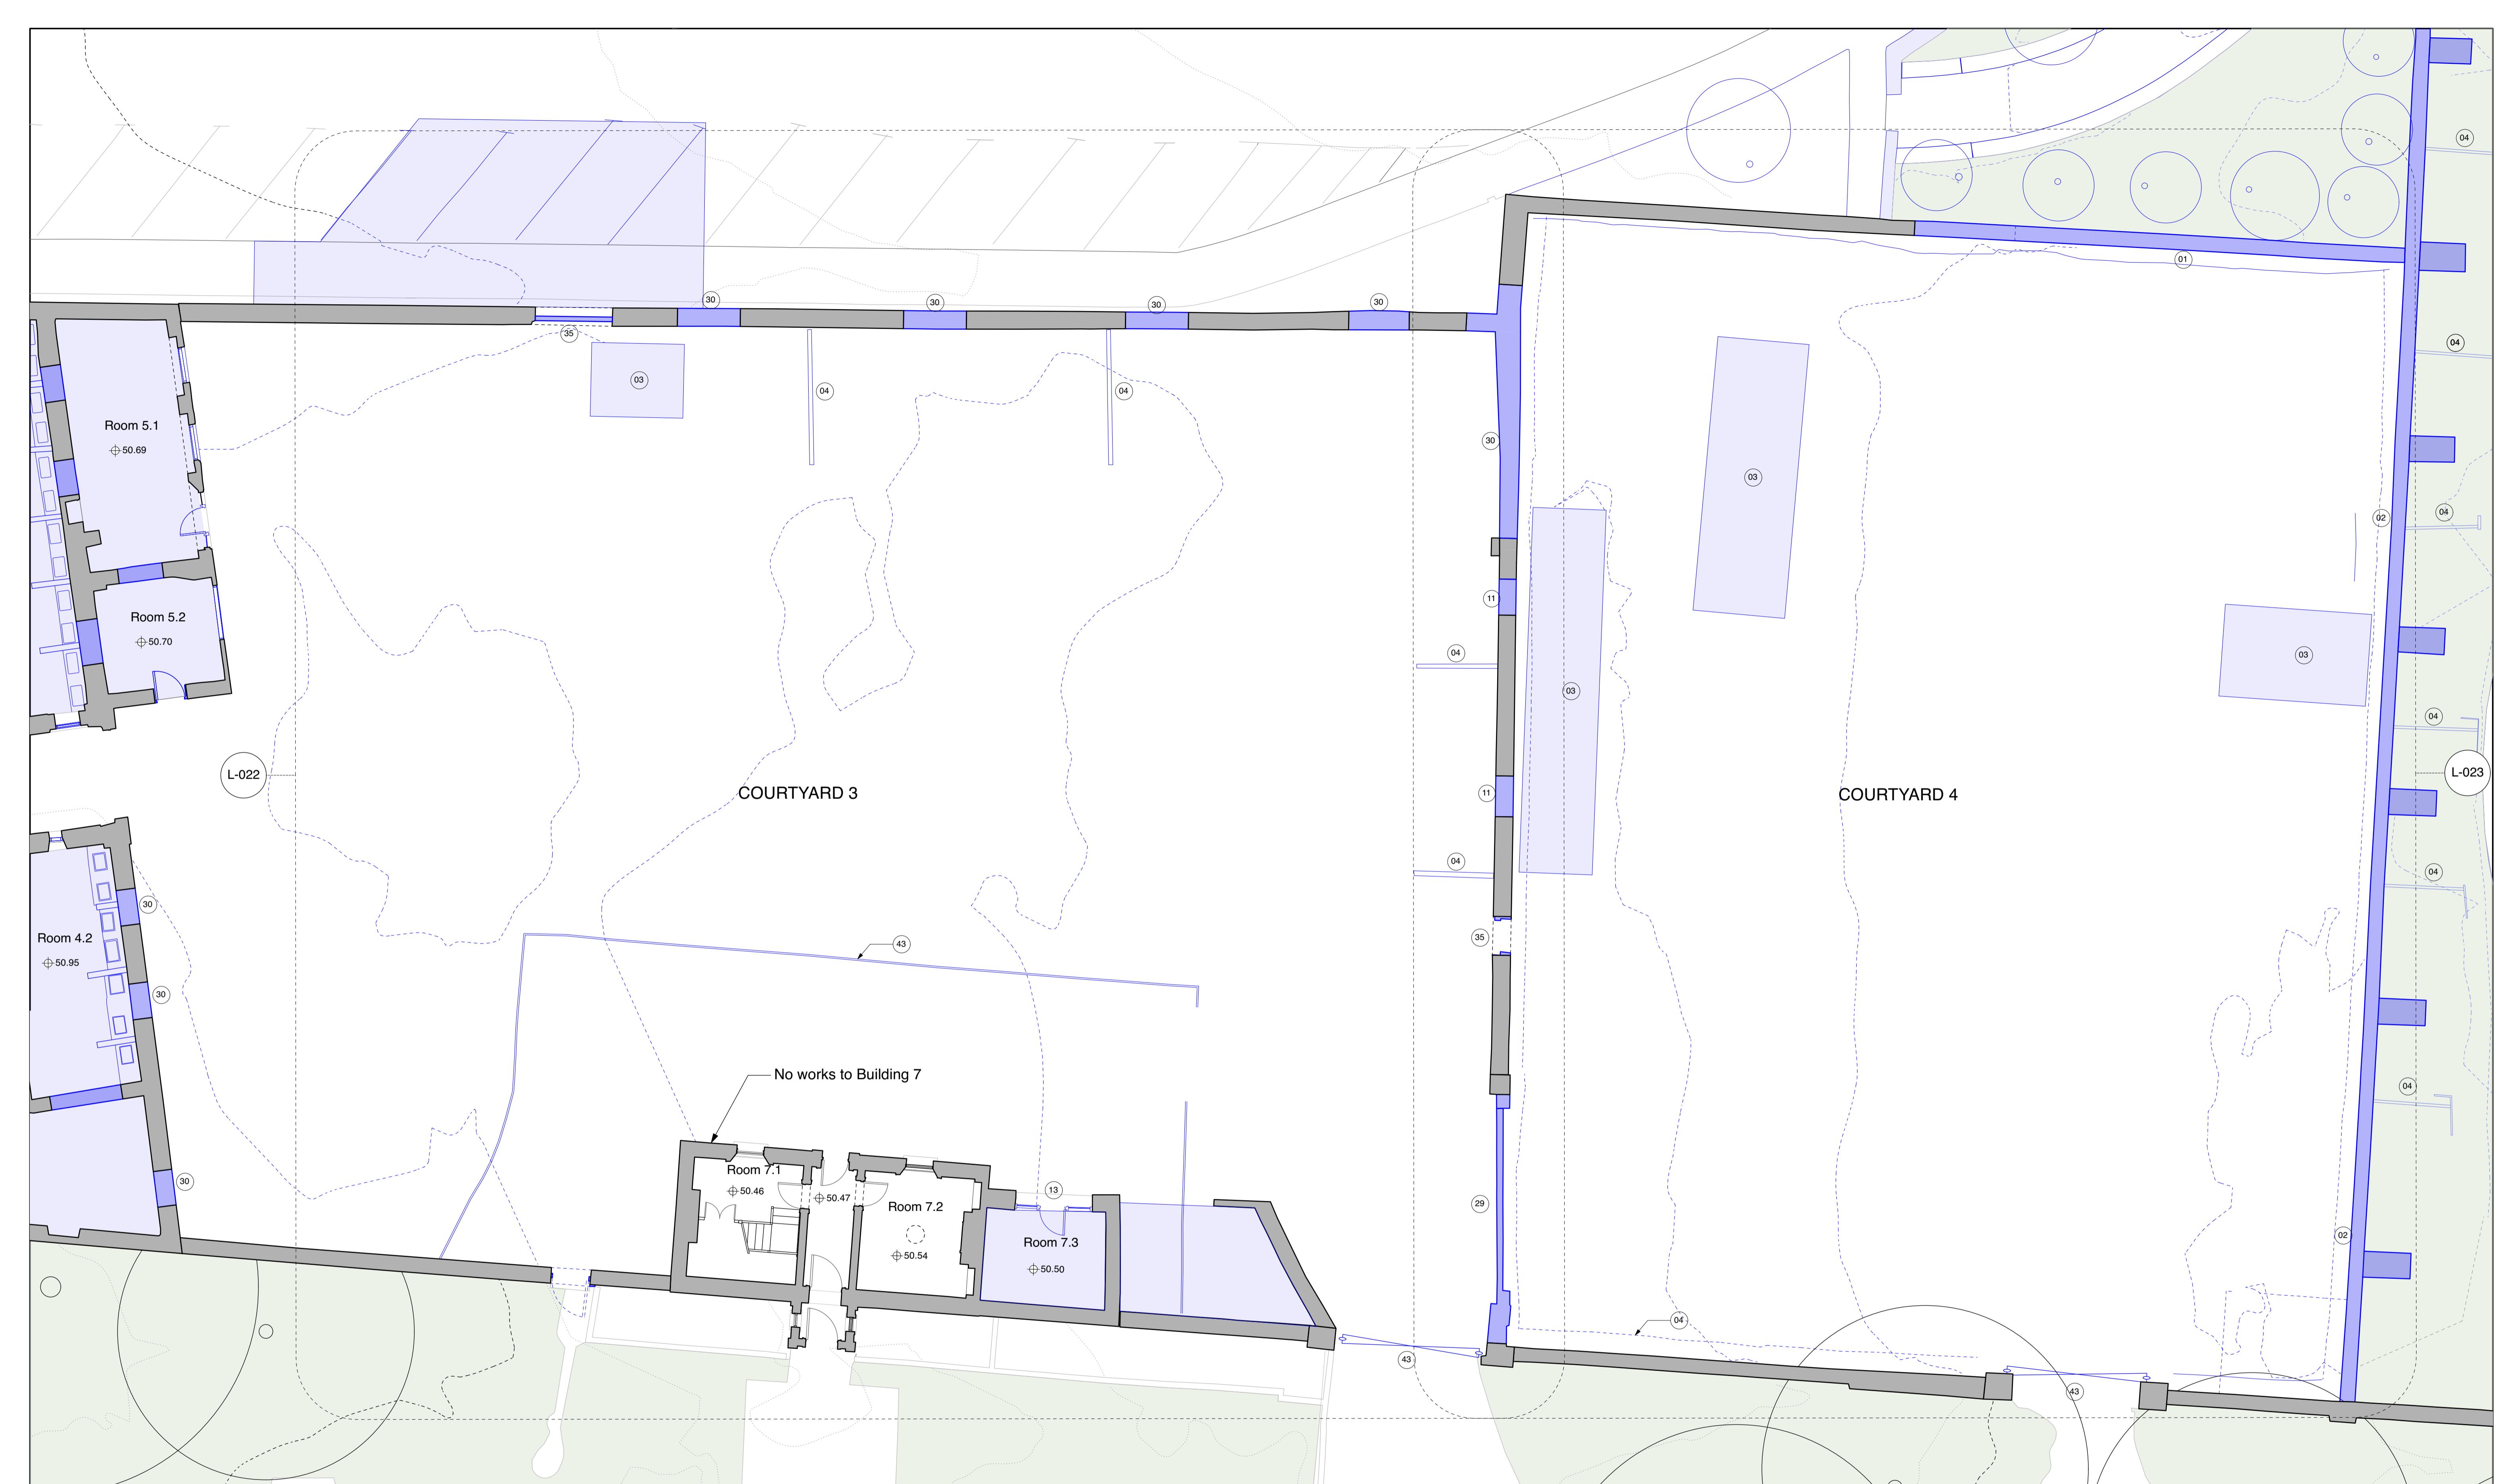
01. Existing perimeter wall, formed predominantly of rubble cap limestone with some brick infill to west of courtyard 4, to be partially taken down and rebuilt.

02. Existing perimeter wall, formed predominantly of rubble cap limestone with some brick infill to north of courtyard 4 to be carefully taken down and rebuilt.

03. Existing temporary cabin structures to be removed.
04. Existing temporary props and modern security railings to yard walls to be removed.
05. Existing concrete floor slabs to be removed.

06. Existing cut stone floor slabs to be carefully lifted and stored on site for reuse.
07. Existing floor tiles to be carefully lifted and retained for reuse on site, existing floor slab beneath to be removed.

08. Existing loose cobbles to be carefully removed and stored on site for future reuse.
09. Floor boards and non-historic solid floor slab to be removed.

10. Existing masonry dividing wall to be removed.
11. Blockwork infill to be removed from existing opening.
12. Existing plywood and blockwork crosswall to be removed.

13. Existing timber door to be removed.
14. Existing modern timber door to be removed.
15. Existing dressed granite door surrounds to be cleaned and repaired as required.

16. Existing timber sliding sash windows to be repaired and reglazed.
17. Existing timber sliding sash windows to be repaired and reglazed.
18. Existing window frame & temporary timber sheeting and bracing to be removed.

19. Existing window frame to be removed.
20. Existing lime and lime render to be removed.
21. Existing lime and lime render to be removed with exposed brick/stone door and window reveals to be made good (with local repairs/lime render) as required.

22. Existing lime rendered finish to the existing barrel vault, with local repairs as required.
23. Existing rubble cap limestone wall with areas of brick infill and evidence of former openings including brick arches. Pennystrock pointing to existing brick window and door reveals. Remnants of lime render to courtyard facing facades.

24. Existing rubble cap limestone walls with areas of brick infill and evidence of former openings, with brick door and window reveals and slightly projecting brick eaves courses. Remnants of lime render to courtyard facing facades.

25. Existing lime and lime render to be removed.
26. Existing exposed masonry wall, generally with the lower half formed of cap limestone and the upper half formed of brick.

27. Existing lime and lime render to be removed.
28. Existing lime and lime render to be removed.
29. Modern concrete blockwork wall to be removed.
30. New opening within existing wall. Opening to follow existing coursed where possible.

31. Existing temporary intermediate/mezzanine floor structure to be removed.
32. Existing temporary profiled metal roof covering to be removed. Clay ridge tiles to be carefully removed and stored on site for reuse.

33. Existing fibreglass roof including fascias and flashings to be removed.
34. Existing temporary timber trussed rafter to be removed.
35. Existing temporary plywood sheeting to be removed from all openings.

36. Existing trussed rafters to be retained.
37. Existing lime and lime render to be removed from all openings.
38. Existing PVC rainwater goods to be removed.

39. Exposed concrete/concrete blockwork to be made good in preparation for new opening.
40. Location to which existing walls where former building elements have been removed.

41. Top of existing predominantly rubble cap limestone wall to be removed.
42. Existing lime and lime render agricultural equipment including damaged troughs and stepped concrete floor to be removed.

43. Existing modern metal security railings and gates to be removed.
44. Existing lime and lime render to be removed.
45. Existing modern pond and landscaping to be removed.

46. Existing timber partition wall to be removed.
47. Existing lime and lime render to be removed.
48. Existing decorative brick chevron cornices.
49. Evidence of previous archaeological opening up works, repairs to be discussed and agreed with archaeologist.
