## THE CAMAC

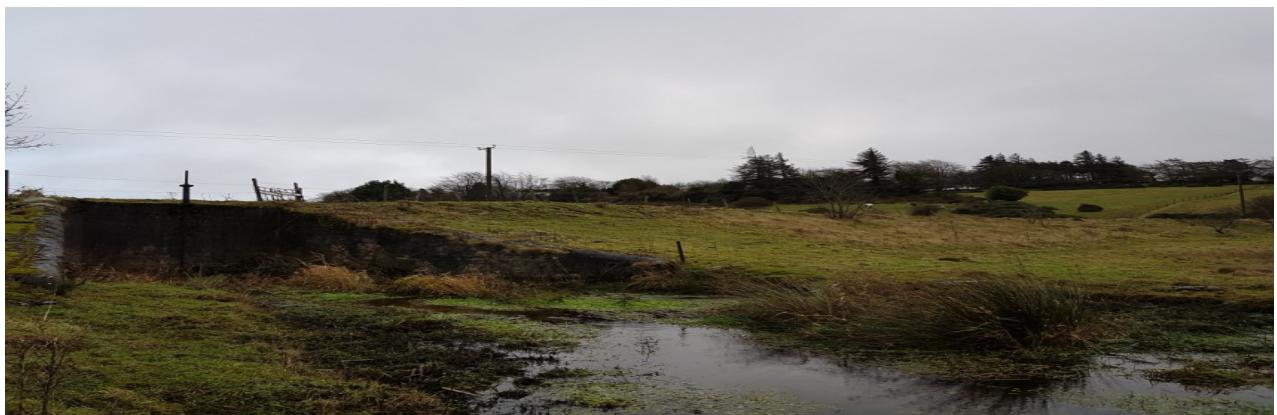
Brittas Overflow Detention Pond sluice 4 metres

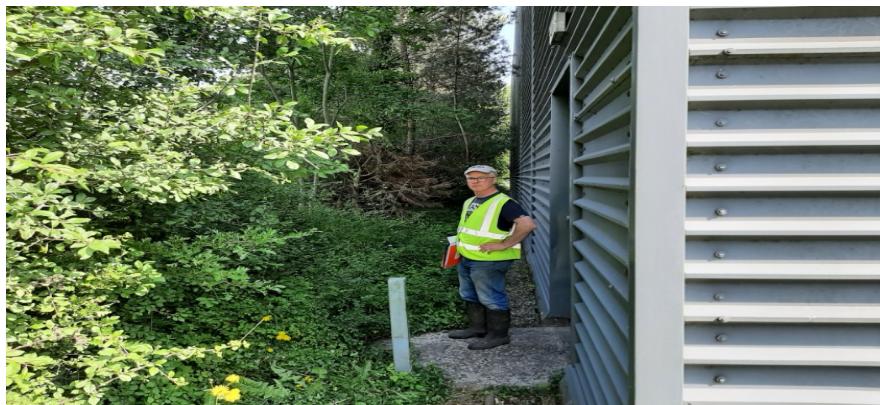
Citywest Industrial Unit encroaching 4 metres from Camac tributary.

Drainage and flood attenuation here is totally inadequate. Industrial building, housing estates and apartment building is continuing, further encroaching to the banks of the Camac tributaries. Retrofitting for flood relief and flood attenuation is essential.

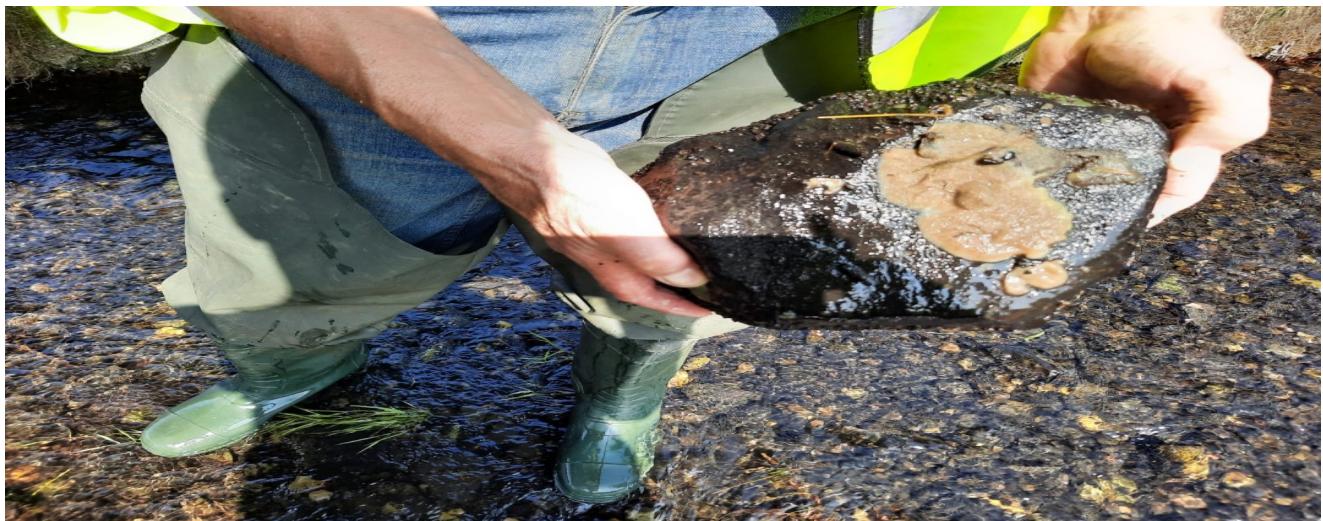
In 2018 and 2019 water quality analysis at Clondalkin and upstream yielded moderate results. On 01/07/2021 sampling on the Kingswood / Fortunestown Tributary yielded the following : Ephemeroptera : 0 Plecoptera : 0 Trichoptera : 4 . Slime mould extensive. Result : Bad

Slime mould also visible on riverbed Kingswood Tributary of Camac 01/07/2021

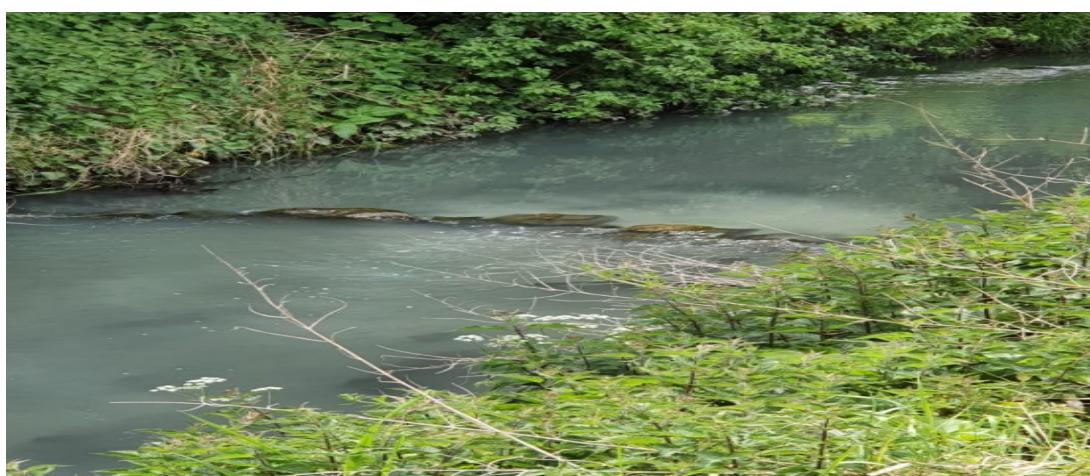
The majority of the pollution is from culverts, inadequate stormwater management, lack of riparian buffer corridors and total absence of sustainable drainage systems (SUDS)

Pollution from Camac culvert below Cruidin Clondalkin Park July 2021
