# Stables and Courtyards at Rathfarnham Castle

Conservation Management Plan

30th April 2025

RATHFARNHAM CASTLE, CO. DUBLIN. 11551. W.L.

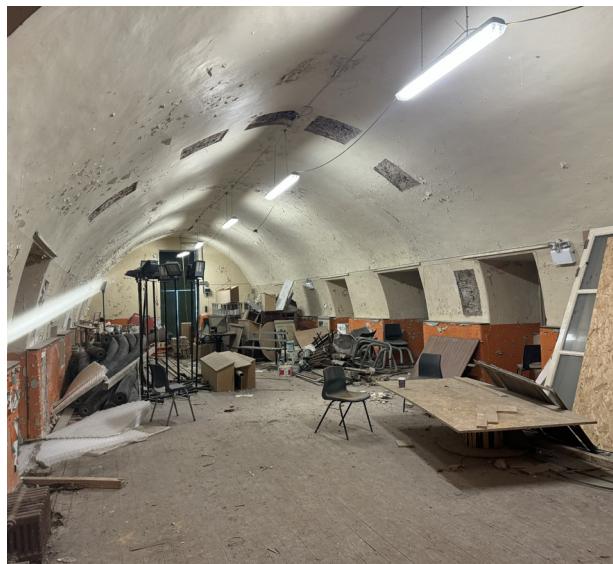
Figure 32 - Cromwell's Fort, Room 1.1, interior.

There is extensive peeling and damage to the paintwork of the vaulted ceiling & walls in room 1.1, indicating a high level of moisture and lack of ventilation internally.

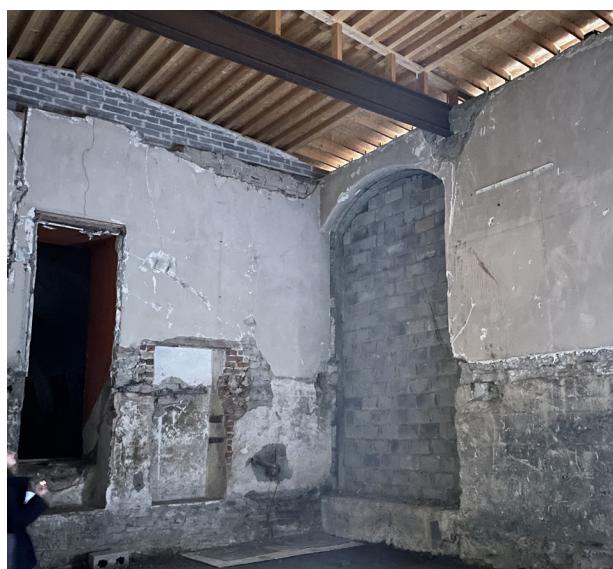
Figure 33 - Cromwell's Fort Room 1.2, interior.

The walls of room 1.2 are in poor condition with extensive cracking and damage to the wall surfaces and in some areas portions of masonry have been damaged where embedded services installations have previously been removed.

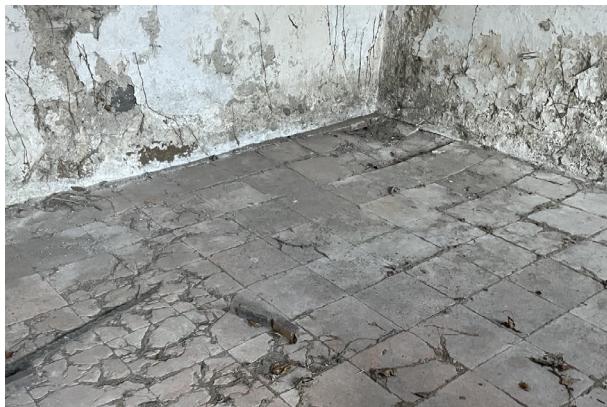
Figure 36 - Building 2, Floor surface in room 2.7.

The floor finish in 2.7 contains a later square stone or ceramic tiles are mostly intact, however, there

are extensive areas of cracking to the tiled surface throughout the centre of the room. Elsewhere in room 2.6, a cobbled sub-floor edged with a stone drainage channel is visible immediately north of the entrance door.

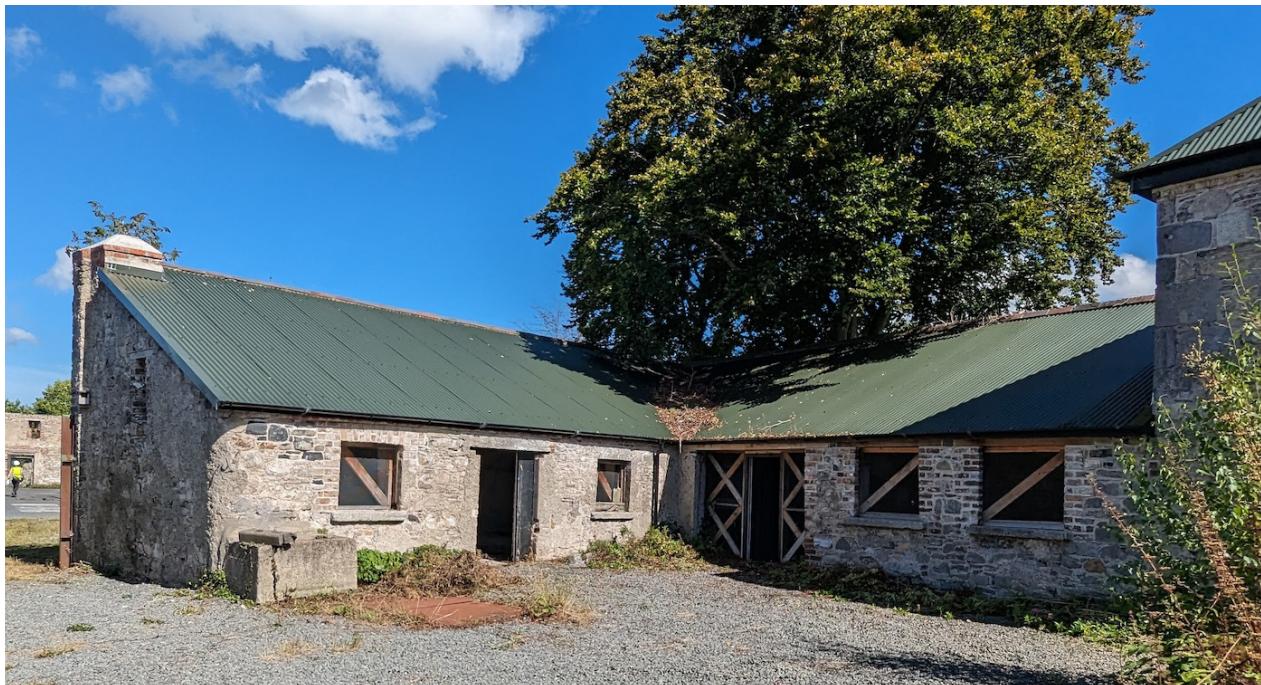
Figure 41 - Exterior of Building 4, viewed from Courtyard 2.

Due to the presence of an adjacent mature tree, Building 4 is prone to a build-up of heavy leaf fall within the valley gutter. The valley gutter and base of the walls, particularly at the internal corner, should be regularly monitored and cleared of debris. This will prevent the blockage of gutters and drainage channels and any associated damage to the building fabric caused by water ingress and prolonged dampness. Vegetation build-up was also visible internally, within room 4.1. This should be cleared regularly and a lock fitted to the braced and ledged door to prevent it from being blown open.

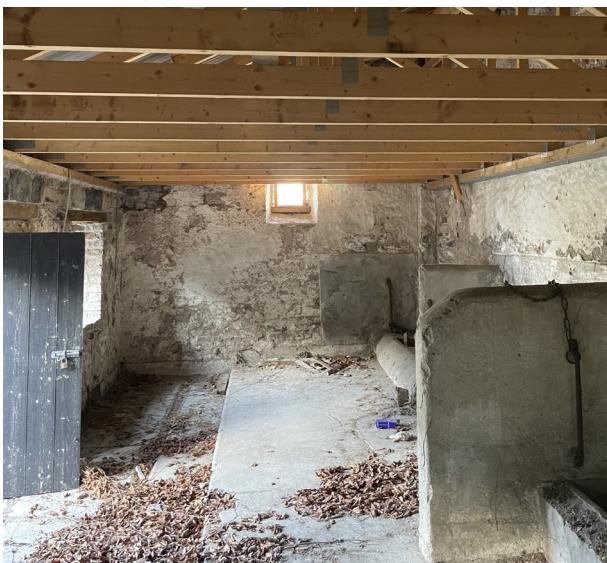
Figure 44 - Building 4, Interior. Remains of animal stalls and raised feeding troughs visible along northern wall.

Limewash partially remains on the internal walls but has generally been worn away and is entirely missing in places. The former animal feeding stalls are in disrepair with walls and plinths broken and severely damaged.

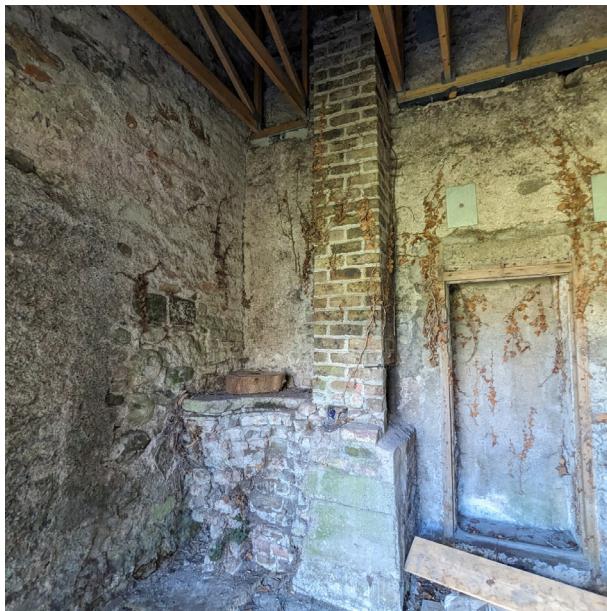
Figure 47 - Interior building 5 (A), chimney stack with widened base, resembling construction of a forge.

The chimney stack, visible externally, continues internally within the south-east corner of Building 5 (A). Widening at the base to form a flat surface approx. 1m height above the ground, it resembles the construction of a forge. There is a blocked-up niche in the wall adjacent to the chimney stack which may have previously provided a connection with Building 6. Internally the floor consists of a cobbled stone surface with drainage channel running east-west formed within the cobbles. The internal wall faces of Building 5 (B) have been plastered and painted, with surface cracking and peeling paint visible throughout. Graffiti on the wall dates this paintwork to some time before 1985. There is a concrete floor finish within this room with a recessed channel running along the base of the north wall.

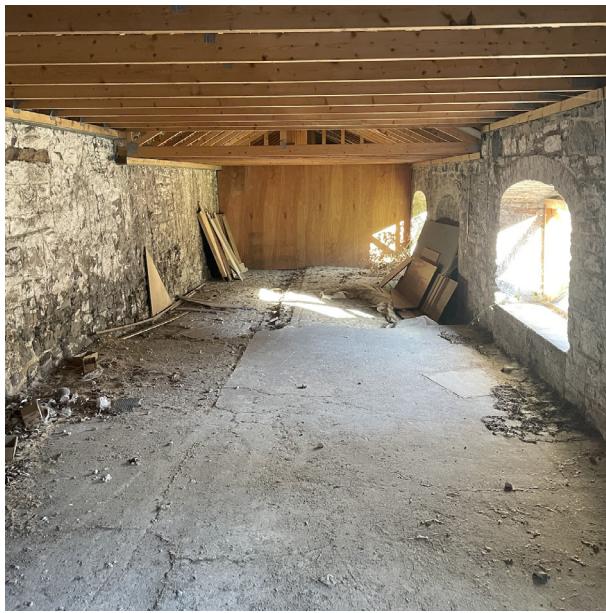
Figure 50 - Building 6, west range interior. The floor slopes significantly downwards heading north.

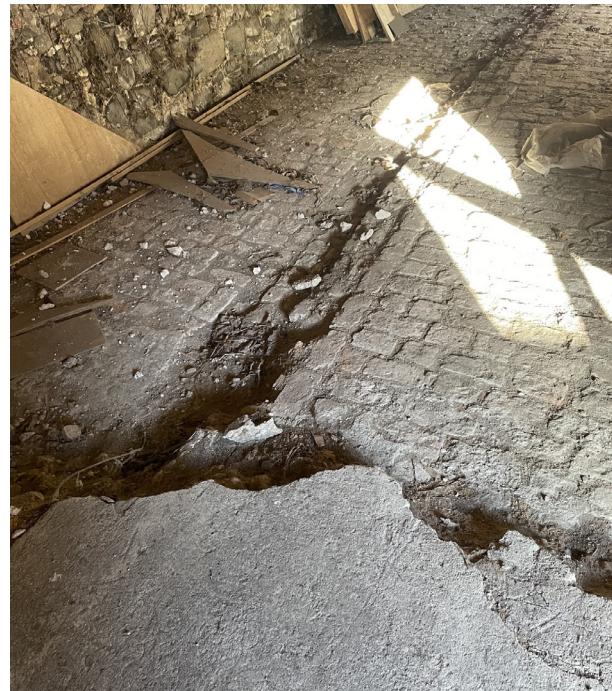
Figure 51 - Building 6, west range, drainage channel formed in stone sets.

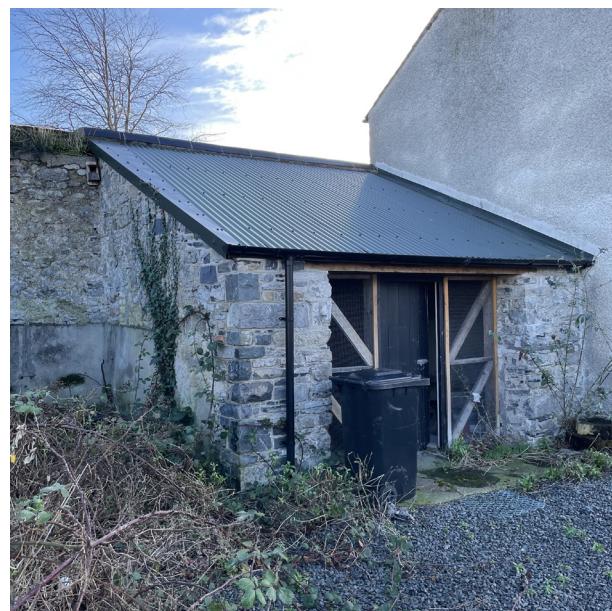
Figure 54 - The single storey building to the north of the Seismograph House has been reroofed in a profiled metal sheeting and has PVC gutters and downpipes.

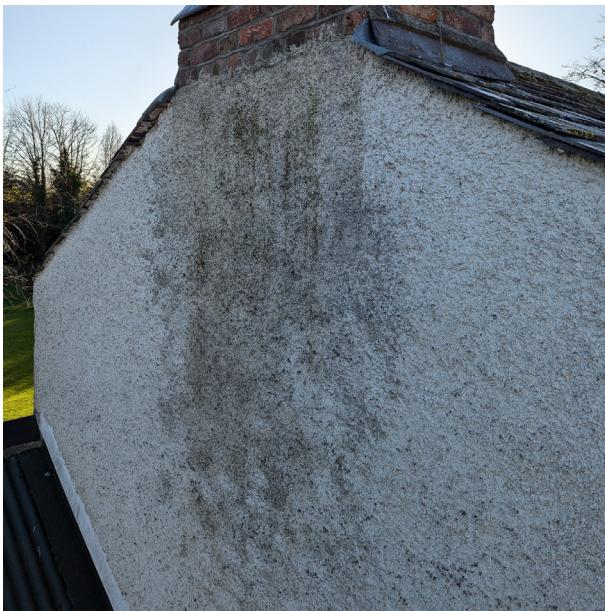
Externally, plasterwork of the northern gable wall is discoloured due to damp staining beneath the chimney stack. Rainwater runoff appears to be travelling from the lead flashing at the base of the stack on to the wall below. Ends of the timber roof battens are exposed where render has broken away. Further inspection of the chimney and attic space internally should be carried out to determine the source and extent of any damp penetration internally. The render to the base of the southern chimney appears loose and should

Figure 57 - Discolouration to north facing gable.

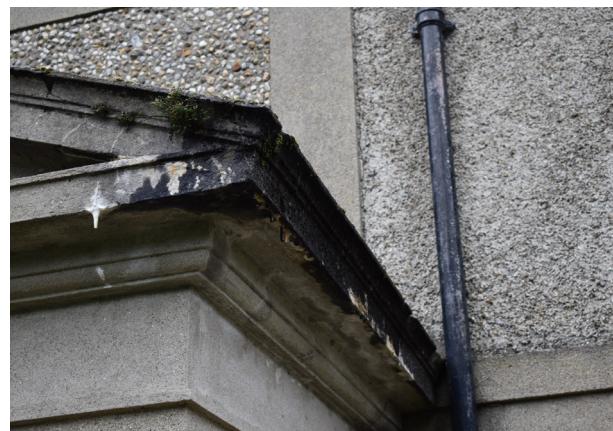
The roof of the eastern entrance porch is in poor condition. The edges of the stonework are damaged, with vegetation growth and damp staining visible. The small area of flat roof behind the pediment should be inspected and replaced with lead roofing of an appropriate grade, with flashing to stone parapets to protect from further decay.

Figure 58 - Stone work to western entrance porch. The edges of the stonework are damaged, with vegetation growth and damp staining visible

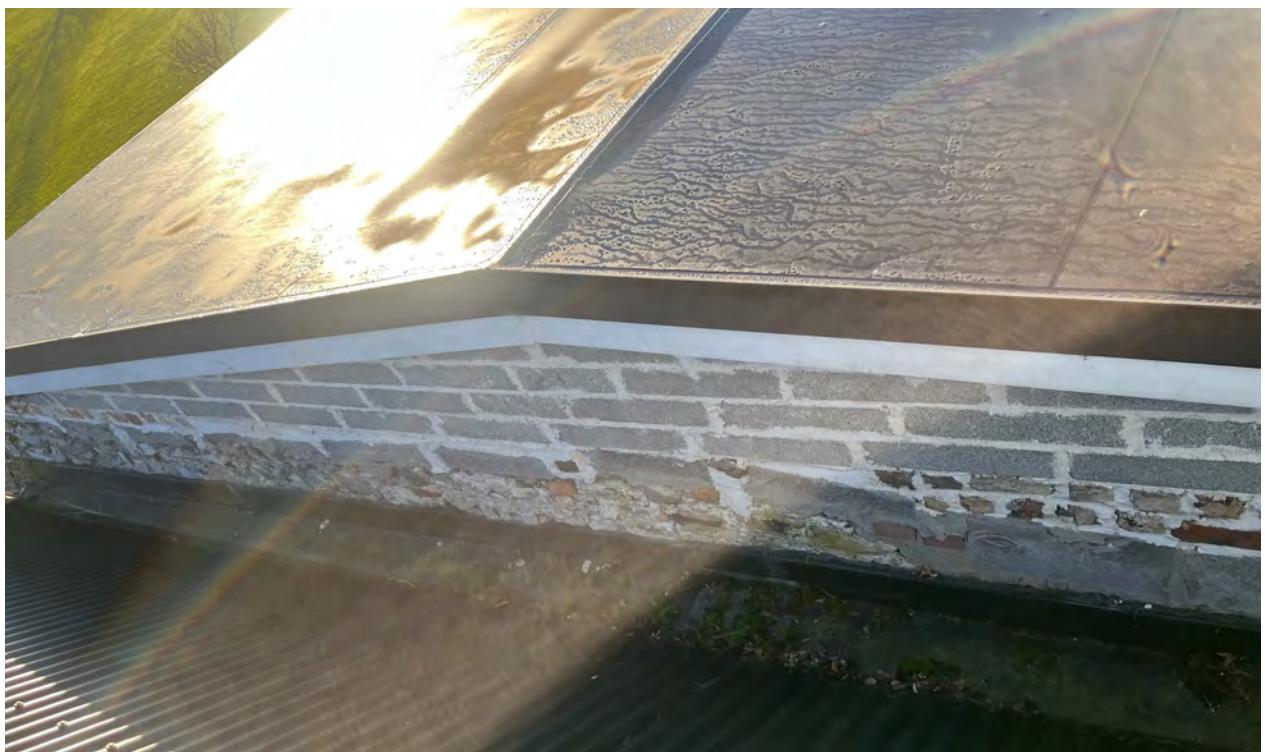
*Unrendered blockwork built upon existing brick / stone wall, form gable end of pitched roof.*

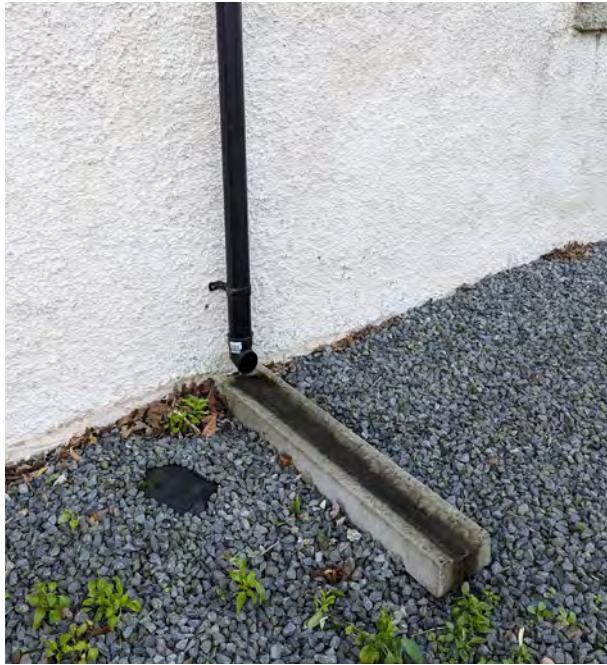
Downpipe discharging directly on to concrete channel piece perpendicular to wall.

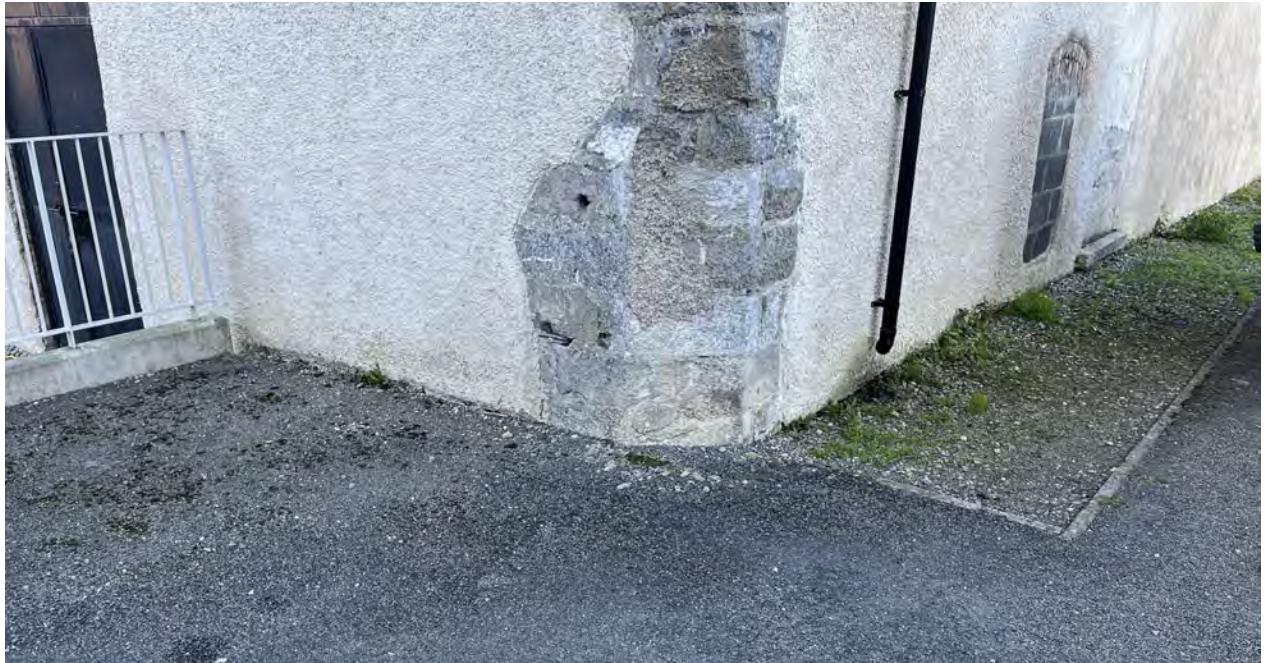
South-East corner of Cromwell's Fort. Gravel drainage channel of approx. 1m width to the base of the eastern wall. The asphalt road surface has been built up against the base of the southern wall. There is a change in level where the ground has been built up by approx 600mm at the base of the wall.

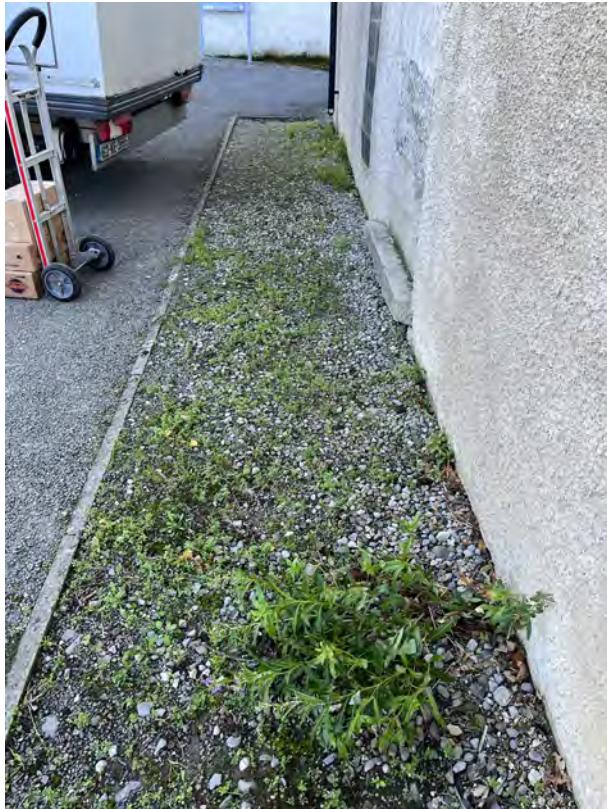
Gravel drainage channel of approx. 1m width to the base of the walls to the east facade. Vegetation growth visible.

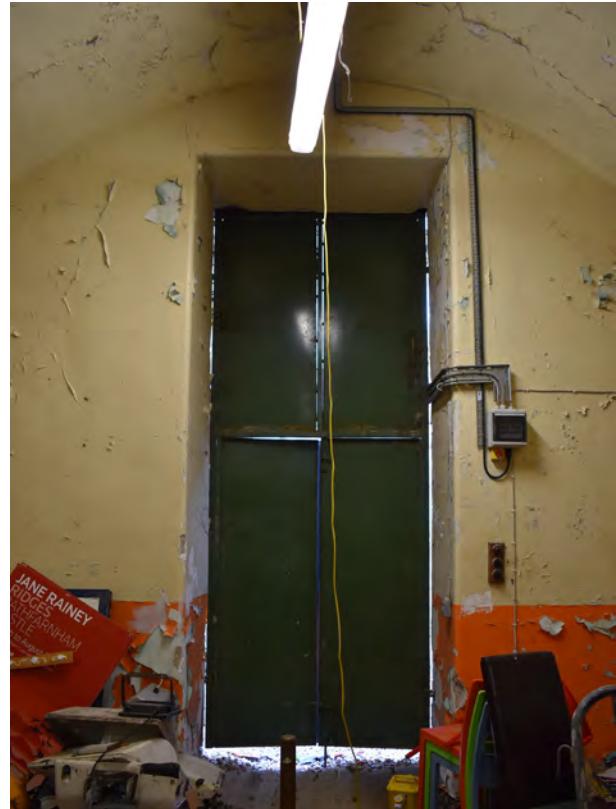
Metal doorway in the southern wall as viewed internally. Outward opening double doors and fixed panels above.

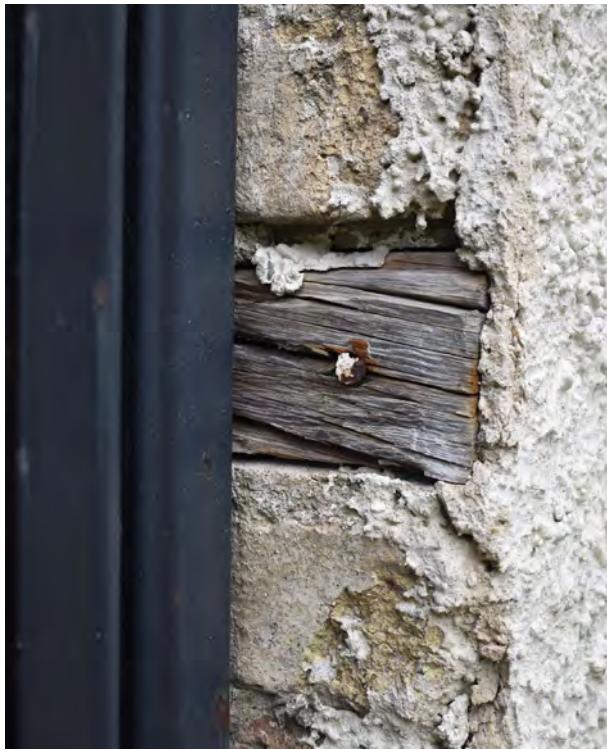
Detail of reveal to doorway in southern wall. Brick reveals with bedded timber fixings. Reveals are not rendered.

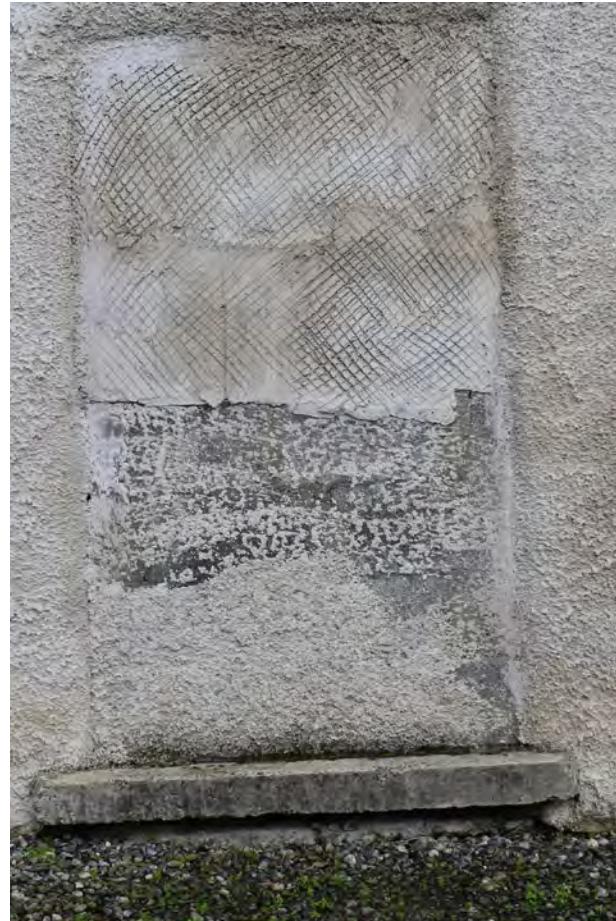
Ope 12, blockwork infill, partially rendered. Concrete cill.

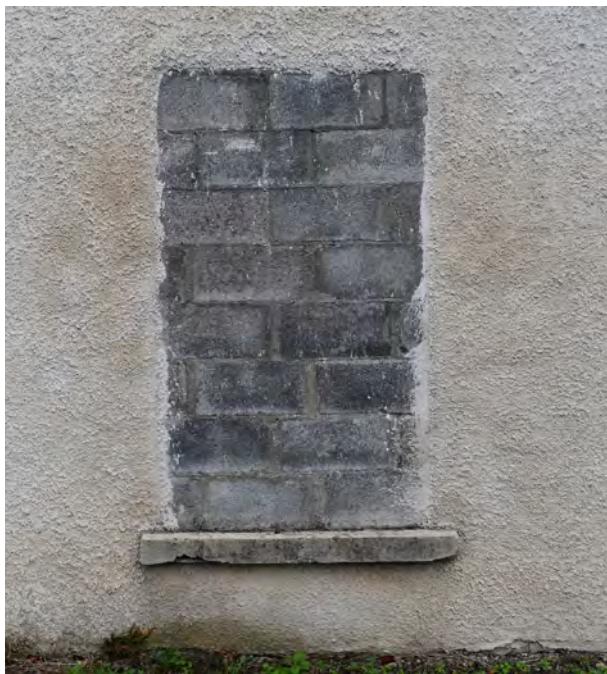
Ope 2, blockwork infill unrendered. Damage to concrete cill.

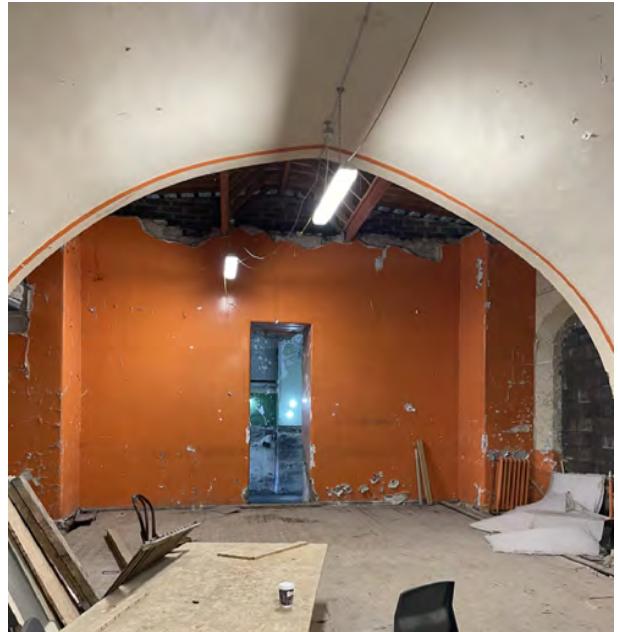
*Barrel vaulted ceiling to interior of Cromwell's Fort, looking north.*

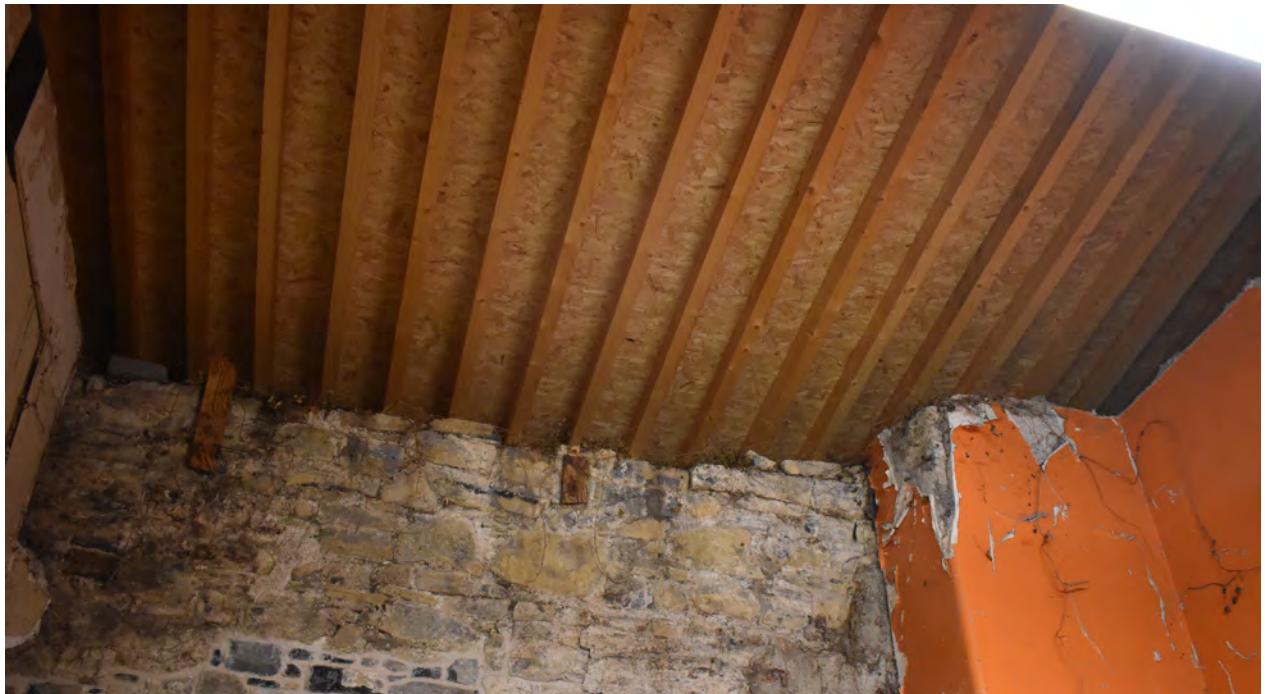
*Modern timber roof structure and roof deck visible.*

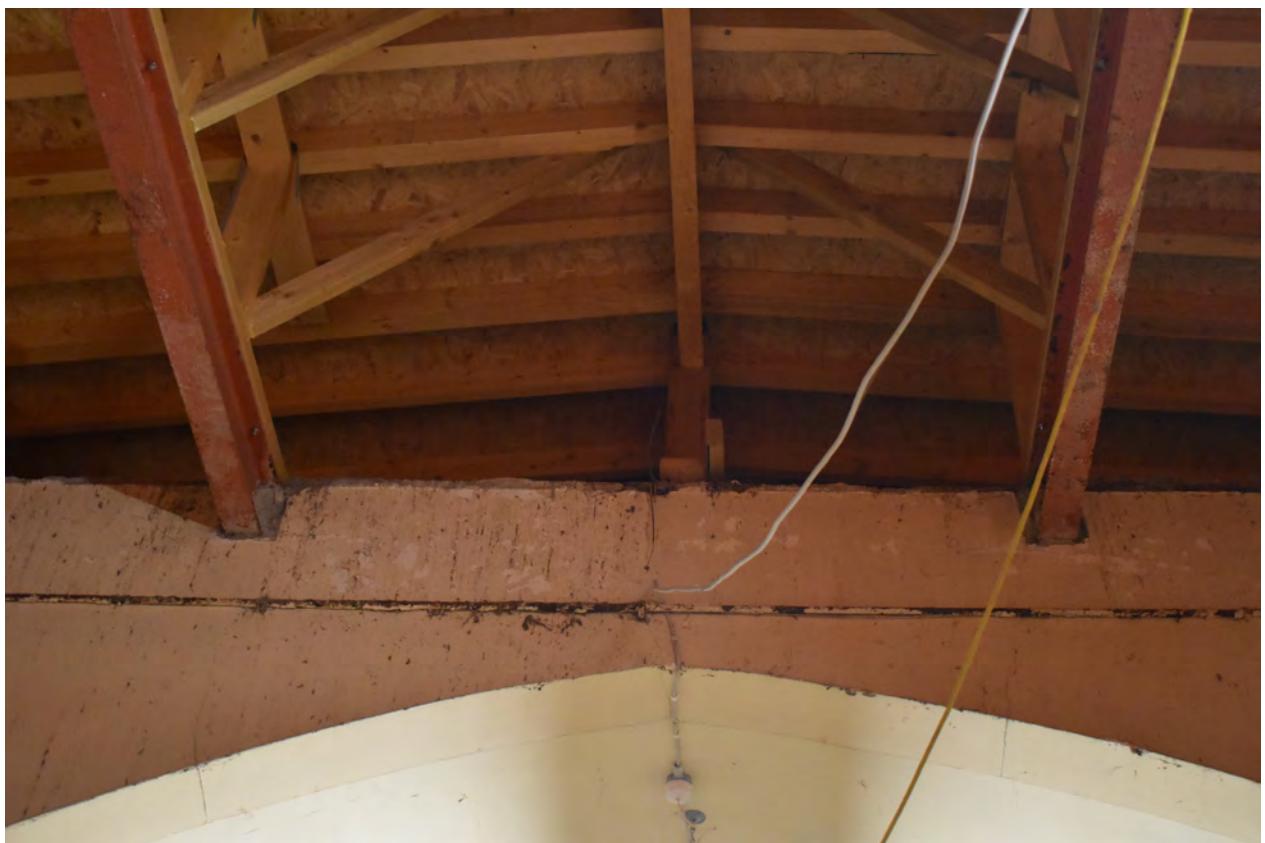
*Timber roof structure supported by steel beams. Continues above the vaulted structure.*

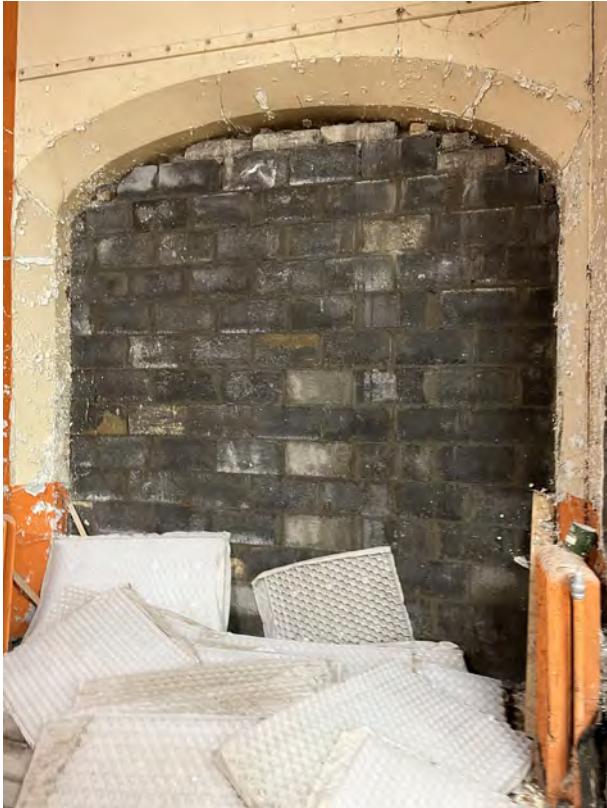
Ope 1 Exposed blockwork to former window ope in eastern wall.

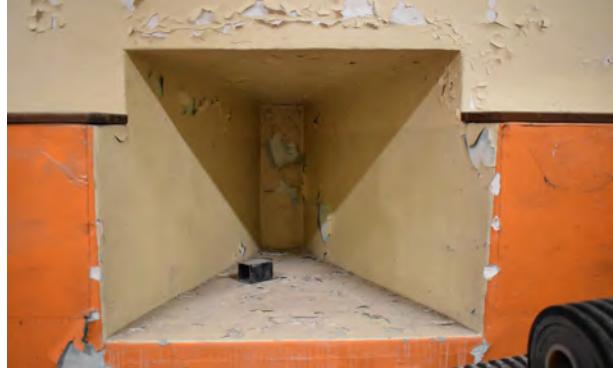
Ope 3 Former opening in eastern wall, plastered and painted. There is no corresponding opening visible externally.

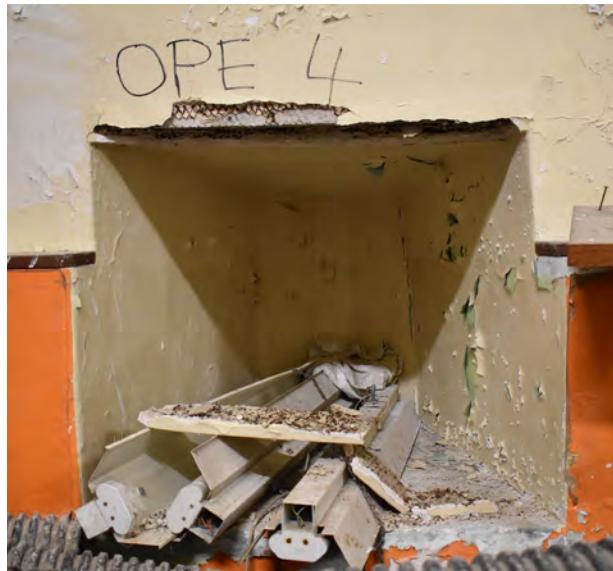
Ope 4 Former opening in eastern wall, plastered and painted. There is no corresponding opening visible externally.

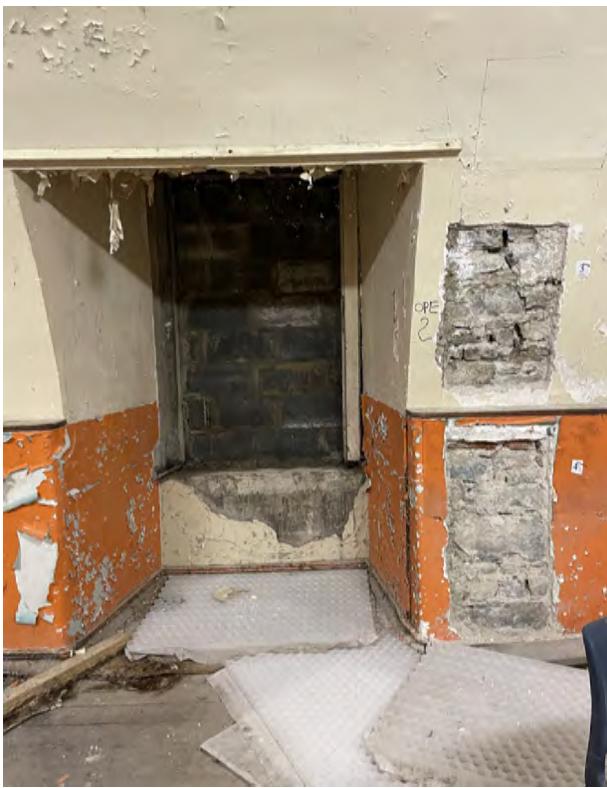
Ope 2 Exposed blockwork to former window ope in eastern wall.

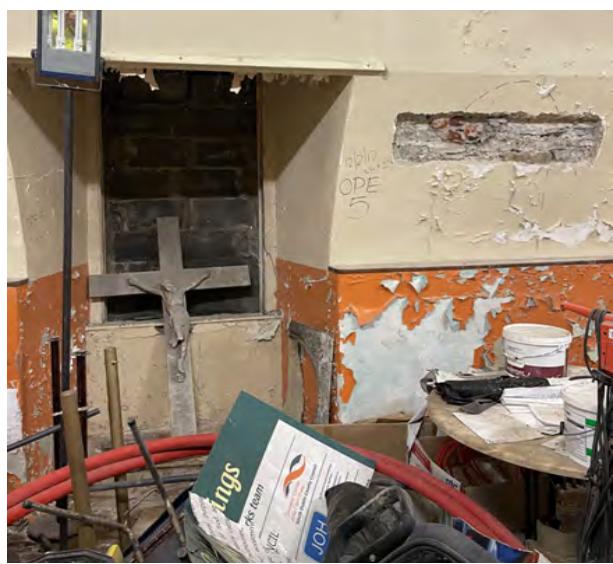
Ope 5: Exposed blockwork to former window ope in eastern wall.

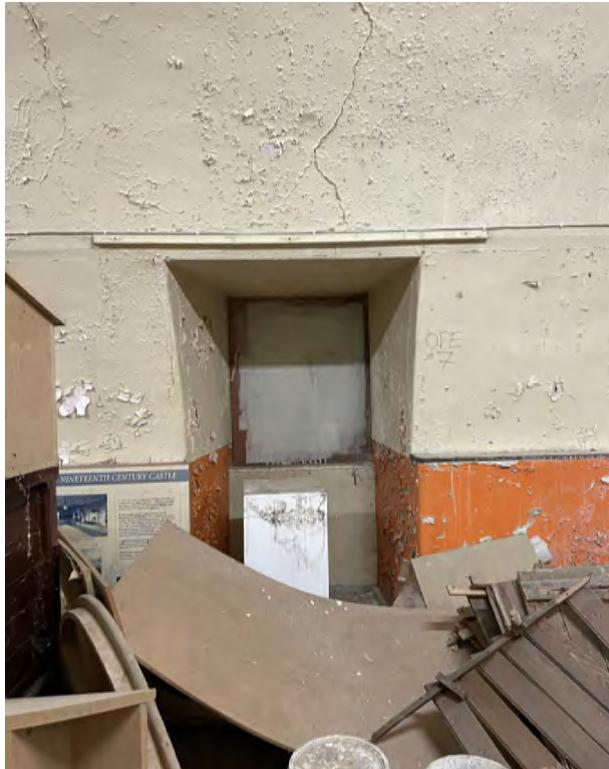
Ope 7: Opening concealed with plywood.

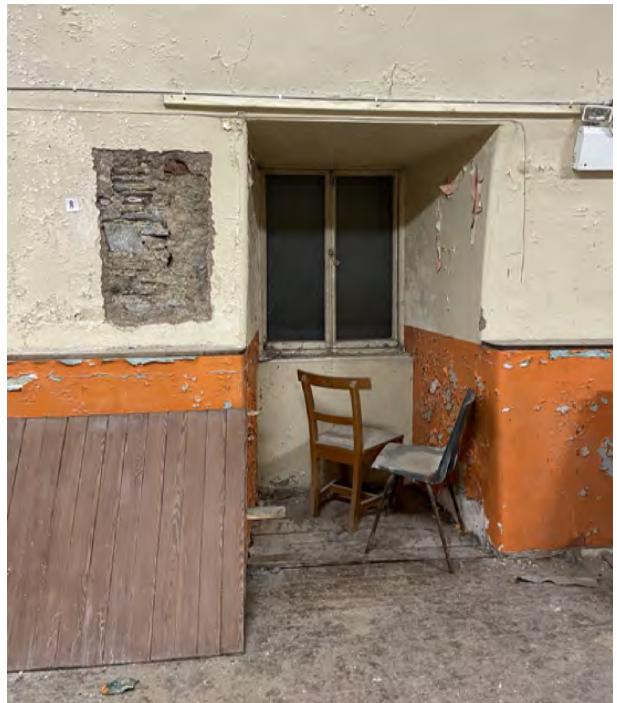
Ope 9: Timber framed window, opaque glass.

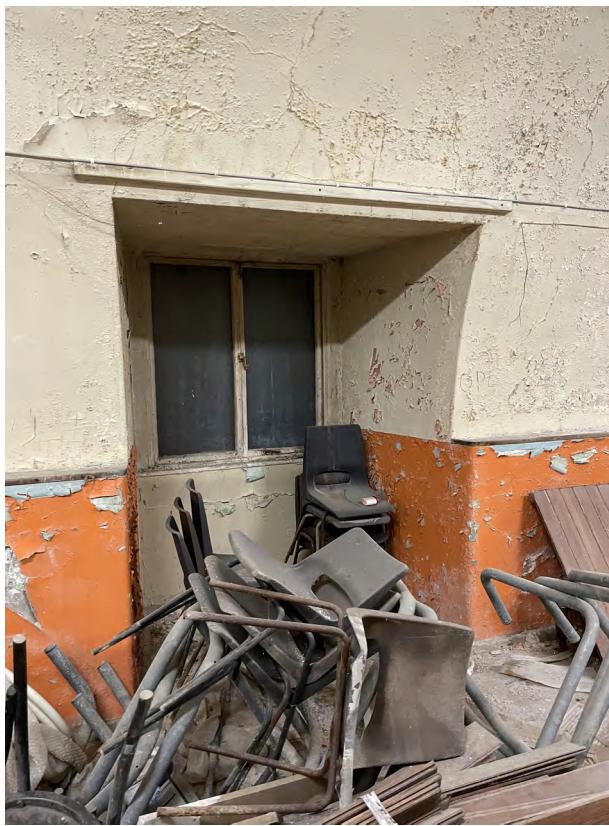
Ope 8: Timber framed window, opaque glass.

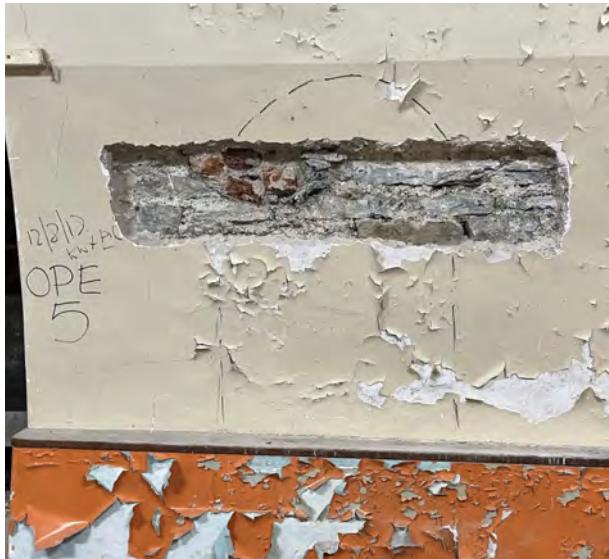
Previous investigations adjacent to Ope 5. Location corresponding with blind ope visible externally (Ope 12). The location of a corresponding internal ope was found to be inconclusive.

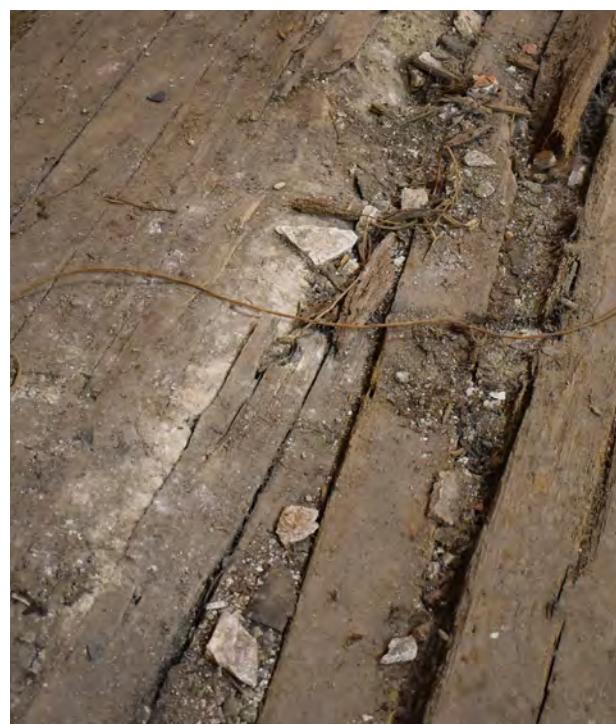
*Damage to floorboards in north-west corner of Room 1 above likely services route to nearby radiators.*

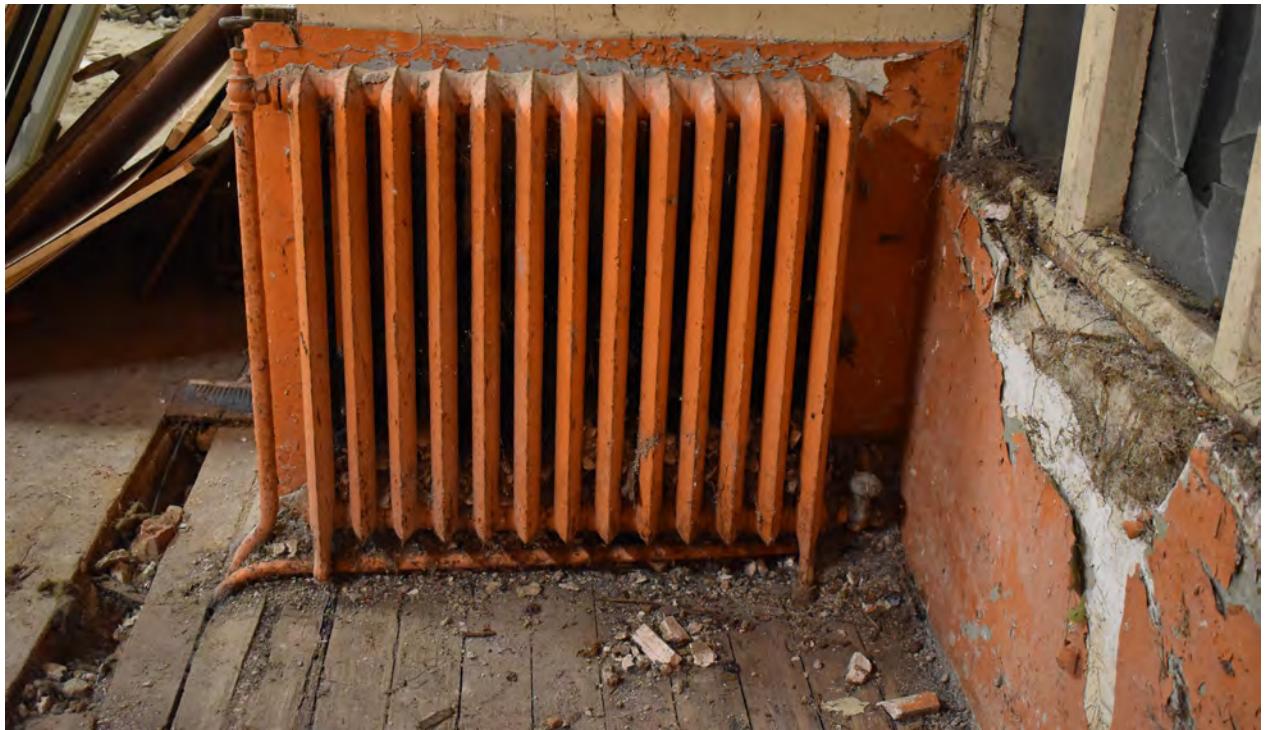
*Cast iron radiators and associated pipework run along the perimeter of the external walls.*

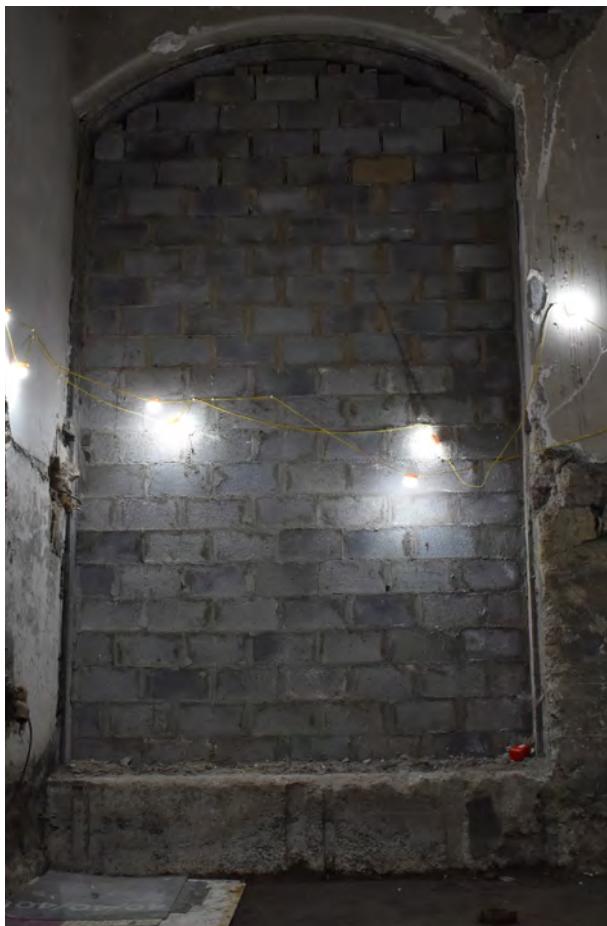
Ope 13 - 2 storey arched opening, blockwork infill.

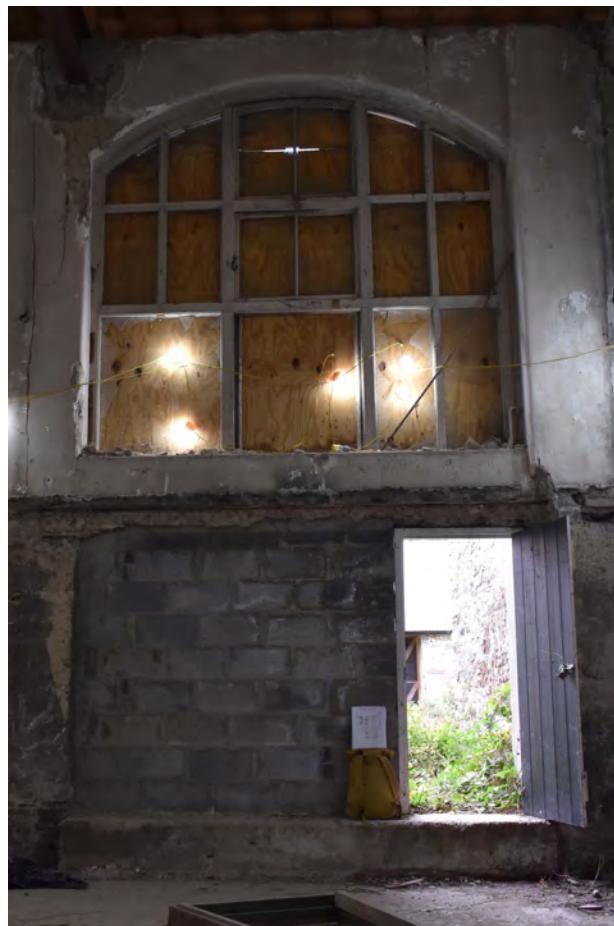
Ope 14 - (A) Multi-pane timber casement window, pivot-hinged opening sections. Some broken opaque glass remains. (B) Timber panelled door & frame provides access. Remaining ope infilled with blockwork.

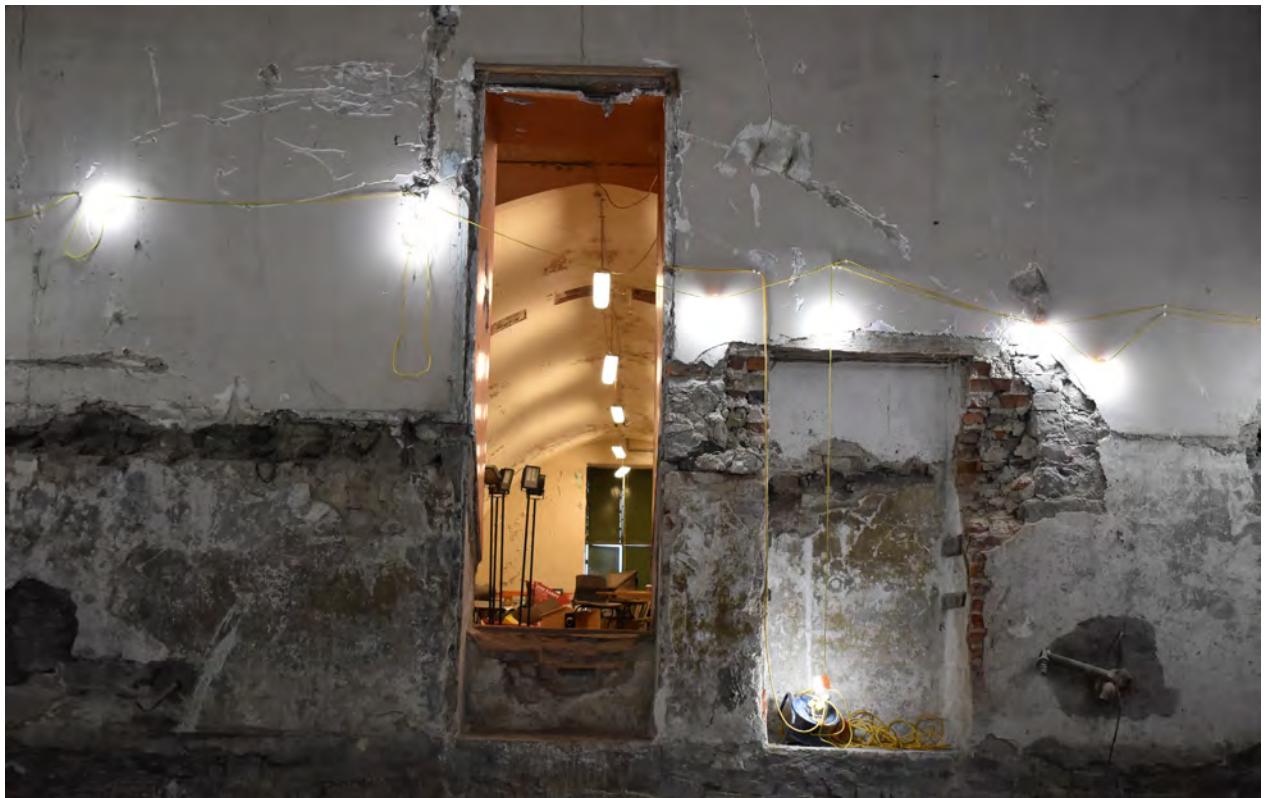
Doorway Linking Room 1 and Room 2, and blind ope / niche to the right.

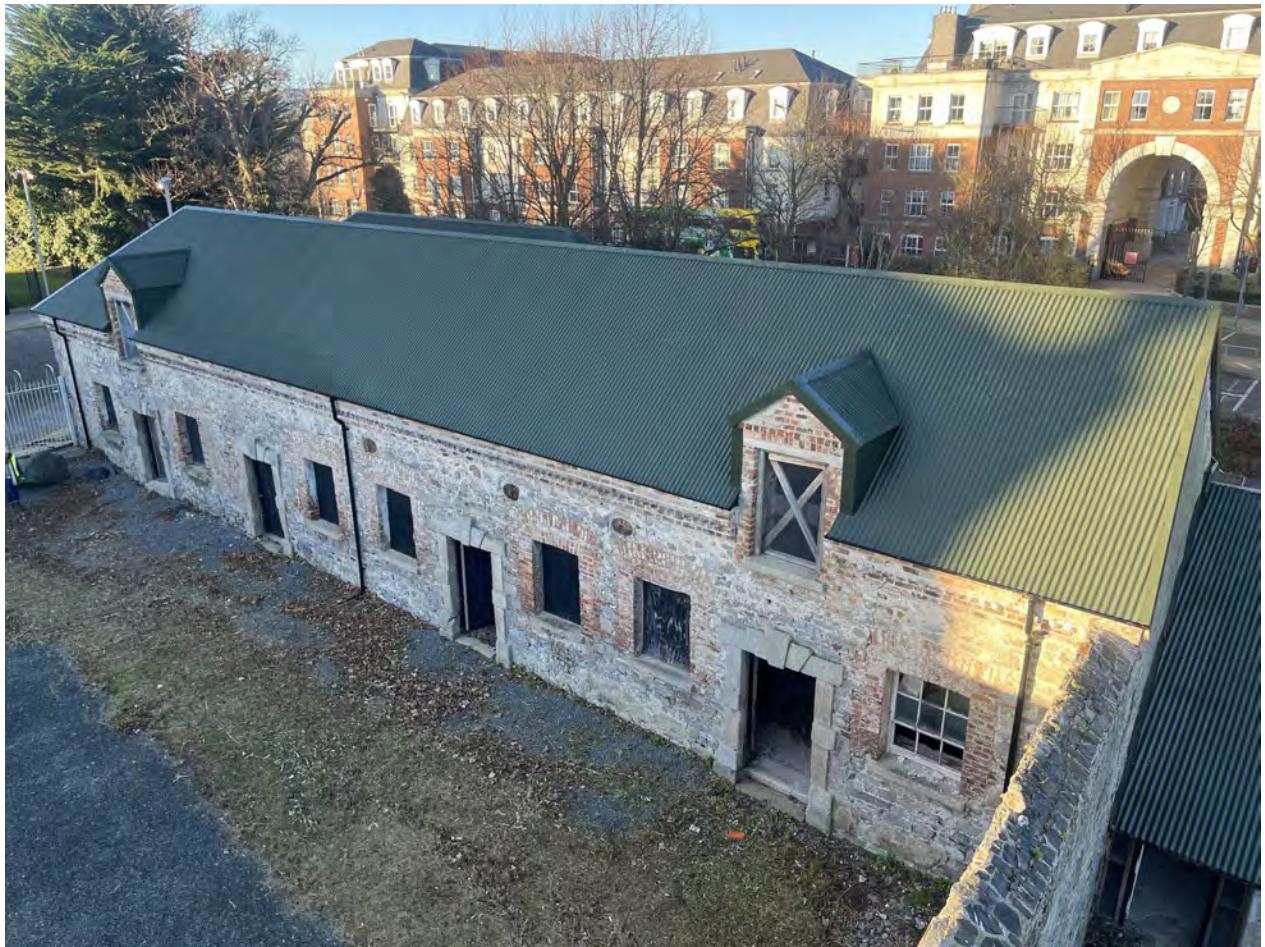
*East Facade of Building 2, as seen from above, cap stone construction and brick detailing. The building has one of the more*

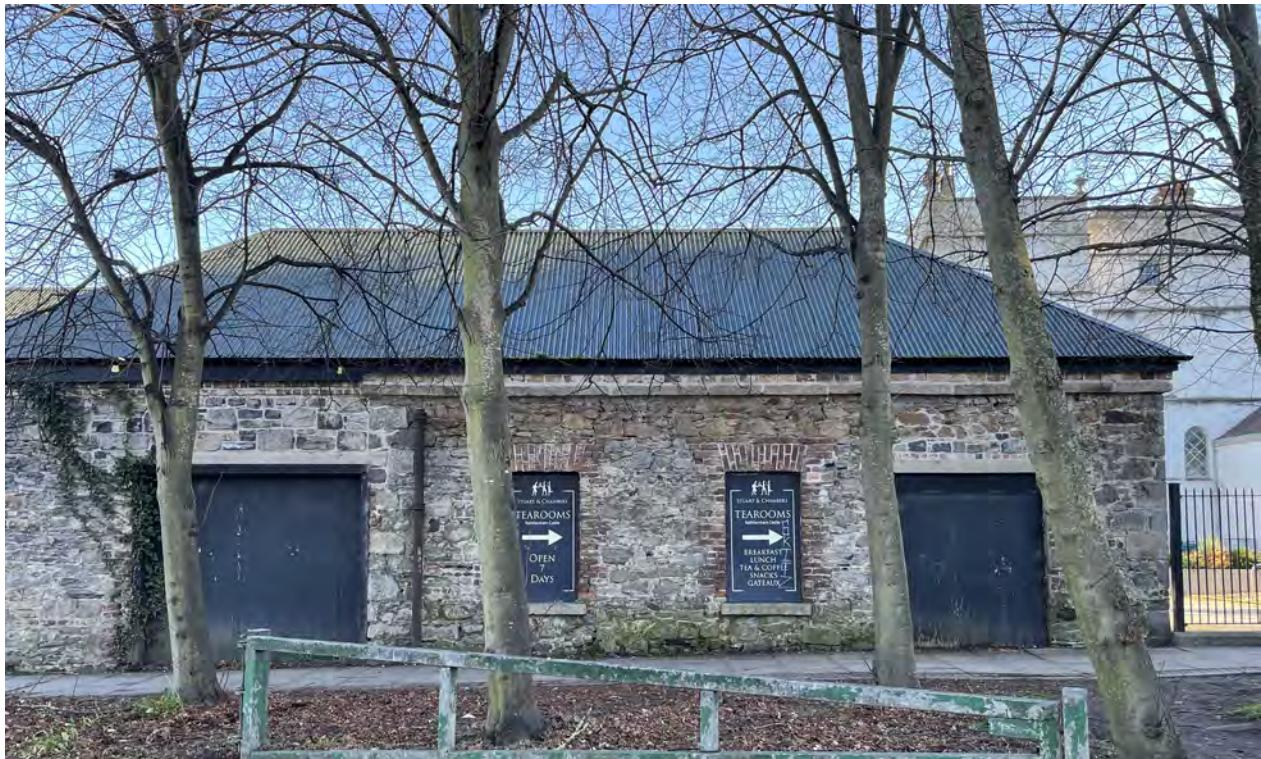
Exterior Building 2, West Range as seen from Rathfarnham Road
