# Stables and Courtyards at Rathfarnham Castle

Conservation Management Plan

30th April 2025

RATHFARNHAM CASTLE, CO. DUBLIN. 11551. W.L.

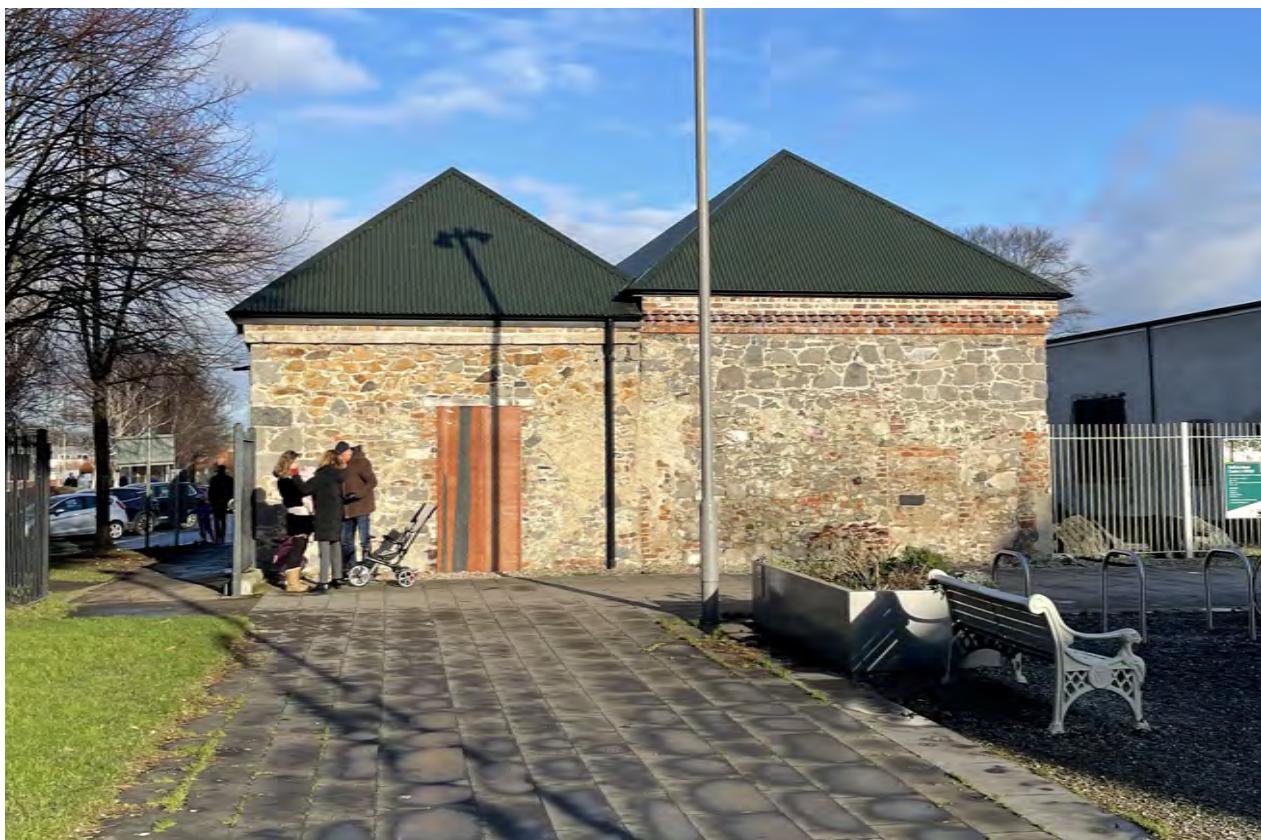
Exterior Building 2, south elevation.

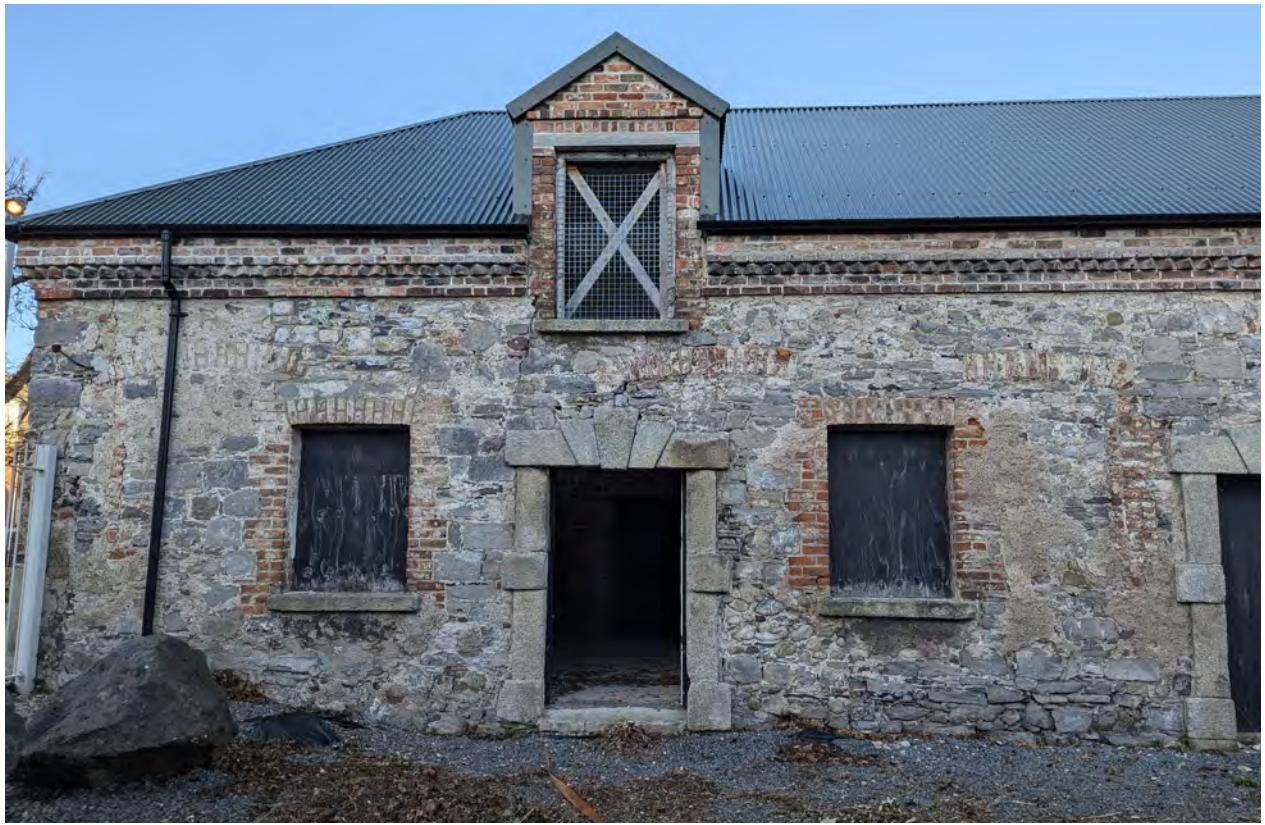
*East Elevation, view from Courtyard 1. Dormer roof above entrance to 2.1*

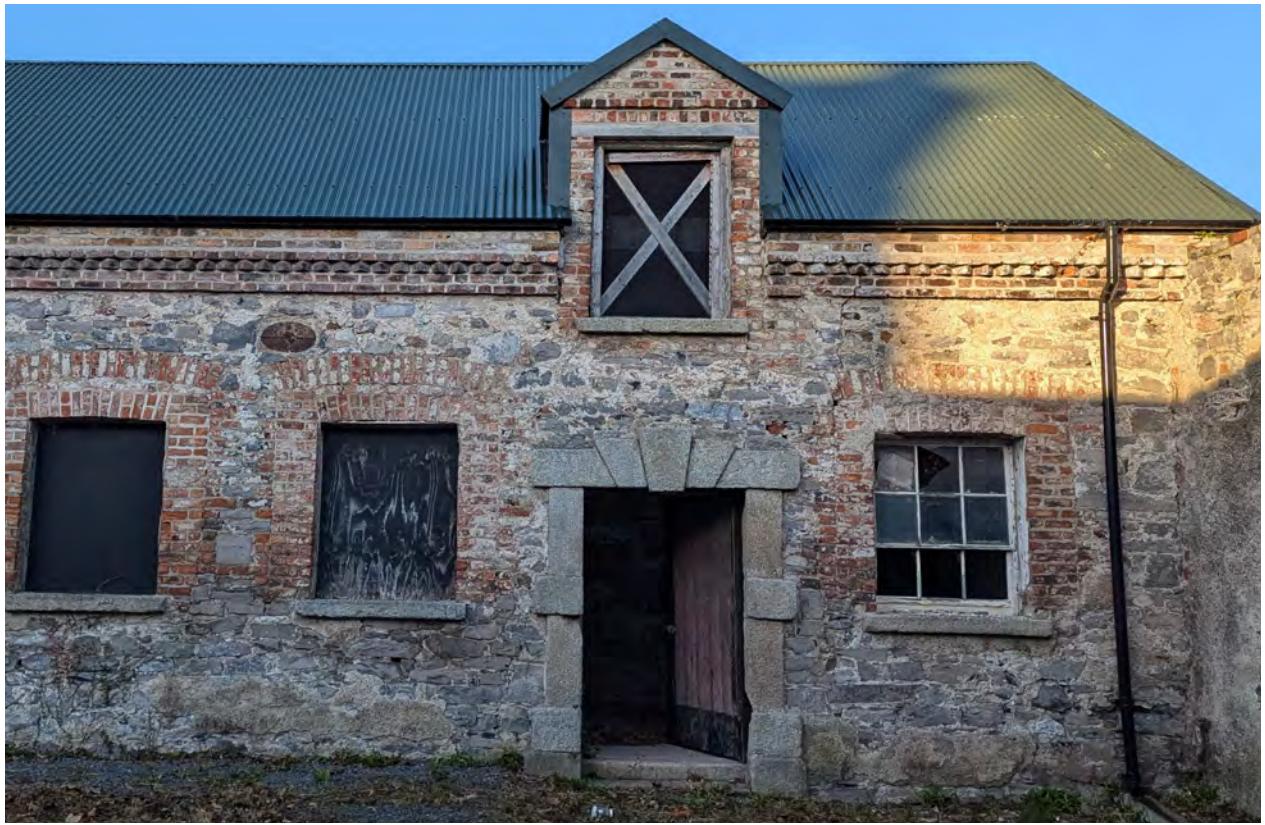
*East Elevation, Dormer roof above entrance to 2.7*

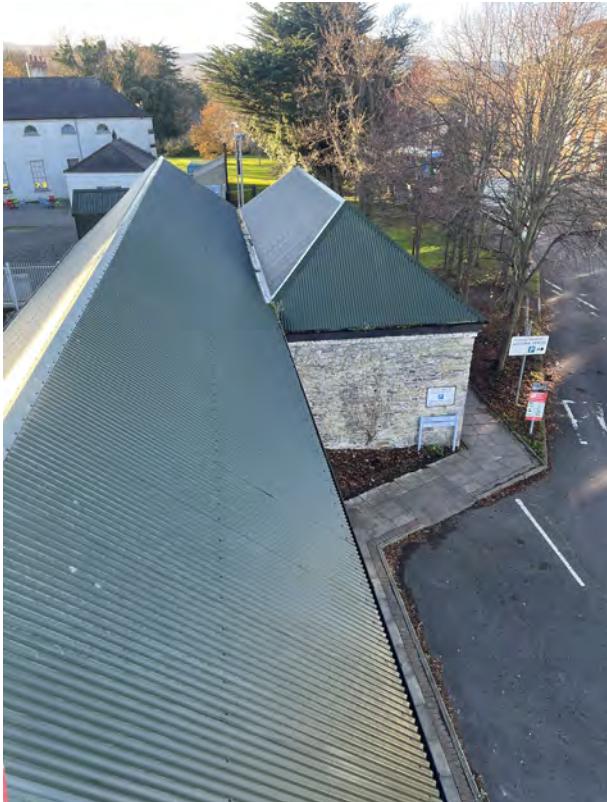
*Roof of Building 2.*

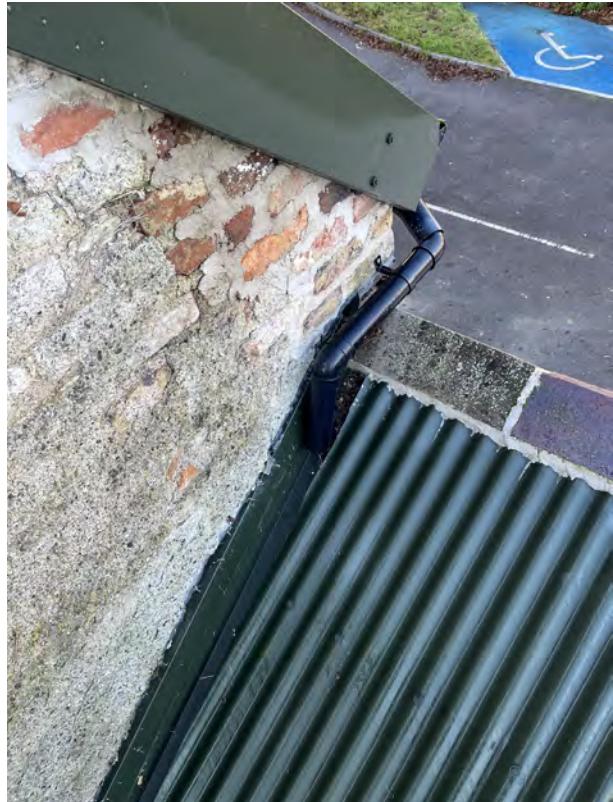
*Downpipe discharging from Building 2 on to roof of Building 6*

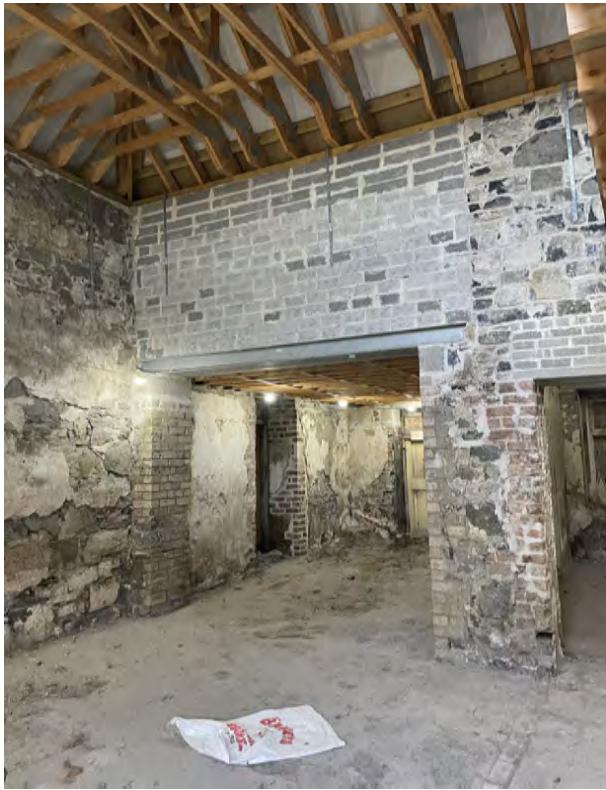
*Recently installed steel lintol with concrete blockwork to wall top above opening between 2.1 and 2.2*

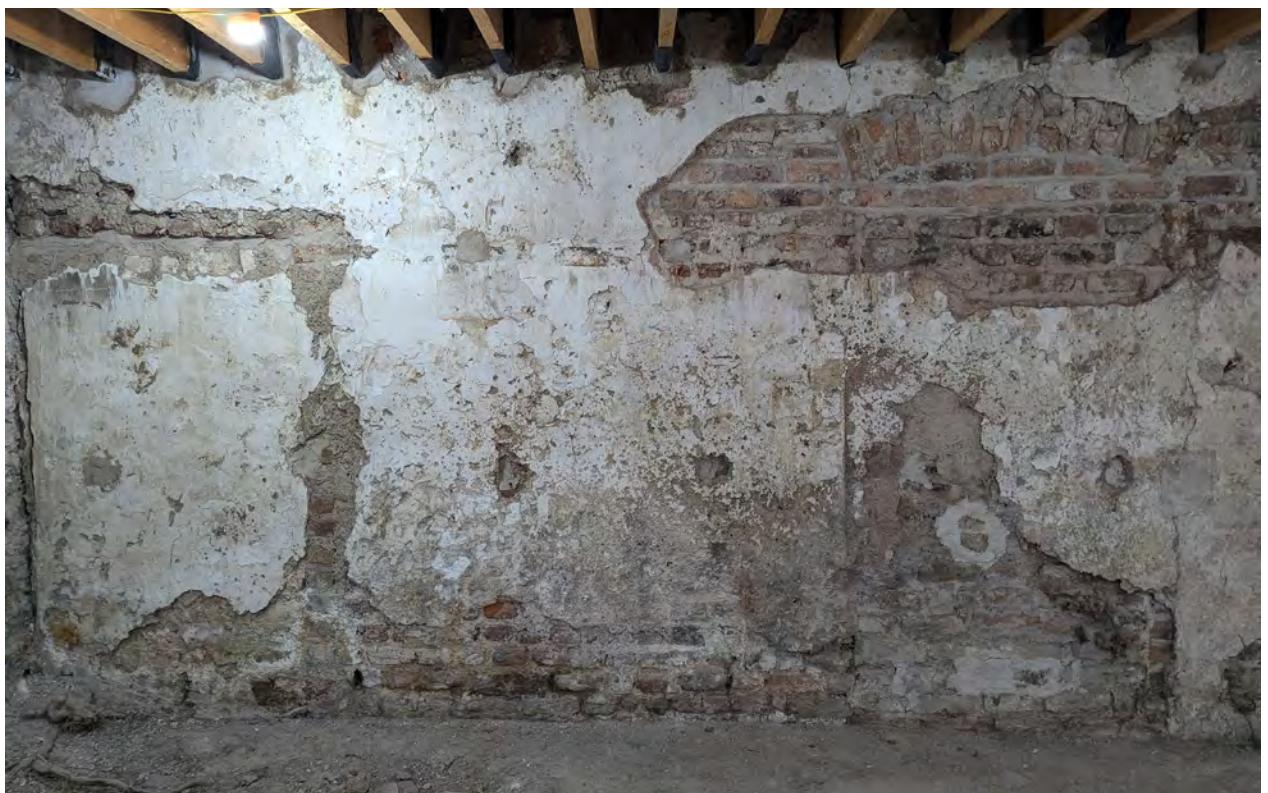
Previous openings in wall between 2.2 and 2.3 partially visible, infilled with brickwork and finished with lime plaster.

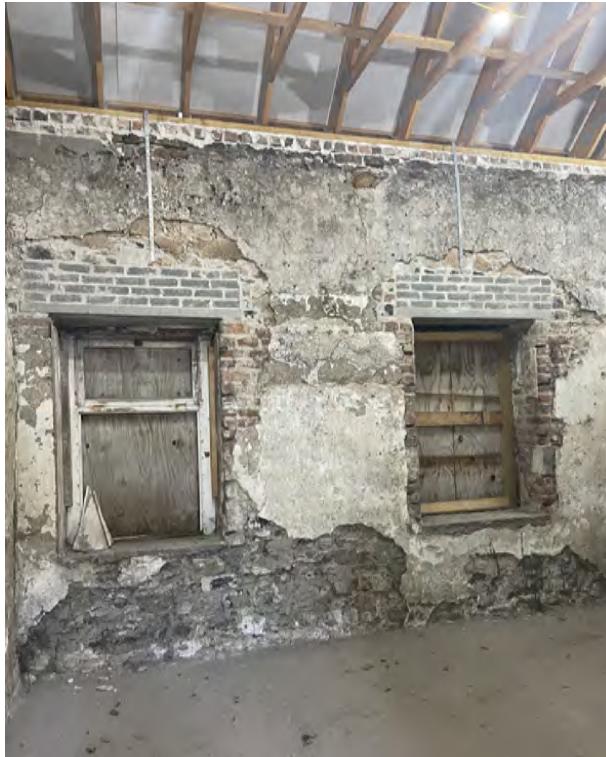
Window ope in room 2.3. New concrete lintels and blockwork have been installed above. A course of brickwork has been added to the tops of the walls to take the wallplate of the new timber structure.

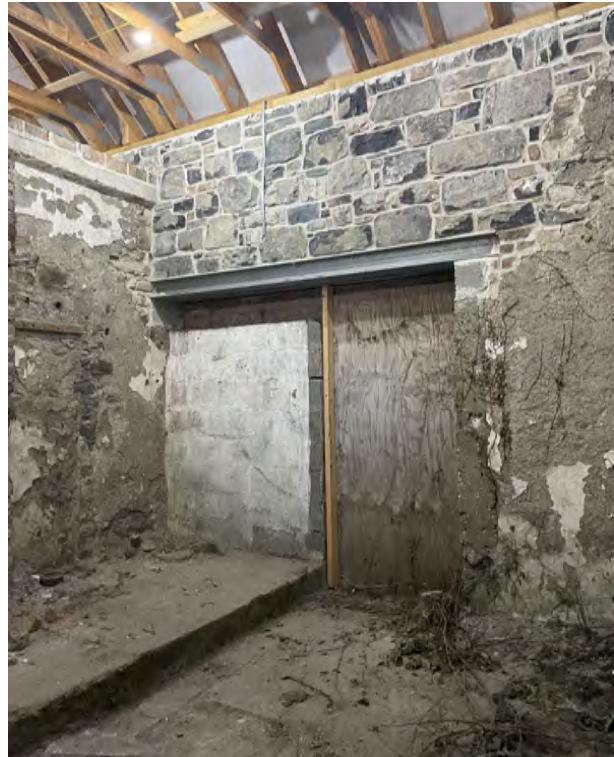
Doorway to 2.4 (leading to Rathfarnham Road). New steel lintel and cap limestone built to wall top.

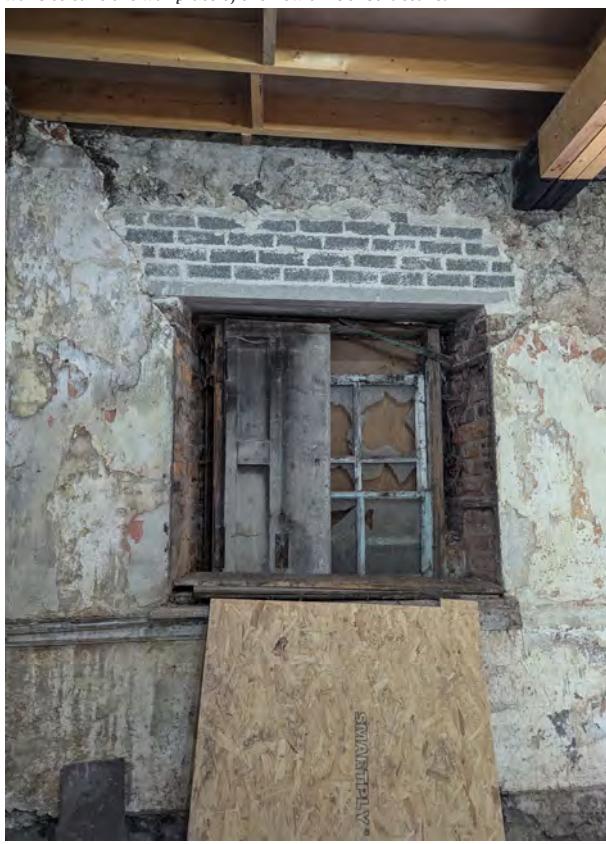
Window joinery including 6 over 3 sash window and shutters stored within the existing ope. Concrete lintol and blockwork over. Textured obscure glass remains, mostly broken.

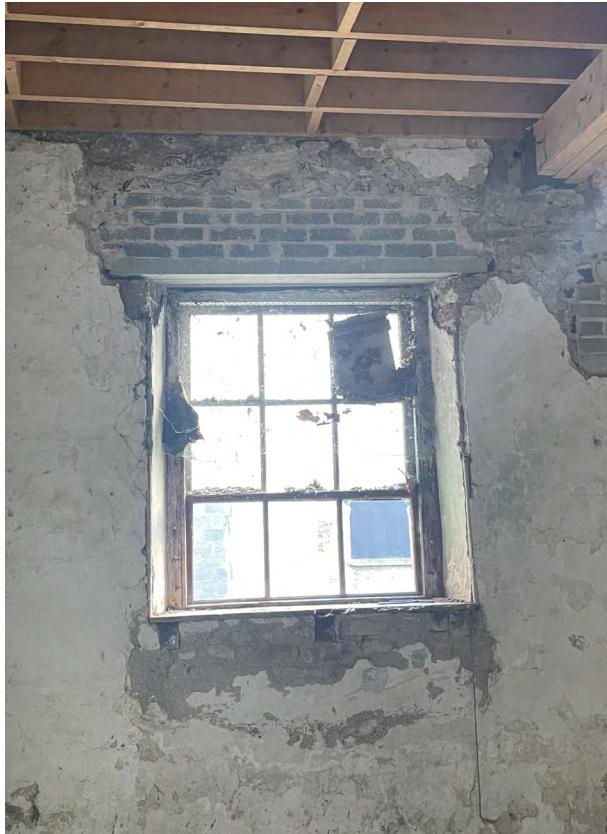
6 over 3 timber sash window in room 2.7. Records from 2018 works report this window to be fitted with a hinge allowing the sash to pivot open.

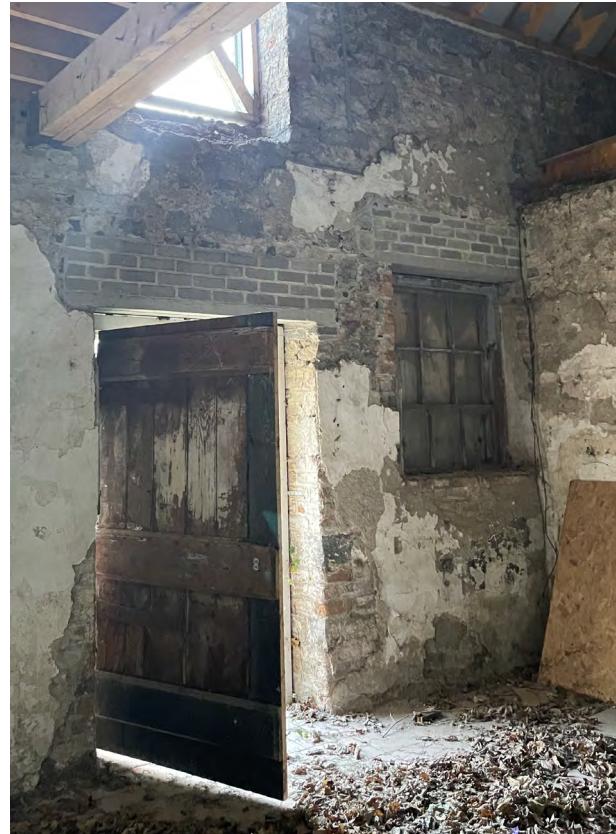
Braced and ledged door to 2.7, recently repaired. 6 over 3 timber sash window.

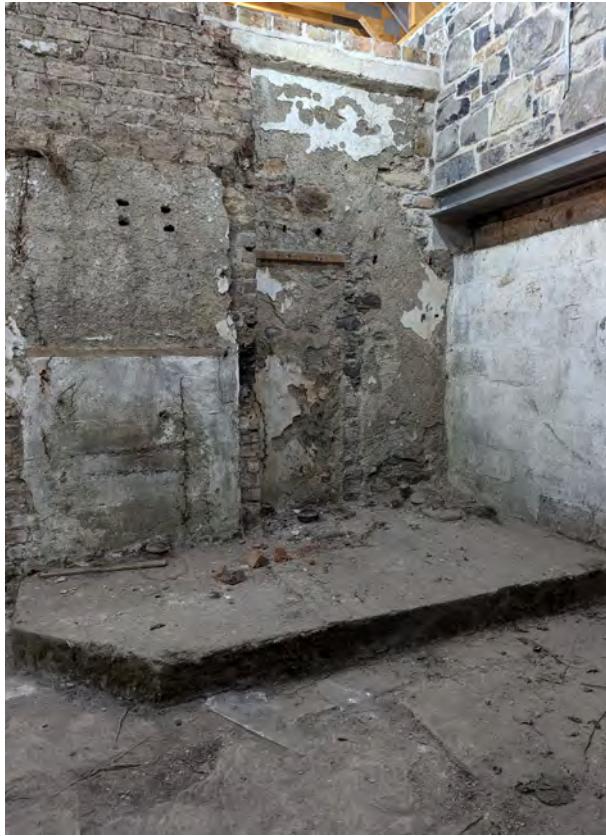
Raised concrete slab in the south-west corner of room 2.4 contains three former WC drainage pipes. These correspond to the location of a soil vent pipe externally on the West facade.

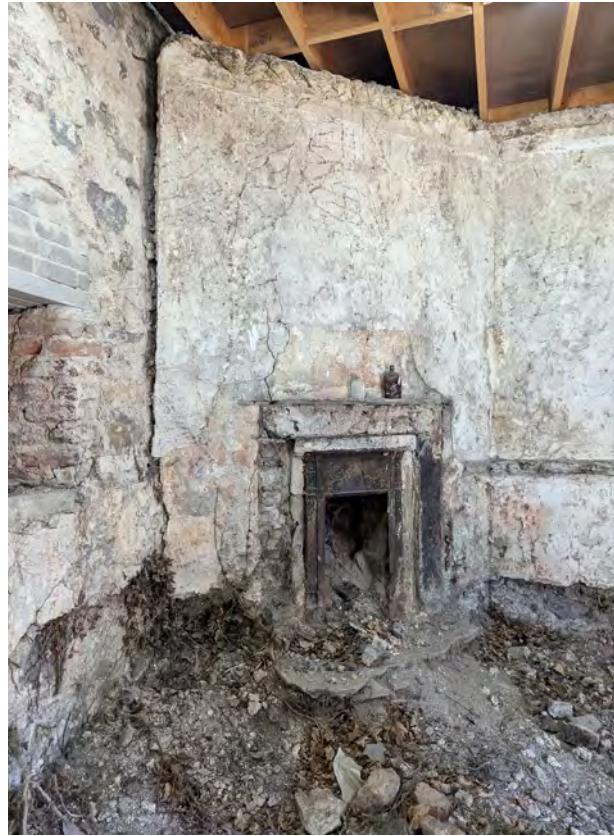
Remains of cast-iron fireplace and angled chimney breast in room 2.5. Interior plasterwork remains. Uneven ground surface consisting of rubble and loose cobbles.

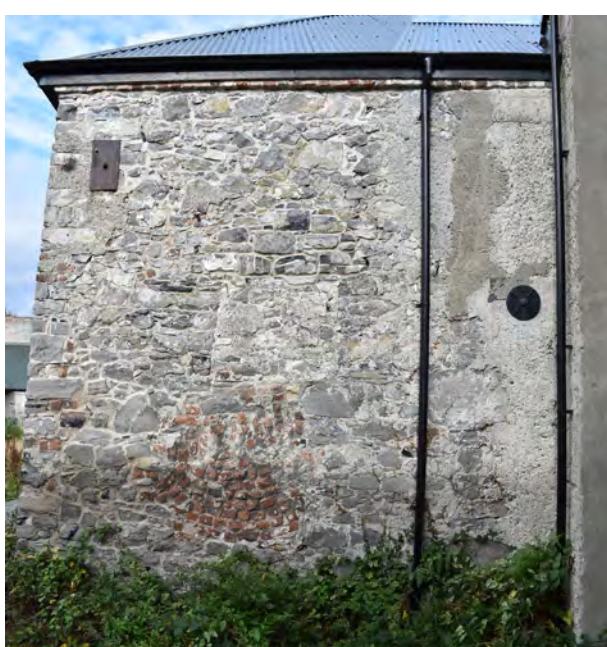
South Facade. There is an unusual brick repair in a round or circular fashion approx .5m – 1m above ground level.

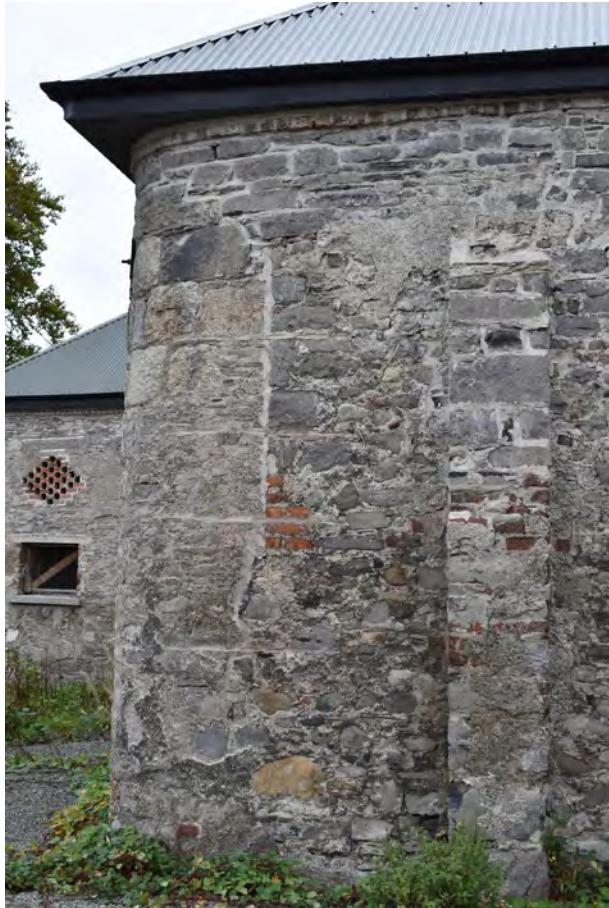
*Western gable wall, rounded corner and remains of buttress.*

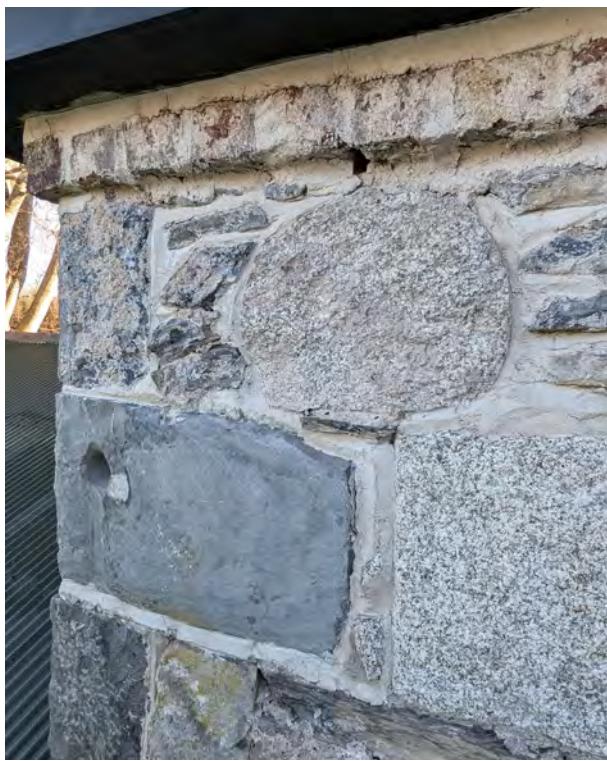
*Rounded granite stone visible in western elevation. Recent repairs to mortar visible.*

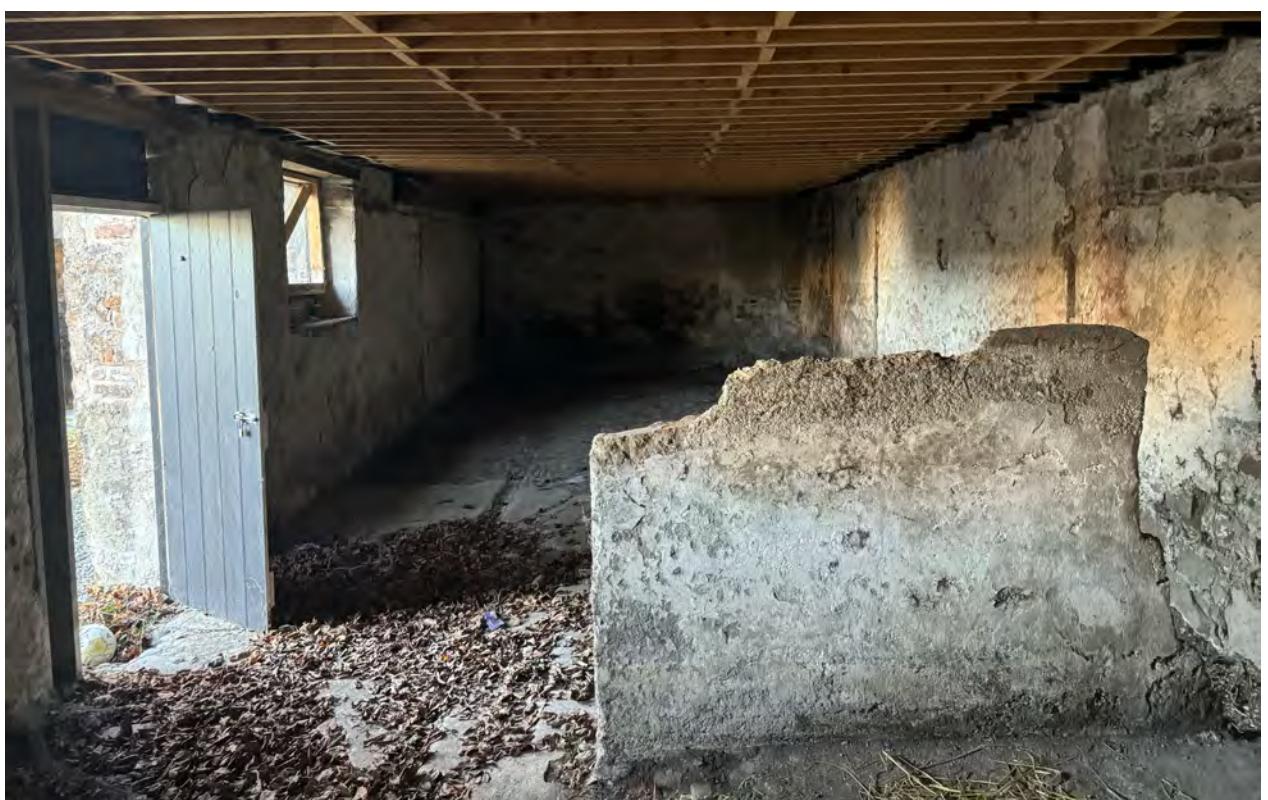
*Interior Building 3, Room 1. Low wall indicating location of former animal stalls.*

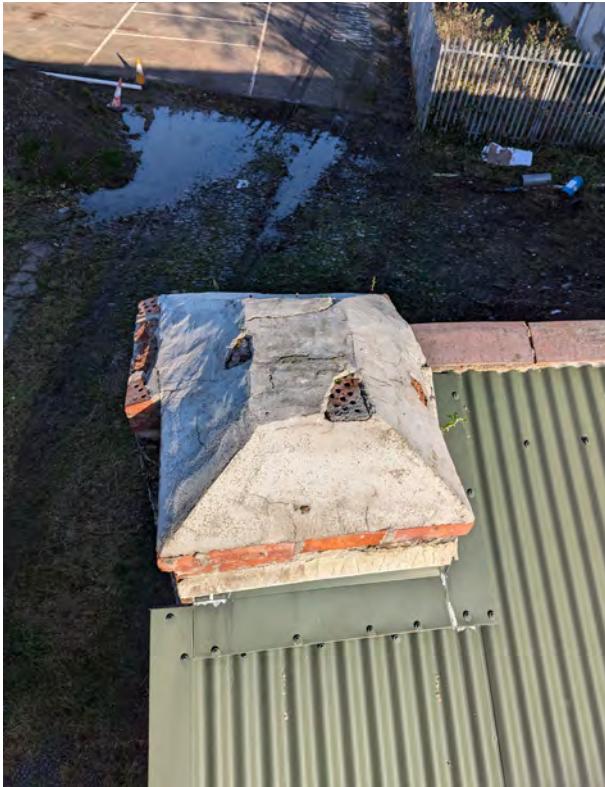
Rendered brick capping to projecting pier at west gable wall.

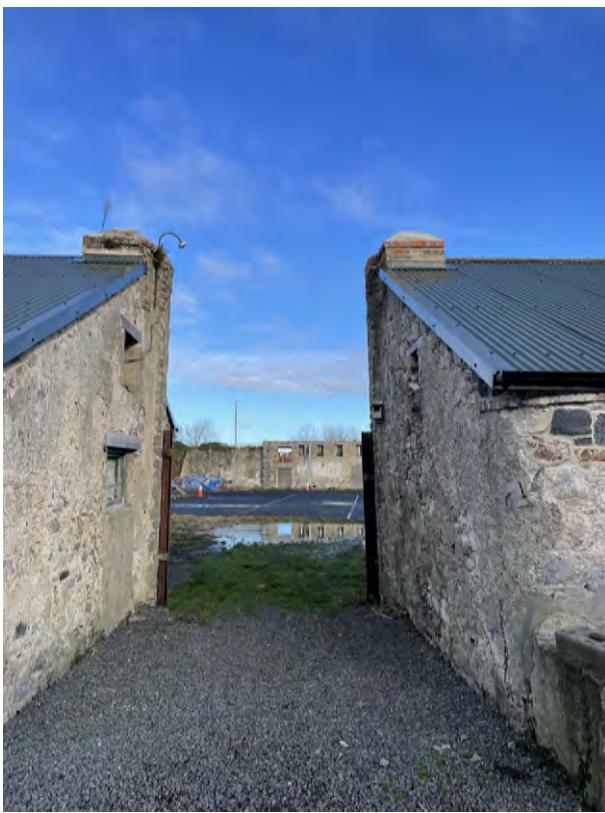
Clay ridge tiles bedded on to profiled metal roof. Maker's mark visible.

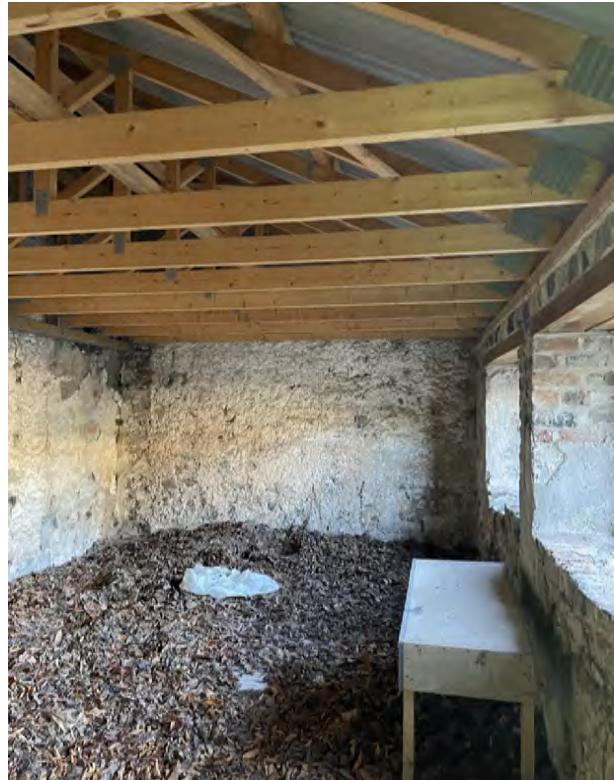
*Interior, Room 4.1. Leaf fall has built up internally entering through open doorway.*

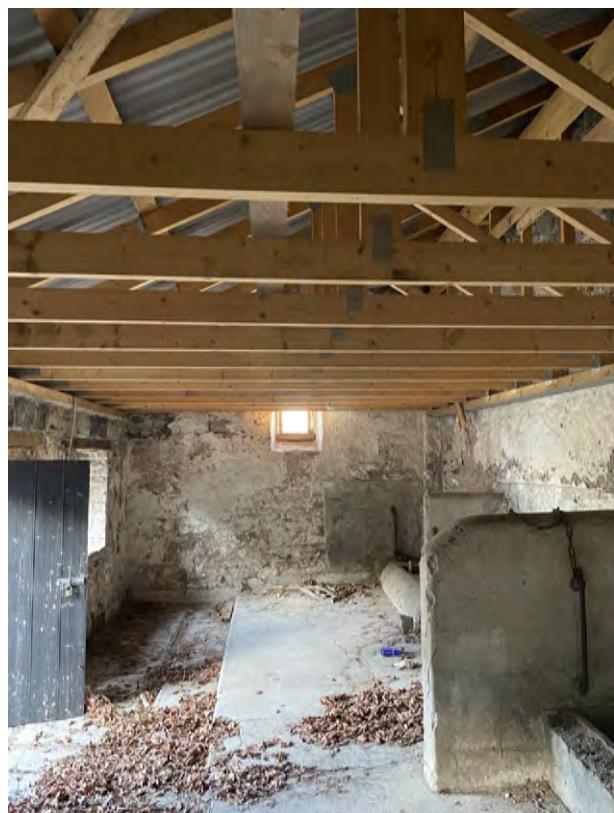
*Interior, Room 4.2. Remains of animal stalls and raised feeding troughs visible along northern wall.*

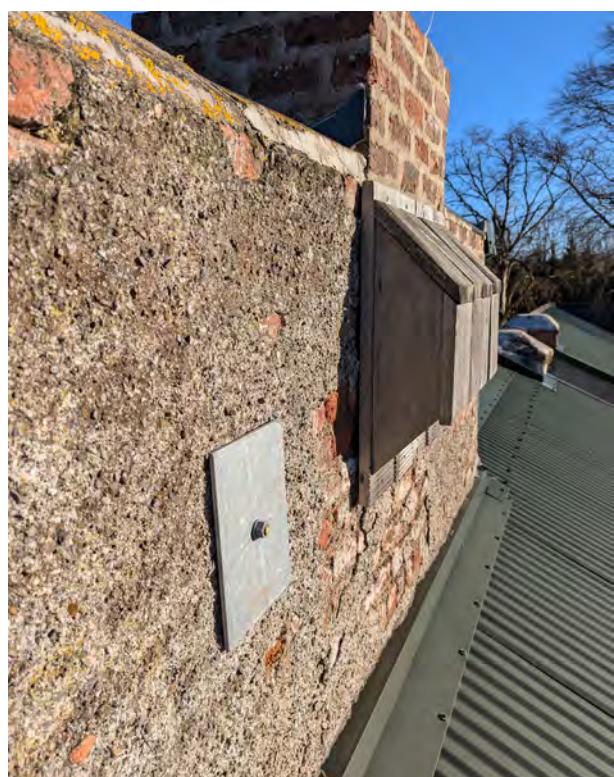
Nesting boxes positioned on shared wall between Building 5 and Building 6.

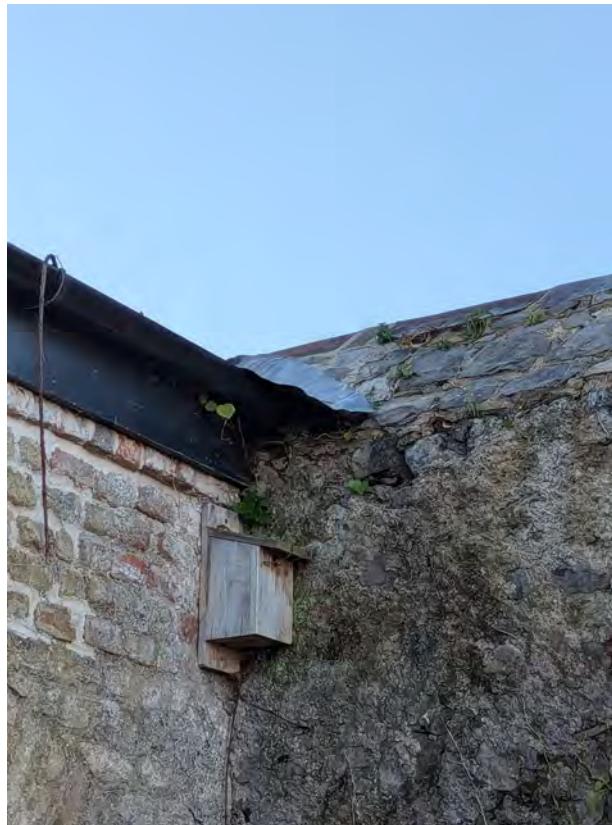
*Nesting box to junction of north wall of building 5 (A) and west perimeter wall.*

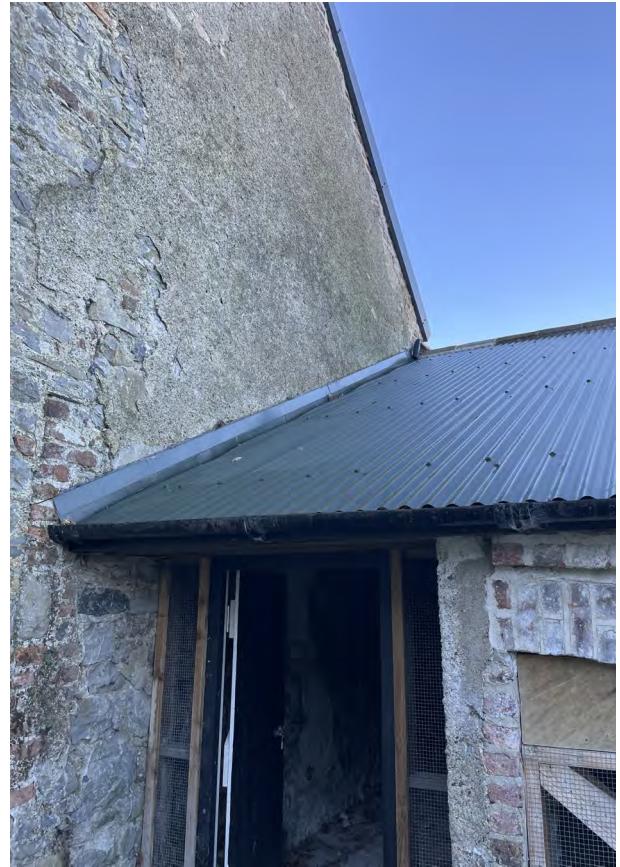
*Roof abutment at junction with Building 2, pressed metal flashings.*

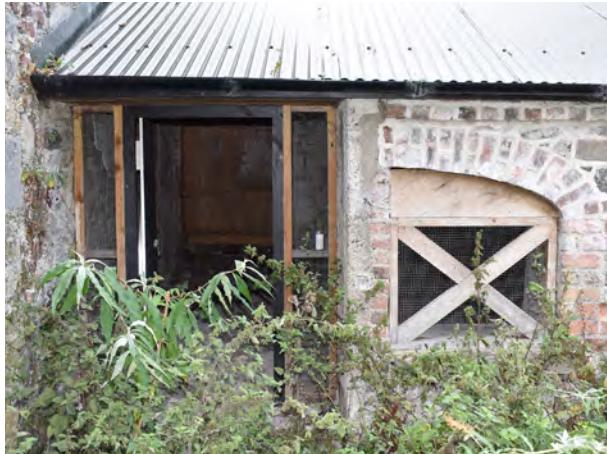
Archway partially demolished to the south of Building 6. A braced and ledged door has been fitted to one half, and a square window opening inserted into the other half.

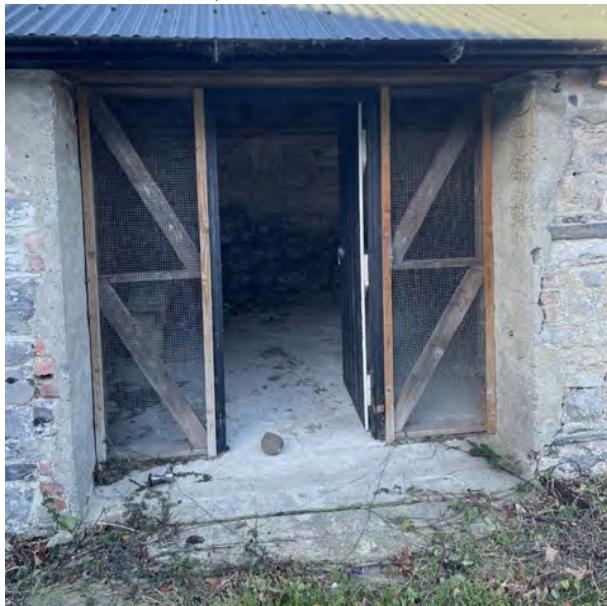
Archway completely demolished and fitted with a braced and ledged door within a mesh surround and a timber lintel. Pre-cast concrete has been installed on the approach to the doorway to create a sloping threshold.

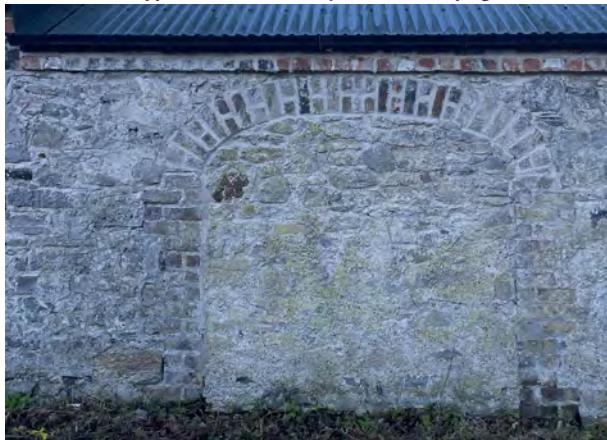
One of four blind archways which have been blocked up with random rubble stone. Partial areas of render remains.

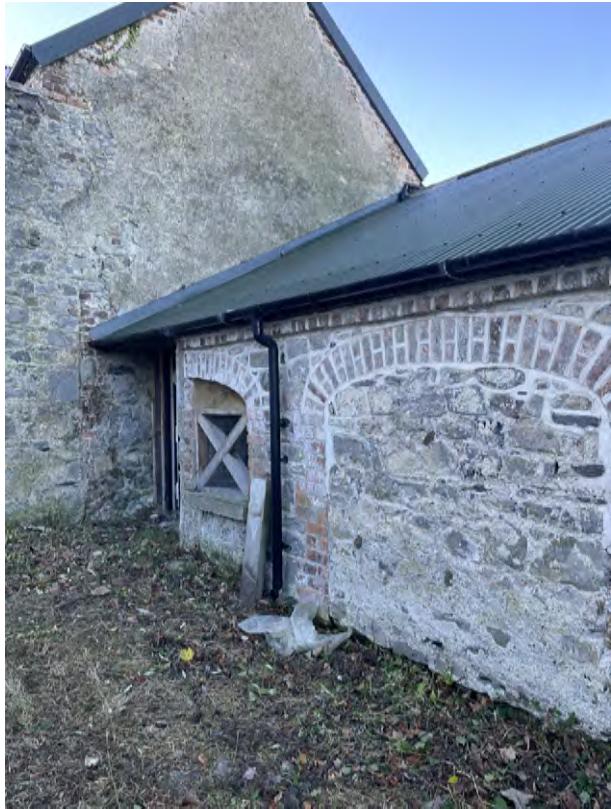
Partially demolished archway and adjacent blind archway situated to the southern end of the west range.

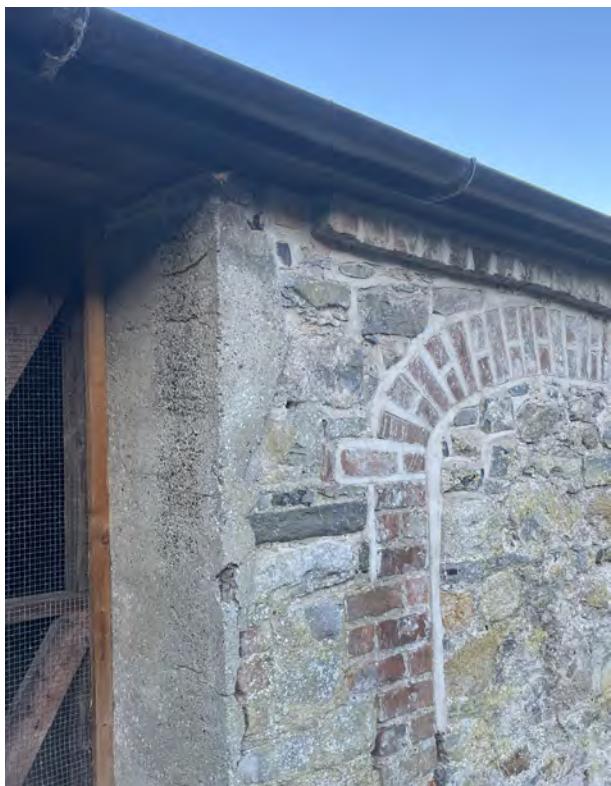
Recent repointing of mortar joints visible at brickwork and tops of walls.

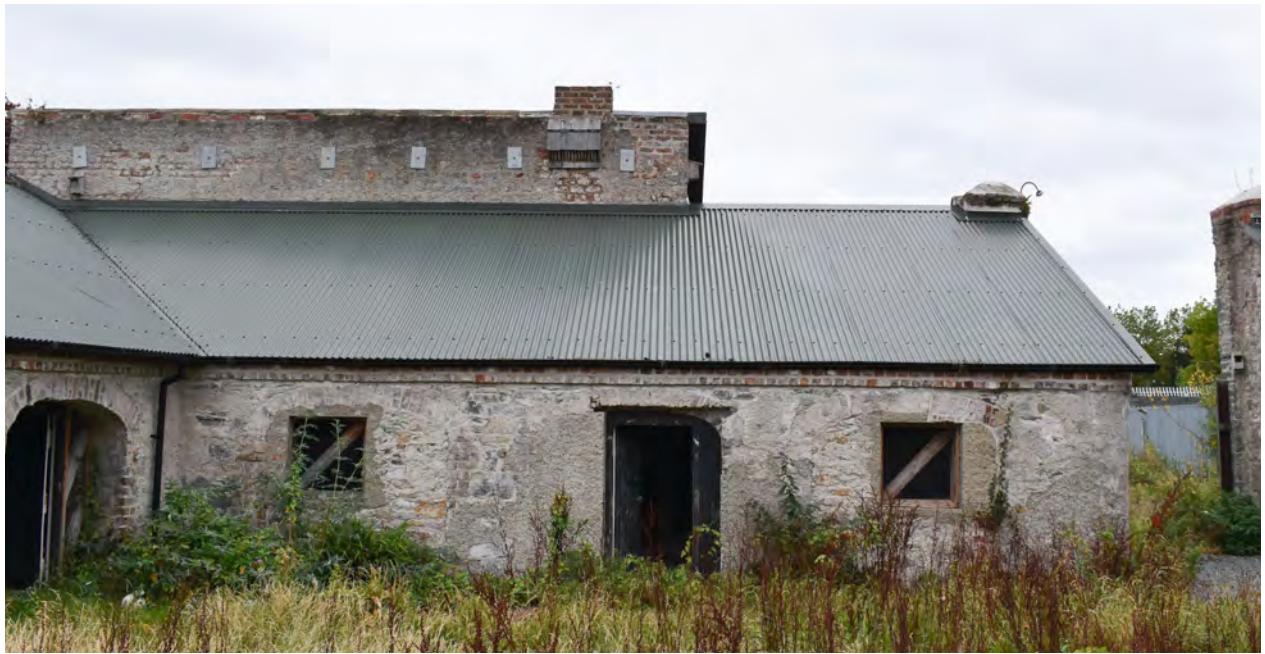
*North range. The three archways have been modified, with a doorway inserted into one half of the central archway flanked by rectangular windows.*

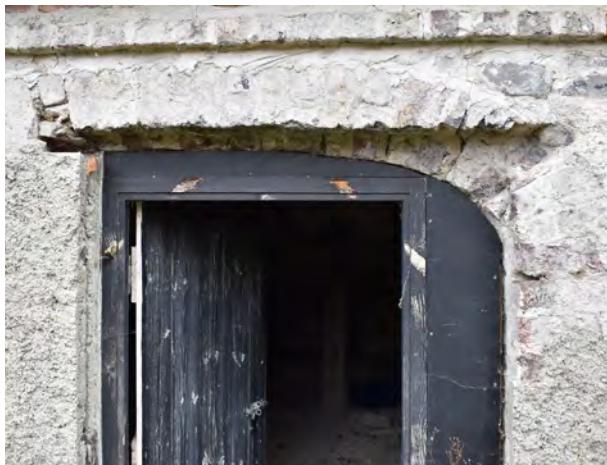
*Doorway inserted into one half of the central arch in the north range.*

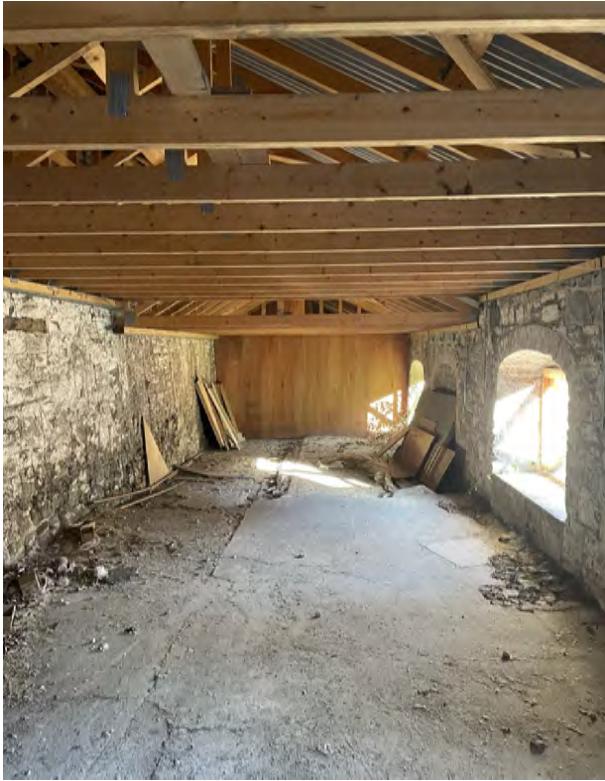
*Interior of the west range. The floor is covered in approx. 150mm concrete within most of the southern portion of the west range, and slopes significantly to the north.*

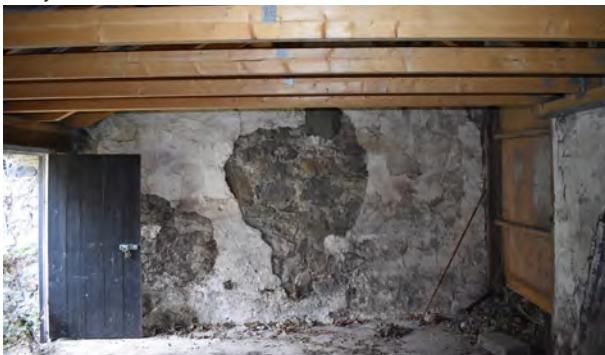
*The southern interior wall is part of the gable of Building 2. Areas of whitewashed lime plaster remains. Where damaged the random rubble stone is visible. Doorway to the left of image leads to Rathfarnham Road.*

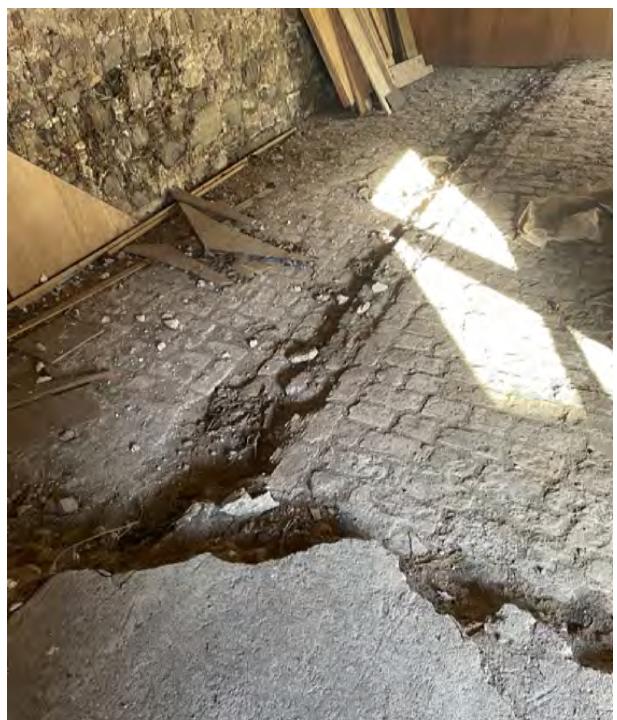
*Drainage channel formed in stone setts.*

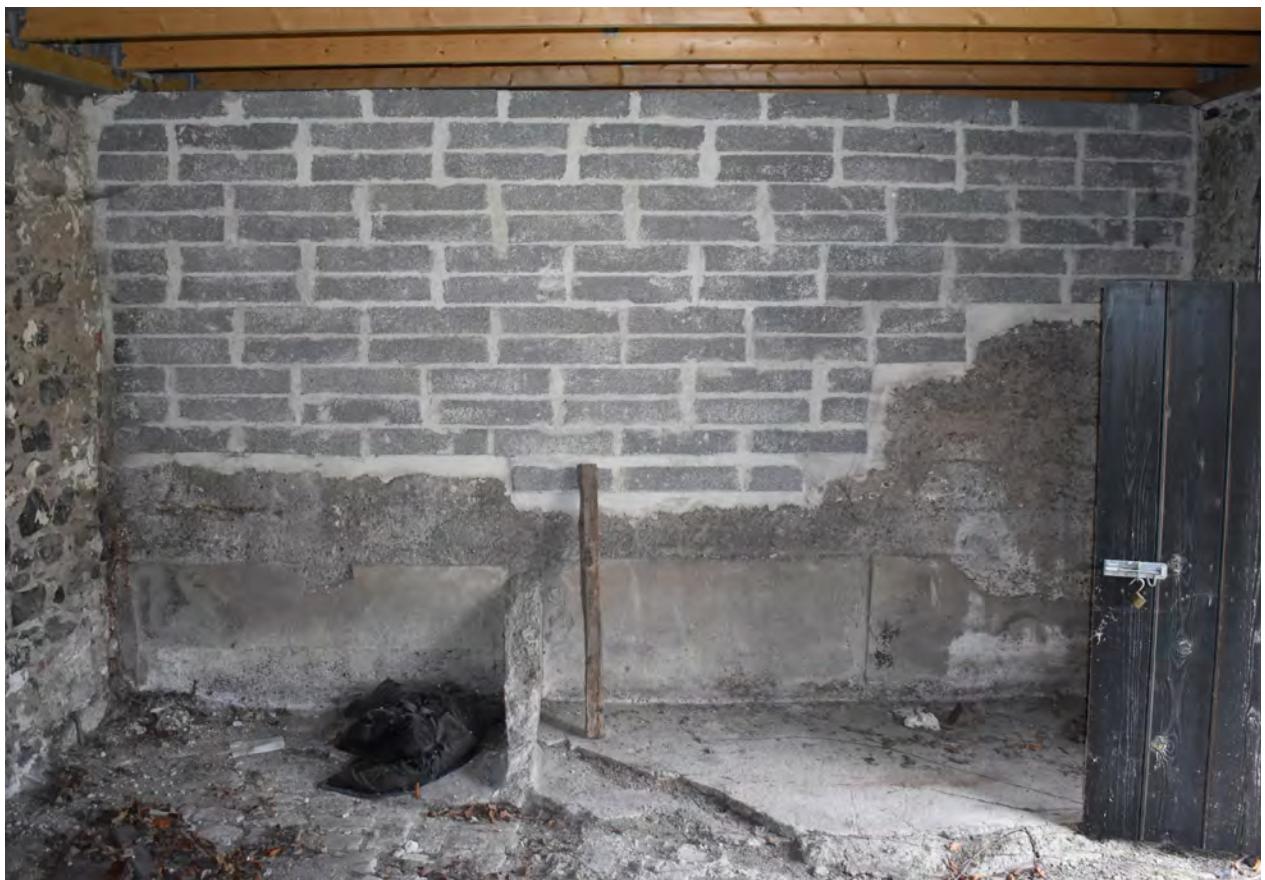
Dividing wall between west and north ranges. Remains of cattle stalls visible at base of the wall which has been built up to the base of the timber roof structure using concrete blocks.

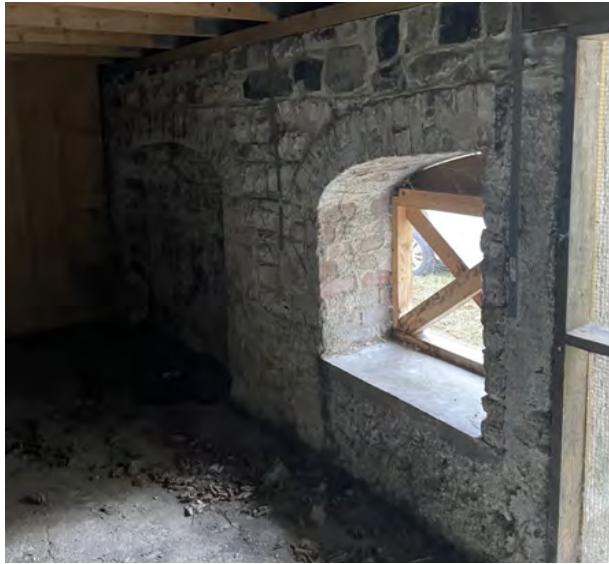
Partially demolished vaulted opening, modified cill height.

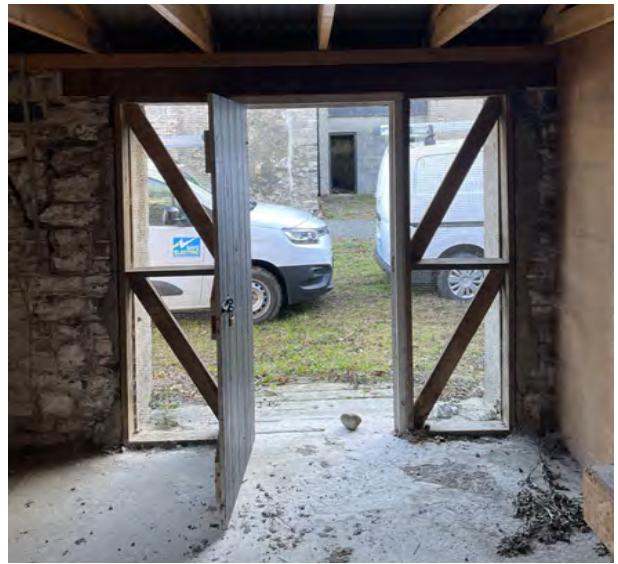
Square-headed door opening leading to west range.

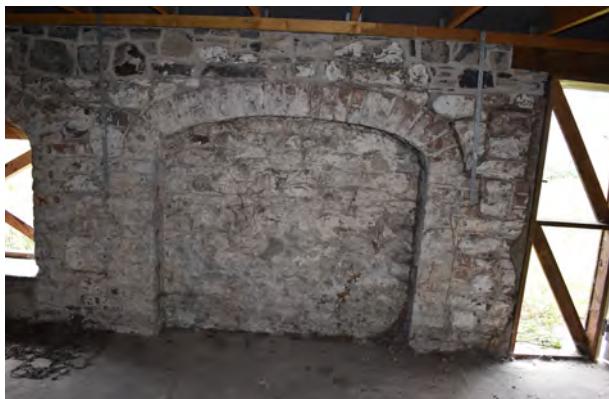
Blind archway filled with stonework.

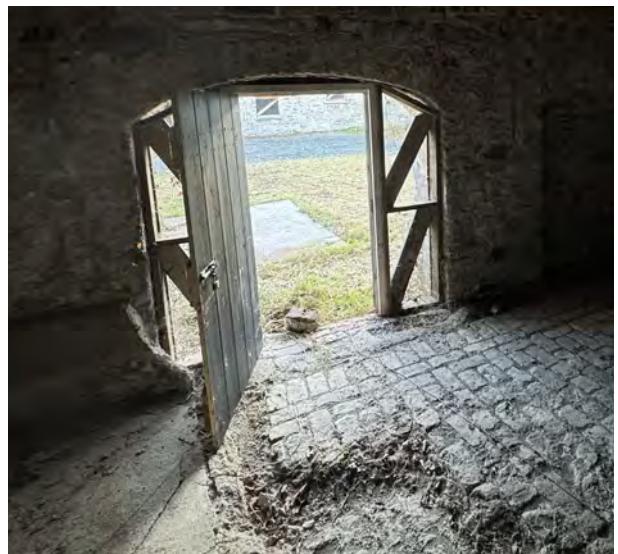
Archway fitted with timber bracing and door.

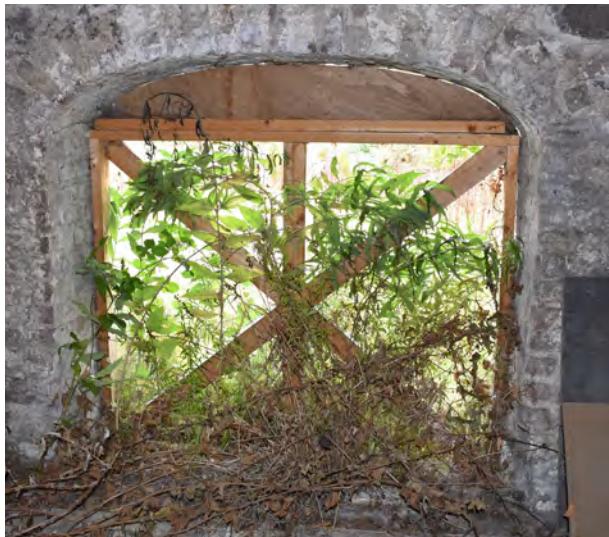
Vegetation growth in archway to northern end of west range.

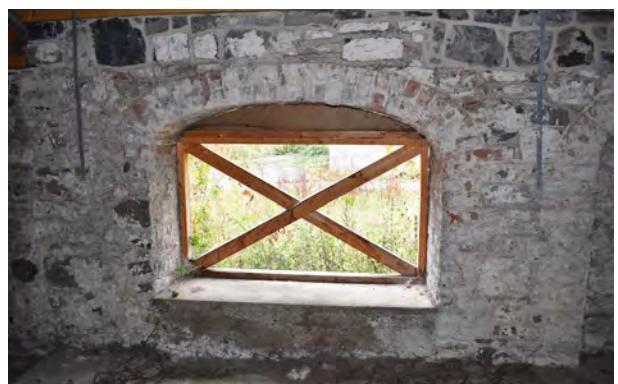
Modified archway with raised cill to create window opening. Opening braced with timber and fitted with protective mesh.
