# Stables and Courtyards at Rathfarnham Castle

Conservation Management Plan

30th April 2025

RATHFARNHAM CASTLE, CO. DUBLIN. 11551. W.L.

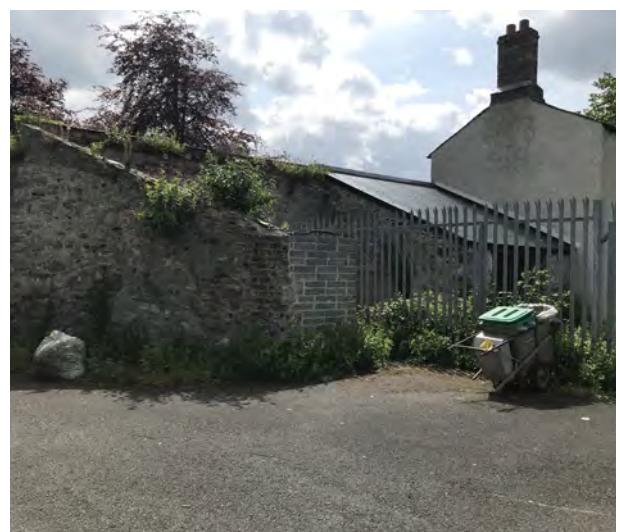
*Remaining walls of outbuildings to the north facing gable.*

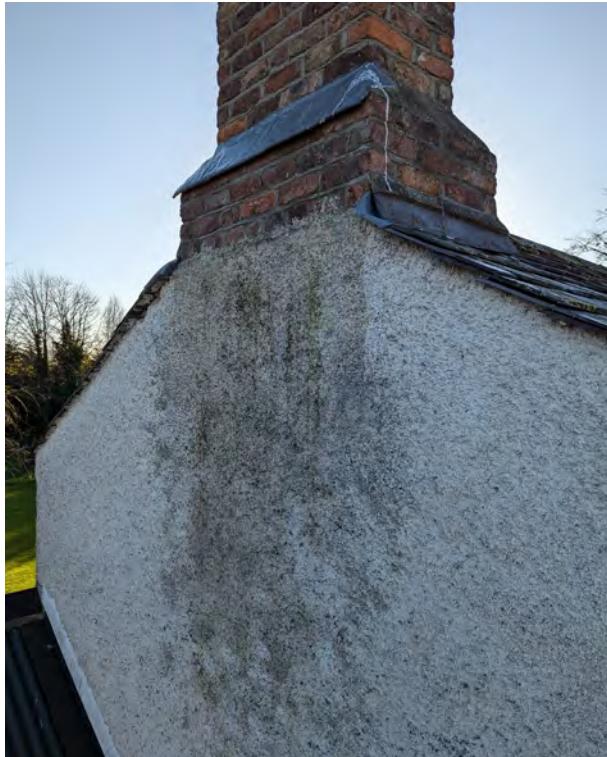
Damp staining to north facing gable.

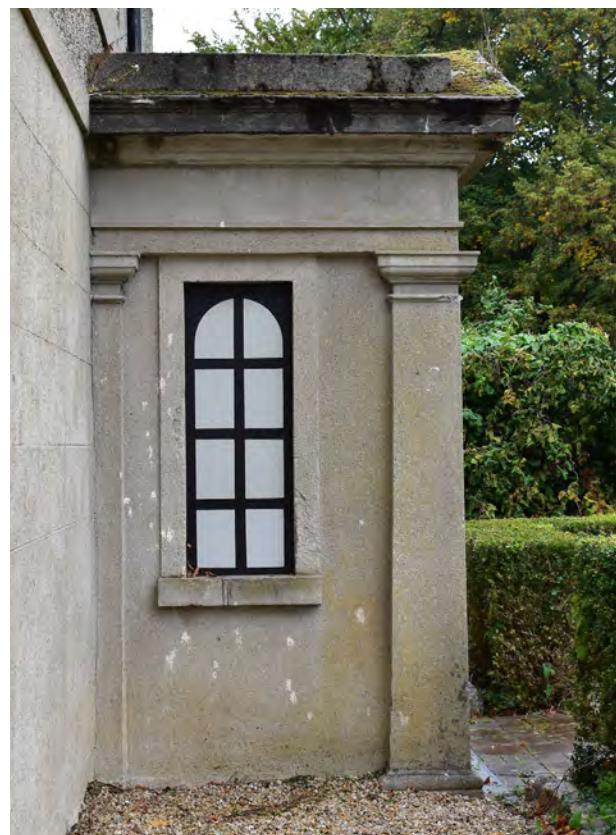
Window opening to the south facing side wall of the porch. Both windows to the north and south have been covered with a painted timber panel.

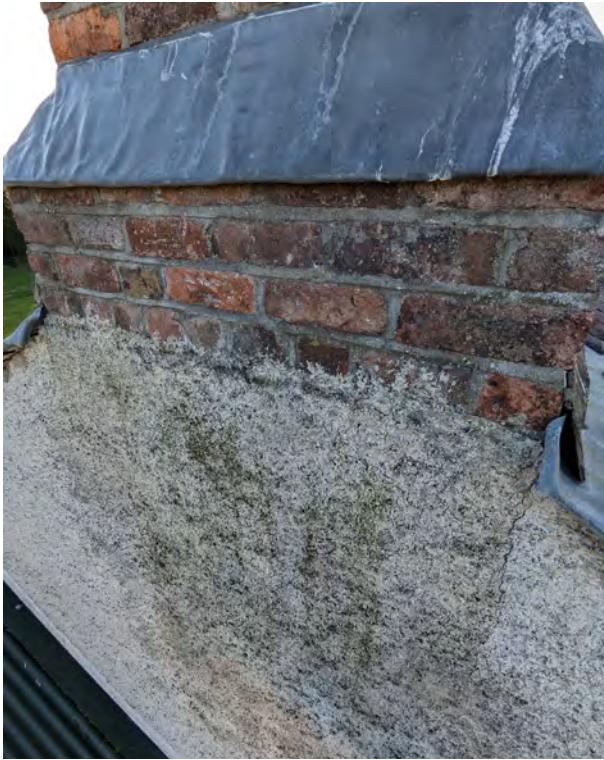
*Plasterwork of the northern gable wall discoloured due to damp staining beneath the chimney stack.*

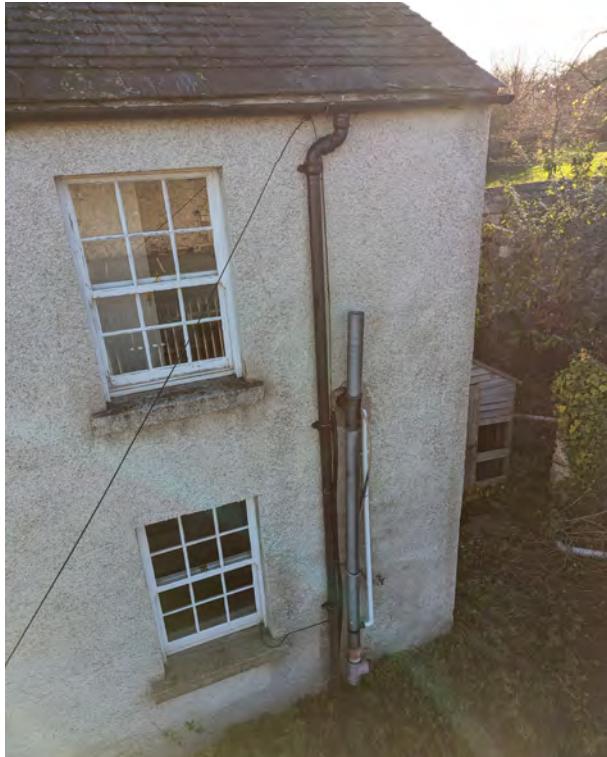
*Untidy services stack and electrical wiring.*

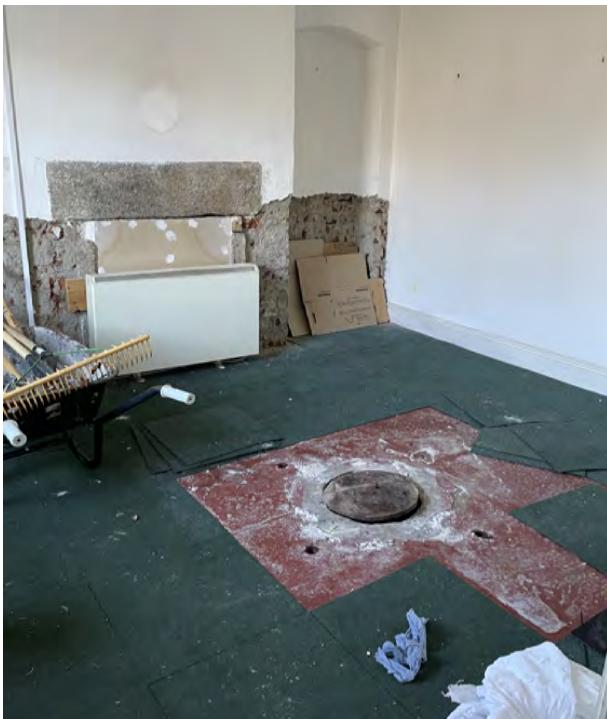
Ground floor room to the north. approx. 1m of internal plaster to the north facing external wall has been removed above finished floor level.

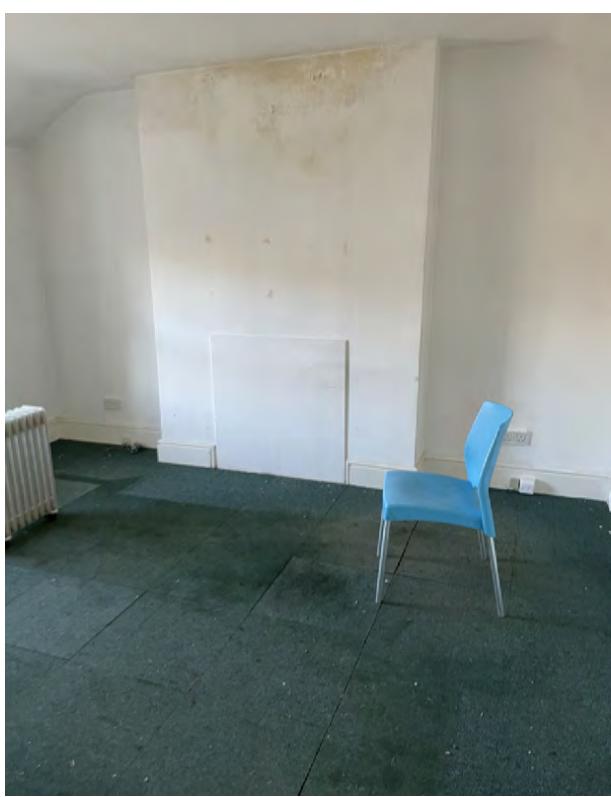
*Discolouration to top of chimney breast, first floor, north room.*

*Fig 4.7.2. 1<sup>st</sup> flr – staining at chimney*

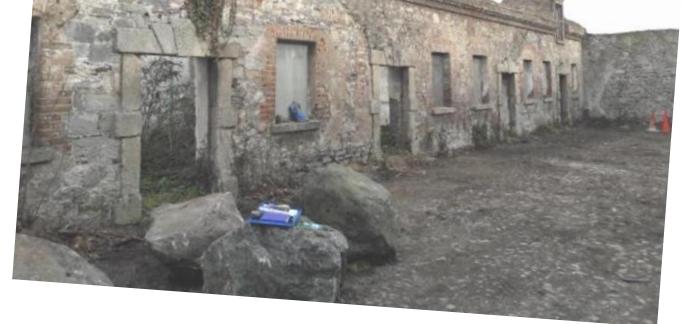
There are some areas of masonry repairs still outstanding such as where mezzanine floor used to be Cromwell's Fort and some pockets of degradation building B2

Fig 3.3.2 Photo from FO'S report 2023 on the 2017-2018 works

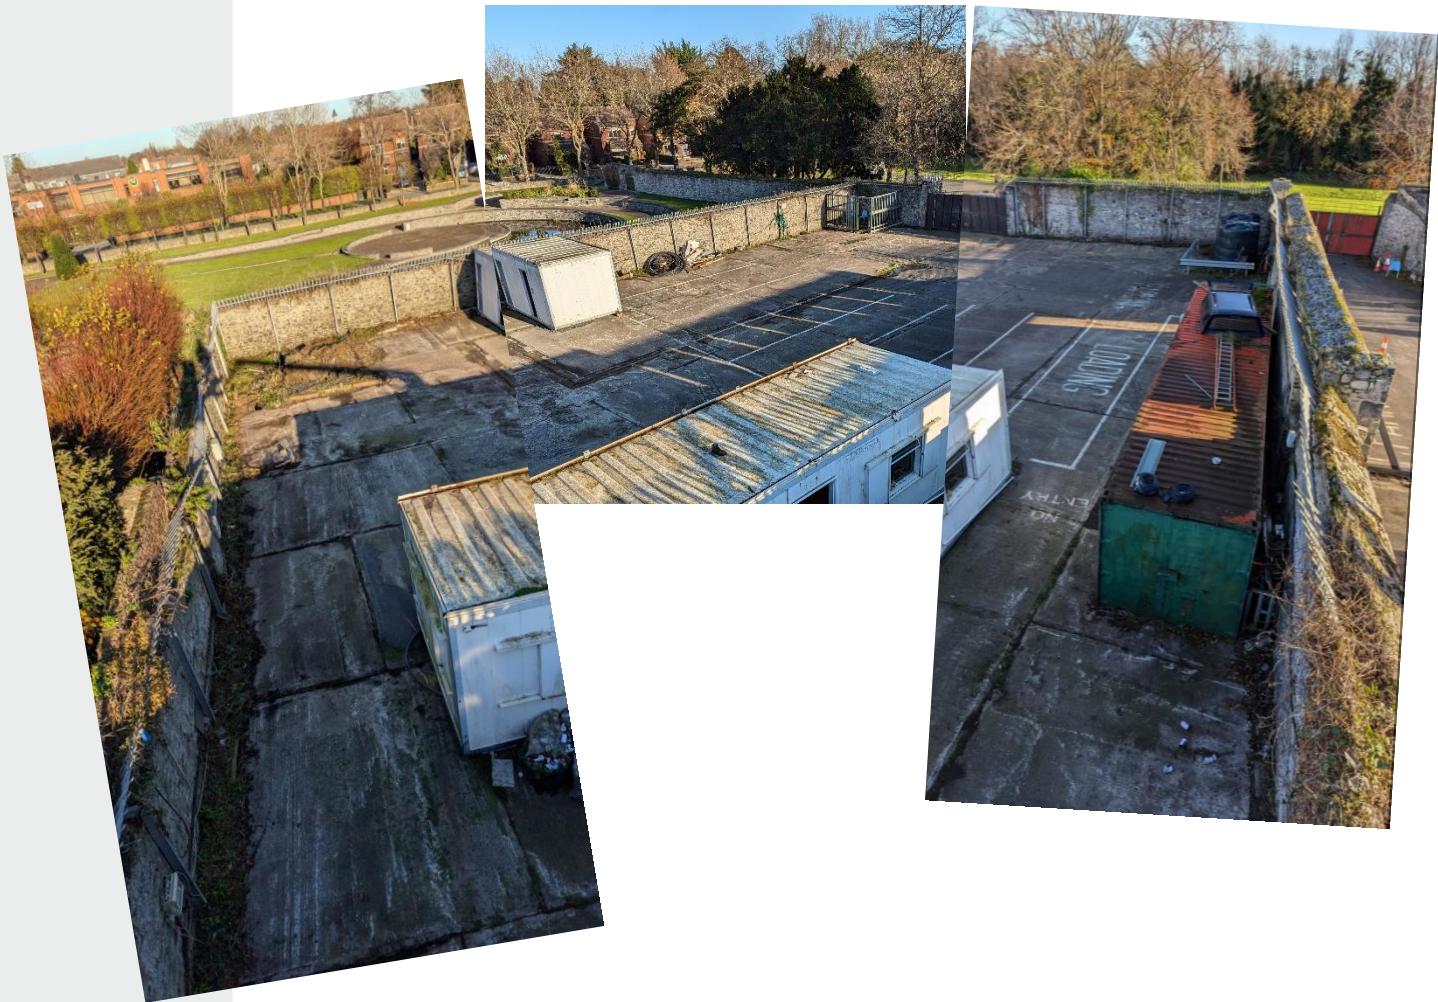
The walls of Courtyard 4 however were not including in the 2018 works.

*Fig 3.4 Courtyard 4 Photos c/o HHC Wall top survey 26<sup>th</sup> November 2024*

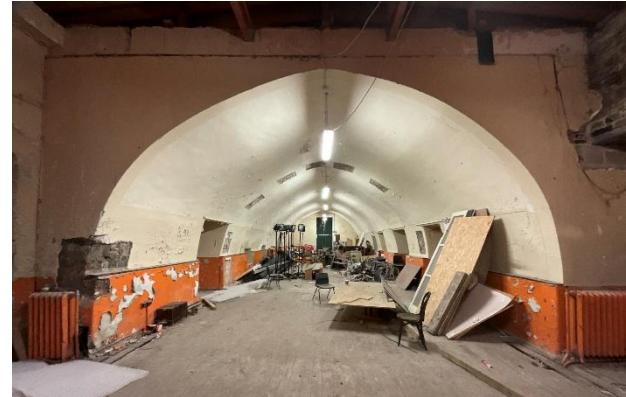
The most southerly portion is a single-story barrel-vaulted room with numerous windows through its thick side walls. The floor is solid and is likely a build up of many iterations of ground bearing slabs. It was re-roofed approx 6 years ago with a flat cut timber roof bearing on the vault. The vault may well have been in a saturated condition in places as it is noted from google maps that portions of the sheeting were missing from 2014 through to 2017. However, the masonry is likely now drying out.

*Fig 4.1.2 Southern portion of Cromwell's Fort*

Monitoring of moisture in this thick masonry fabric would be a worthwhile exercise with drying promoted by way of increased ventilation if moisture levels are found to be concerning. There have been some recent opening up to parts of the walls, but these would appear to have concentrated on finding previous window openings and have stopped short of investigating the current lintel details.

A full survey of the existing lintel condition is recommended prior to developing proposed repair works drawings as it is suspected that there may be some issues with the current lintels. Replacement hardwood timber or precast concrete should be allowed for.

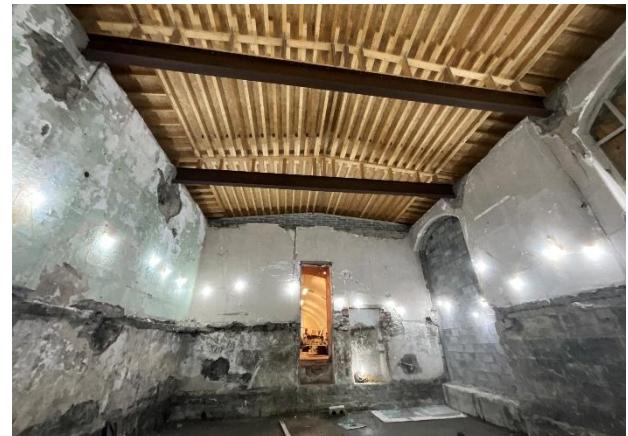
The northern most portion is the most structurally altered and currently fragile section with tall walls with large openings to the west side, the reveals of which have been compromised and now need repair. There are remains of a dismantled previous mezzanine slab again requiring localised masonry repairs. There is no ground floor. The foundations can be seen extending to at least 600mm below the external ground levels leaving some surety about the footings.

*Fig 4.1.3 Northern portion of Cromwell's Fort*

Any new ground floor could be either suspended timber or composite deck on tassel walls or alternatively a ground bearing buildup in either modern insinuation and concrete slab or a limecrete floor. This part was also reroofed in 2018 with steel beams and a cut timber roof to nominal falls. The roof weathering although not seen would appear to be serving its function as no water ingress was noted.

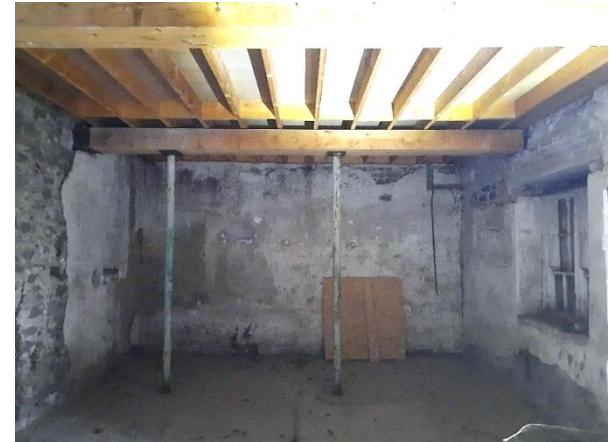
There is some back propping to one of the Mezzanine floor beams which will need to be interrogated if that mezzanine floor beam is to be retained.

Fig 4.2.4 Back propping to Mezzanine Beam noted photo HHC

The mezzanine floor insertion appears to have been carried out to provide a lateral restraining diaphragm and is thus helping stabilise the walls. Removal of the Mezzanine floors can be considered but additional tie rods may be required to compensate.

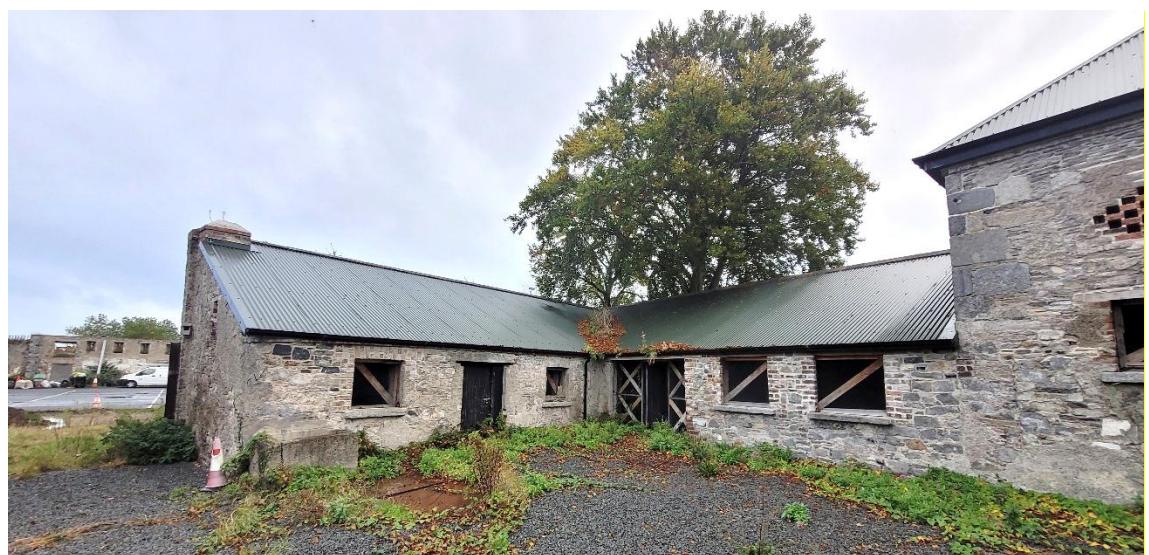
*Fig 4.4.2 Elevation onto courtyard 02, note debris in valley and gutters.*

Weed and vegetation control is required, and the roof valleys and gutters need debris removing on a regular basis particularly with the location of the large tree immediately to the north east.

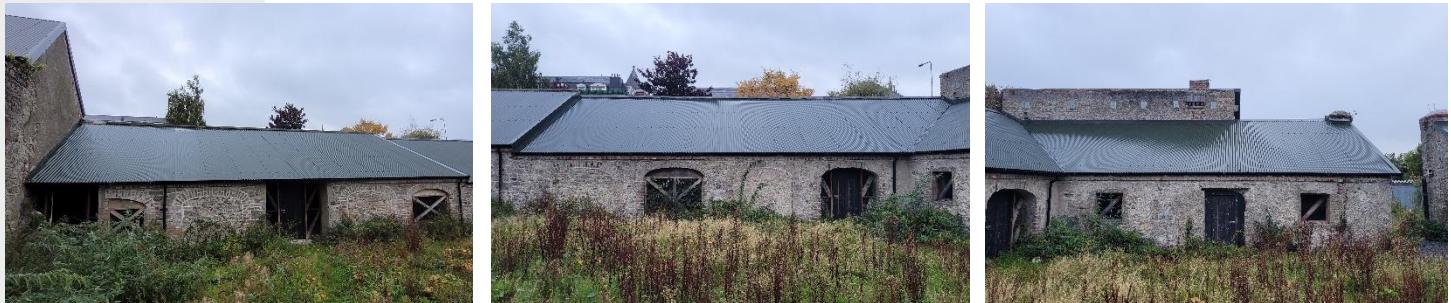
Fig 4.6.1 shallow pitched roofs and steps in roofs along elevation. There may be some capacity to raise roof to north (rhs) section against flank wall of Building 5

However as for building 3 any requirements to improve head room will likely entail removing the current roof and replacing with a cut timber roof

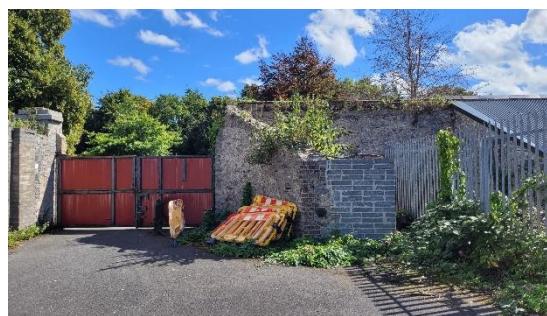
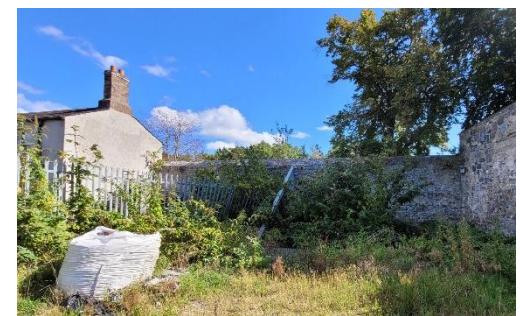
The general condition of this wall is serviceable, there are no excessive deflections. The wall and wall top present well to the east side adjoining the castle main driveway but to the courtyard side there is some plant growth and wall top repairs are required. There are also plants growing from the return wall at the north end that formed the perimeter to a previous outbuilding. Localised repairs will be required along with reinterpretation of the outbuildings to the north of the Seismograph House.

Fig 5.2.2 West side of Wall A - Vegetation control; wall top and localised repairs required.

In the immediate short-term Vegetation growing on the west side of this wall within courtyard 03 needs to be managed and should be undertaken as part of general maintenance now before the end of February 2025.

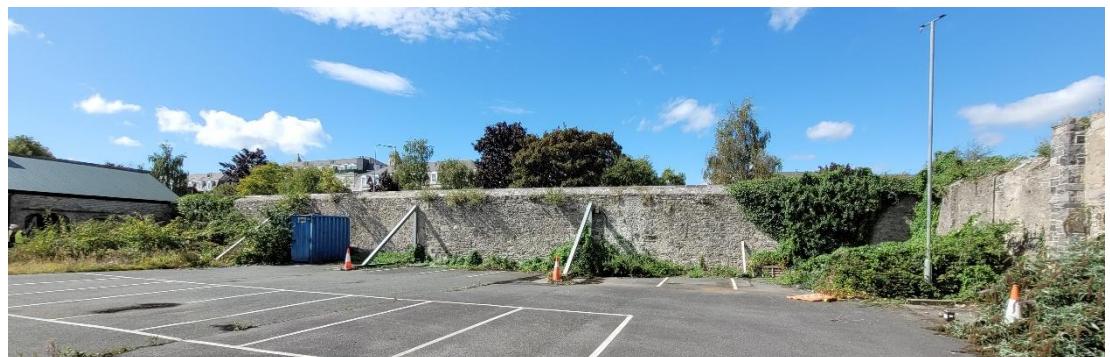
The west wall of courtyard 03 has received significant repairs as part of 2017/2018 works along with restraint by galvanised steel braces, fixed through the wall to pattress plates on the external face of the wall. The general condition of the west wall is fair, the wall tops appear well repaired, but some signs of moss are returning along with mortar loss to the courtyard face near wall top. There is some deflection of the wall top mid span, eastwards into the courtyard.

The vegetation growth is being allowed to return albeit this was cleared off again for the wall inspection 26<sup>th</sup> November 2024. There is a build up of soil against the south end of the wall which is detrimental to the wall health and should be removed.

*Fig 5.3.1 East face of west wall to courtyard 03 as it presented September 2023*

Careful integration into the proposed new buildings will serve to restrain and weather these walls and their further wellbeing should be integral to the design of those buildings. The previous deflections will need to be incorporated into the new building design.

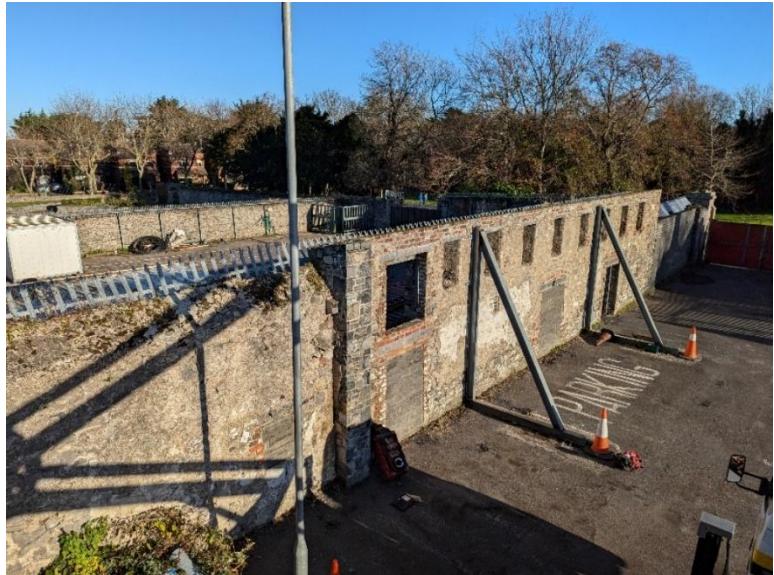
The tall wall to the north of Courtyard 3 is currently freestanding. In places it is offered some restraint by galvanised steel braces through fixed to pattress plates on the external faces of the walls. The general condition of this north wall to courtyard 03 is serviceable, there are no excessive deflections, and the wall and its wall top have been recently repaired keeping the worst of the moisture from the wall cores.

Fig 5.4.2 Photo c/o HHC from wall inspection 26<sup>th</sup> Nov 2024

Some immediate benefit to the wall could be gained by removing the banked up stored soil from against the wall base. The small section of the wall to the west end should also have the vegetation removed – ref works to west end of Courtyard 04

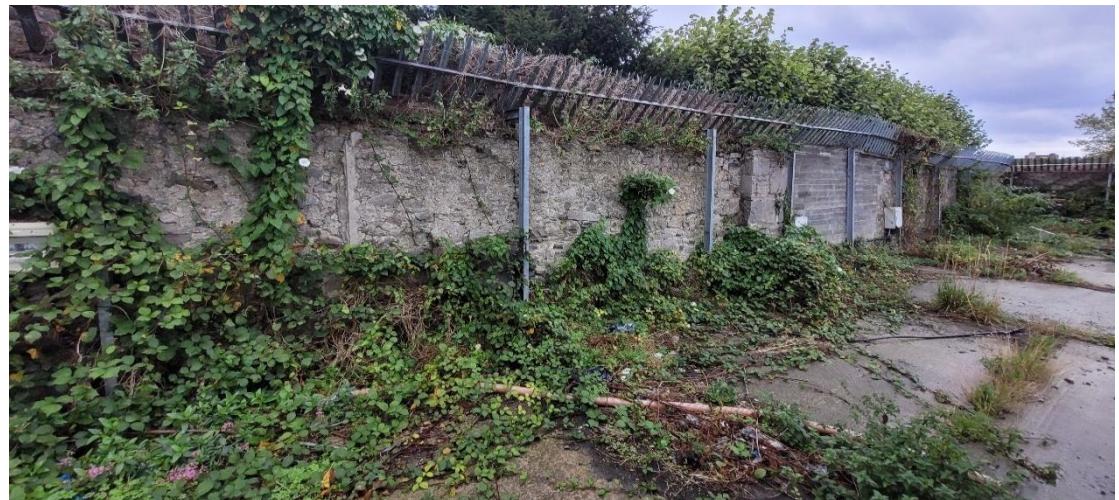
*Fig 5.5.3 View of east face of west wall, note blockwork sections and vegetation growth.*

The most immediate productive action regarding these west and north walls is to cut the vegetation back hard January / February 2025 before the 1st of March wildlife act deadline to allow full detailed assessment of and if necessary, some emergency propping to prevent a collapse of the walls

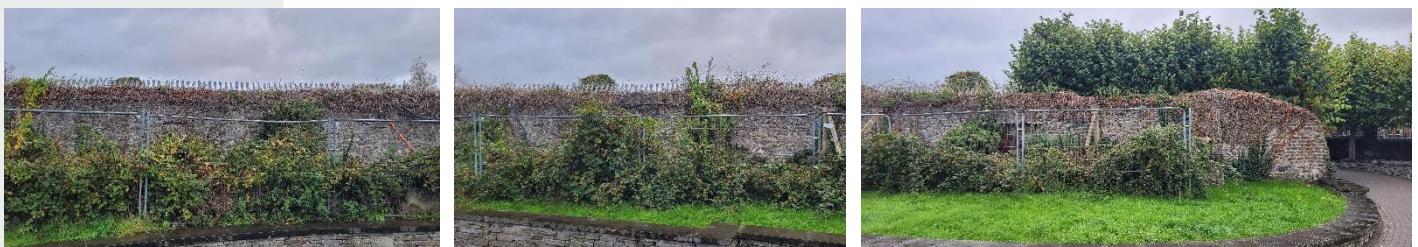
*Fig 5.5.4 View of north face of north wall, Courtyard 04*

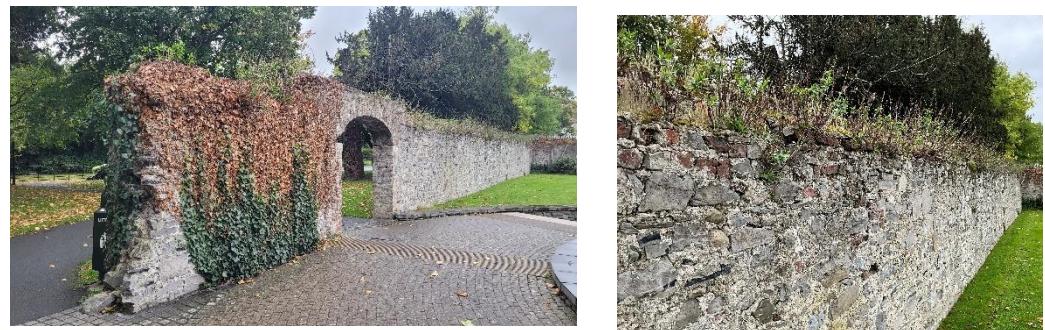
This wall is in fair condition, but its most northerly end is unravelling and needs stabilisation and its brick top 'weathering hat' detail needs attention. It is recommended that the end and top vegetation is carefully removed, the exact wall top detail established and such reconstructed in lime mortars to effectively weather this wall top. It is assumed that the original wall top detail is as the sketch below.

*Fig 5.6.1 Wall G running to east side of park, part of historic layering.*

Cutting back the excess of vegetation growing on the wall should be carried out now before the 1<sup>st</sup> of March 2025 to allow masonry works to occur in the next appropriate lime works season.
